ACCIDENT

Aircraft Type and Registration:	Bolkow 207, D-ENWA	
No & Type of Engines:	One Lycoming O-360-A1A piston engine	
Year of Manufacture:	1965	
Date & Time (UTC):	27 August 2007 at 1535 hrs	
Location:	Near Stapleford Aerodrome, Essex	
Type of Flight:	Private	
Persons on Board:	Crew - 1	Passengers - 2
Injuries:	Crew - 1 (Fatal)	Passengers - 1 (Fatal) 1 (Serious)
Nature of Damage:	Aircraft destroyed	
Commander's Licence:	Private Pilot's Licence	
Commander's Age:	43 years	
Commander's Flying Experience:	158 hours (of which 24 were on type) estimated Last 90 days – 11:10 hours estimated Last 28 days – 6:25 hours estimated	
Information Source:	AAIB Field Investigation

Synopsis

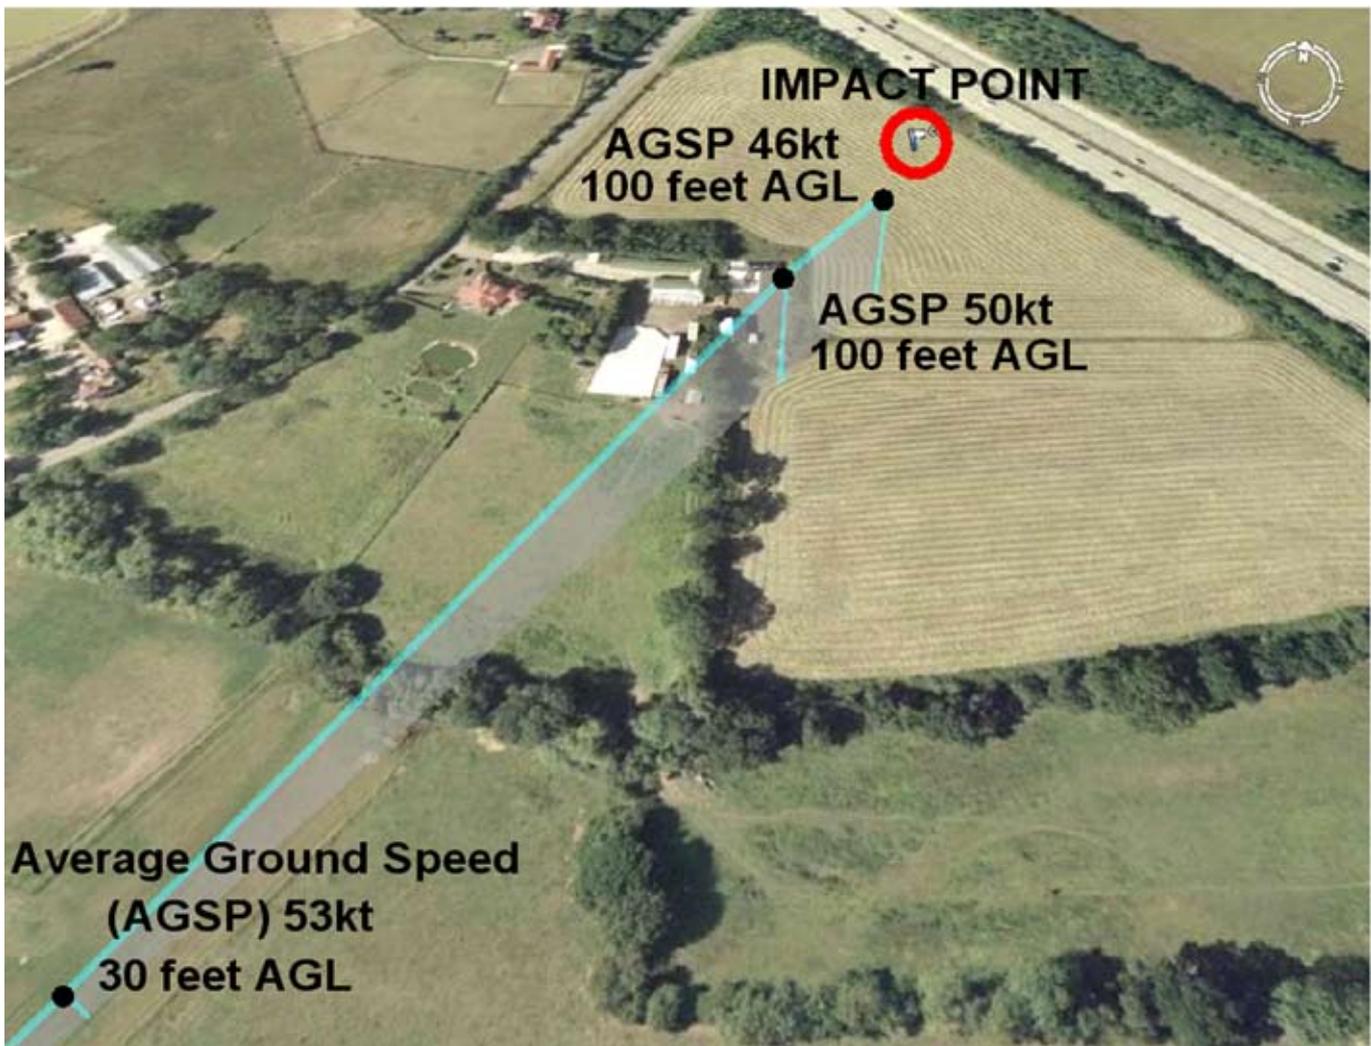
The data provided the average speed of the aircraft during six consecutive segments of the accident takeoff. During the first 50 m segment the average ground speed had been 12 kt, 28 kt during the following 120 m segment, 42 kt over the next 175 m segment, 53 kt over the next 250 m, 50 kt over the next 211 m and 46 kt over the final 50 m segment. The last three segments were recorded after the aircraft had taken off, with heights of about 30 ft, 100 ft and 100 ft recorded respectively. The average climb rate between the 30 ft and first 100 ft point was 555 ft/min. The impact point was about 80 m from the final GPS position. Figure 1

shows a visual plot of the flight path for the final three segments and the ground impact position.

Visual plot of GPS data

The GPS data, when corrected for the light headwind, showed that the aircraft's average airborne airspeed was well below the recommended climb speed, the average over the last 50 m segment being about 51 kt. Although the aircraft did climb initially, this appears to be at the expense of airspeed, which reduced during the period of recorded airborne data.

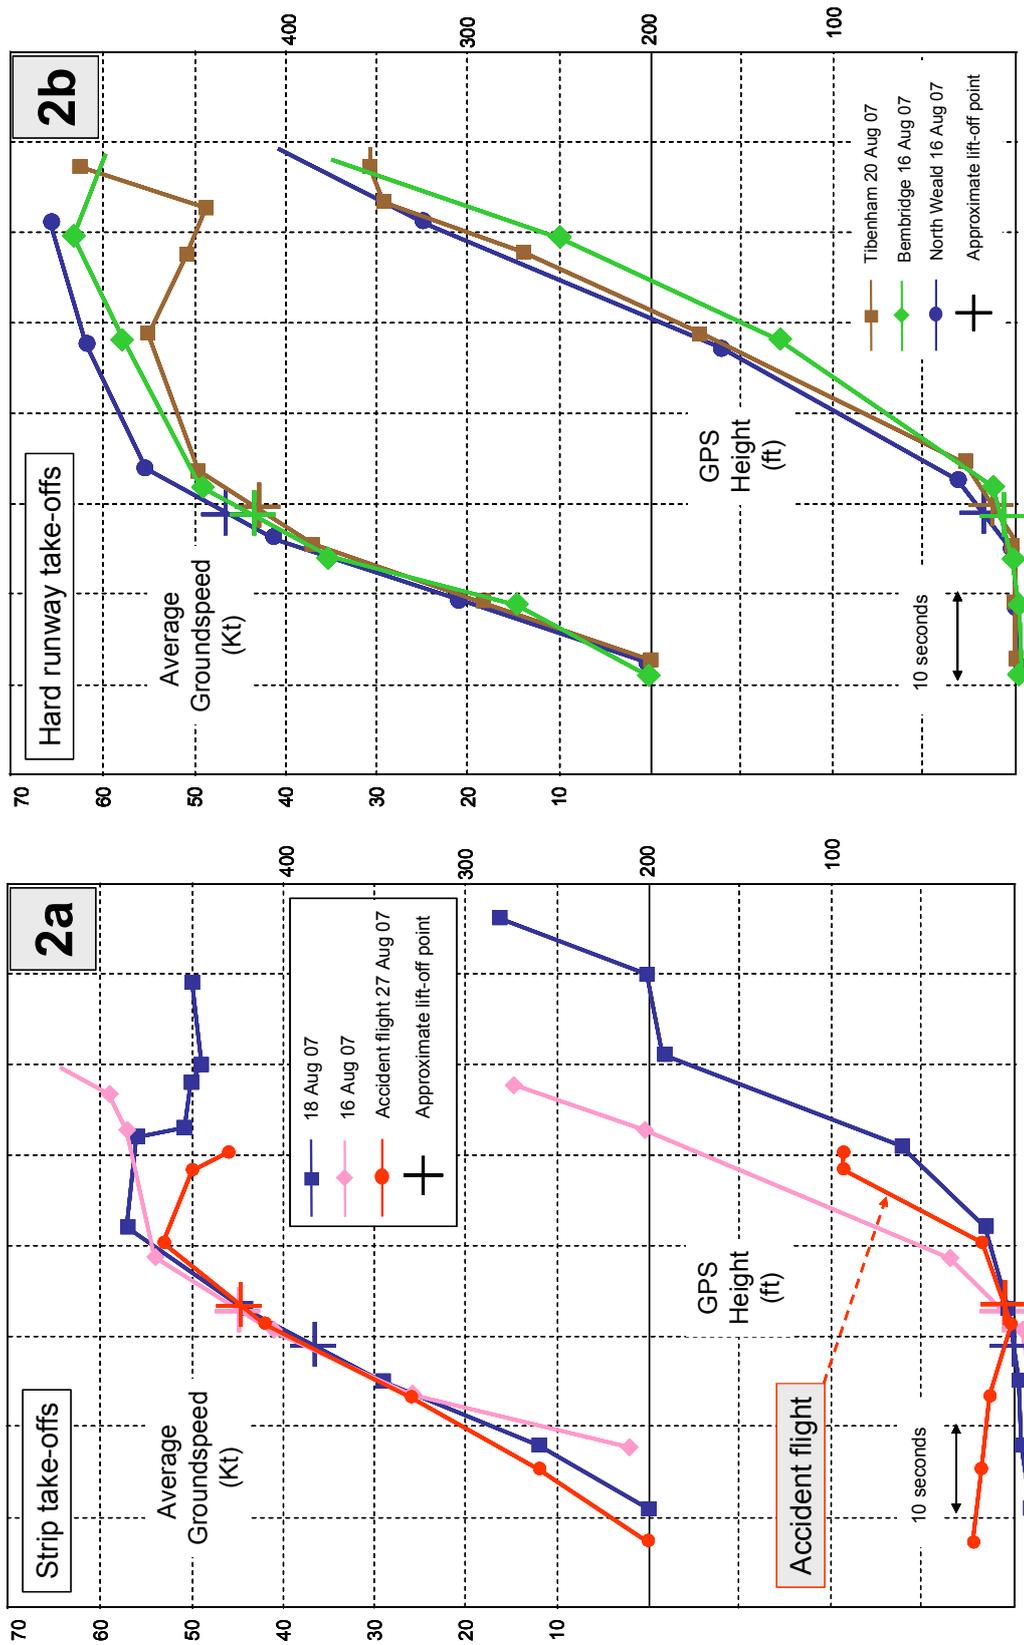
Figure 2
GPS data from previous takeoffs

Of the six takeoffs recorded by the GPS, it is likely that only one had a headwind component exceeding 10 kt. This takeoff is shown in Figure 2a as the blue plot of 18 August 2007 (headwind component about 15 kt). The other strip takeoff, on 16 August 2007 was with little or no headwind component. Of the hard surface takeoffs shown at Figure 2b, two were made at airfields with paved strip lengths of 837 m and 1,250 m (Bembridge and Tibenham) and one at North Weald, with 1,920 m available. The headwind component for these takeoffs is estimated to have varied between nil and 9 kt.

The recorded data also showed previous occasions when the initial climb profile exhibited similar characteristics to the accident flight. This is most notable in the data for 18 August 2007. Although on this occasion the aircraft was climbing into a stronger headwind (about 15 kt), this alone would not account for the significant sustained drop in groundspeed combined with almost level flight over a 10 second period. The takeoff on 16 August was made in very light crosswind conditions so any headwind effect would have been minimal. On this occasion airspeed was also low and increased only slowly as the aircraft climbed.

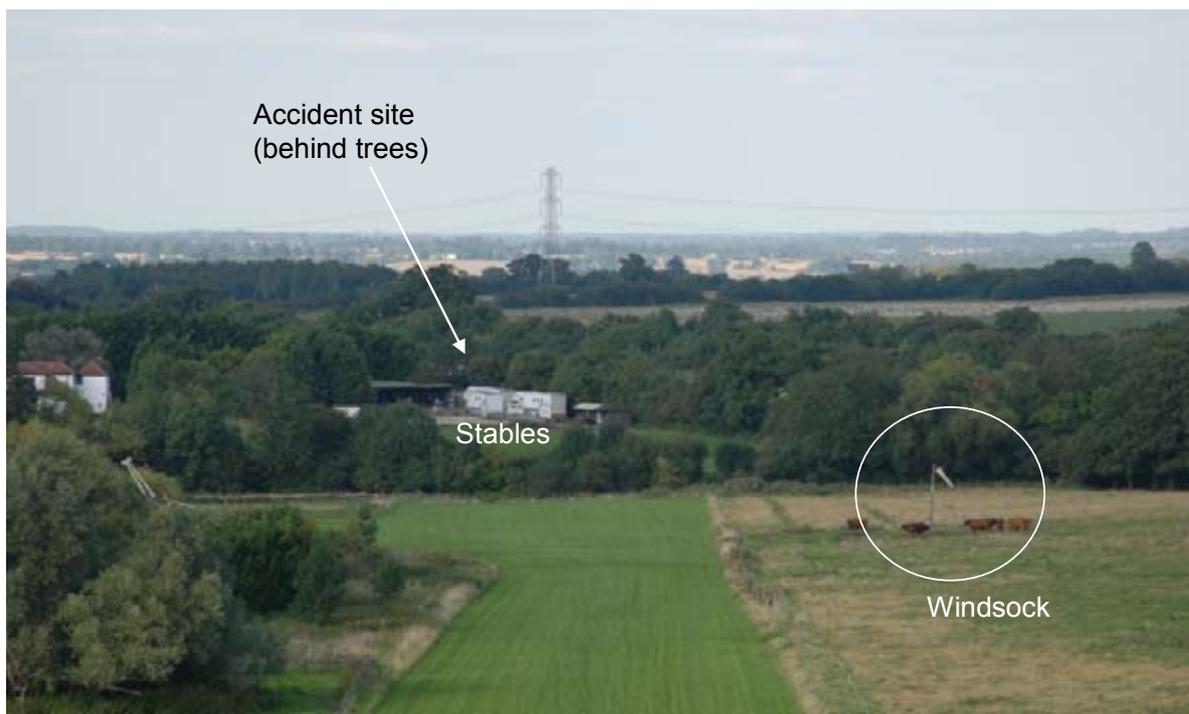
The strip itself was 680 m from hedge to hedge, with an overall down slope of 1.6% in the northerly takeoff direction. The orientation of the strip was 028°/208°(M) and the mean elevation was 230 ft. A tree line crossed the upwind boundary, with further tree lines beyond, including on either side of the M25 motorway. The trees at the end of the strip were about 30 to 40 ft tall, but higher to either side. The taller trees in the vicinity reached an estimated 60 to 70 ft. The M25 ran in a cutting, approximately 290 m from the departure end of the strip. Beyond this was a large field, with power lines. Figure 3 shows the view from the police ASU helicopter whilst hovering over the strip, looking towards the accident site. The pylon is at a distance of 1,000 m from the strip.

Departure end of the strip
