AIRCRAFT ACCIDENT REPORT 3/2004

**Report on the accident to
Eurocopter AS332L Super Puma, G-BKZE
on-board the West Navion Drilling Ship
80 nm west of the Shetland Islands
on 10 November 2001**

Air Accidents Investigation Branch

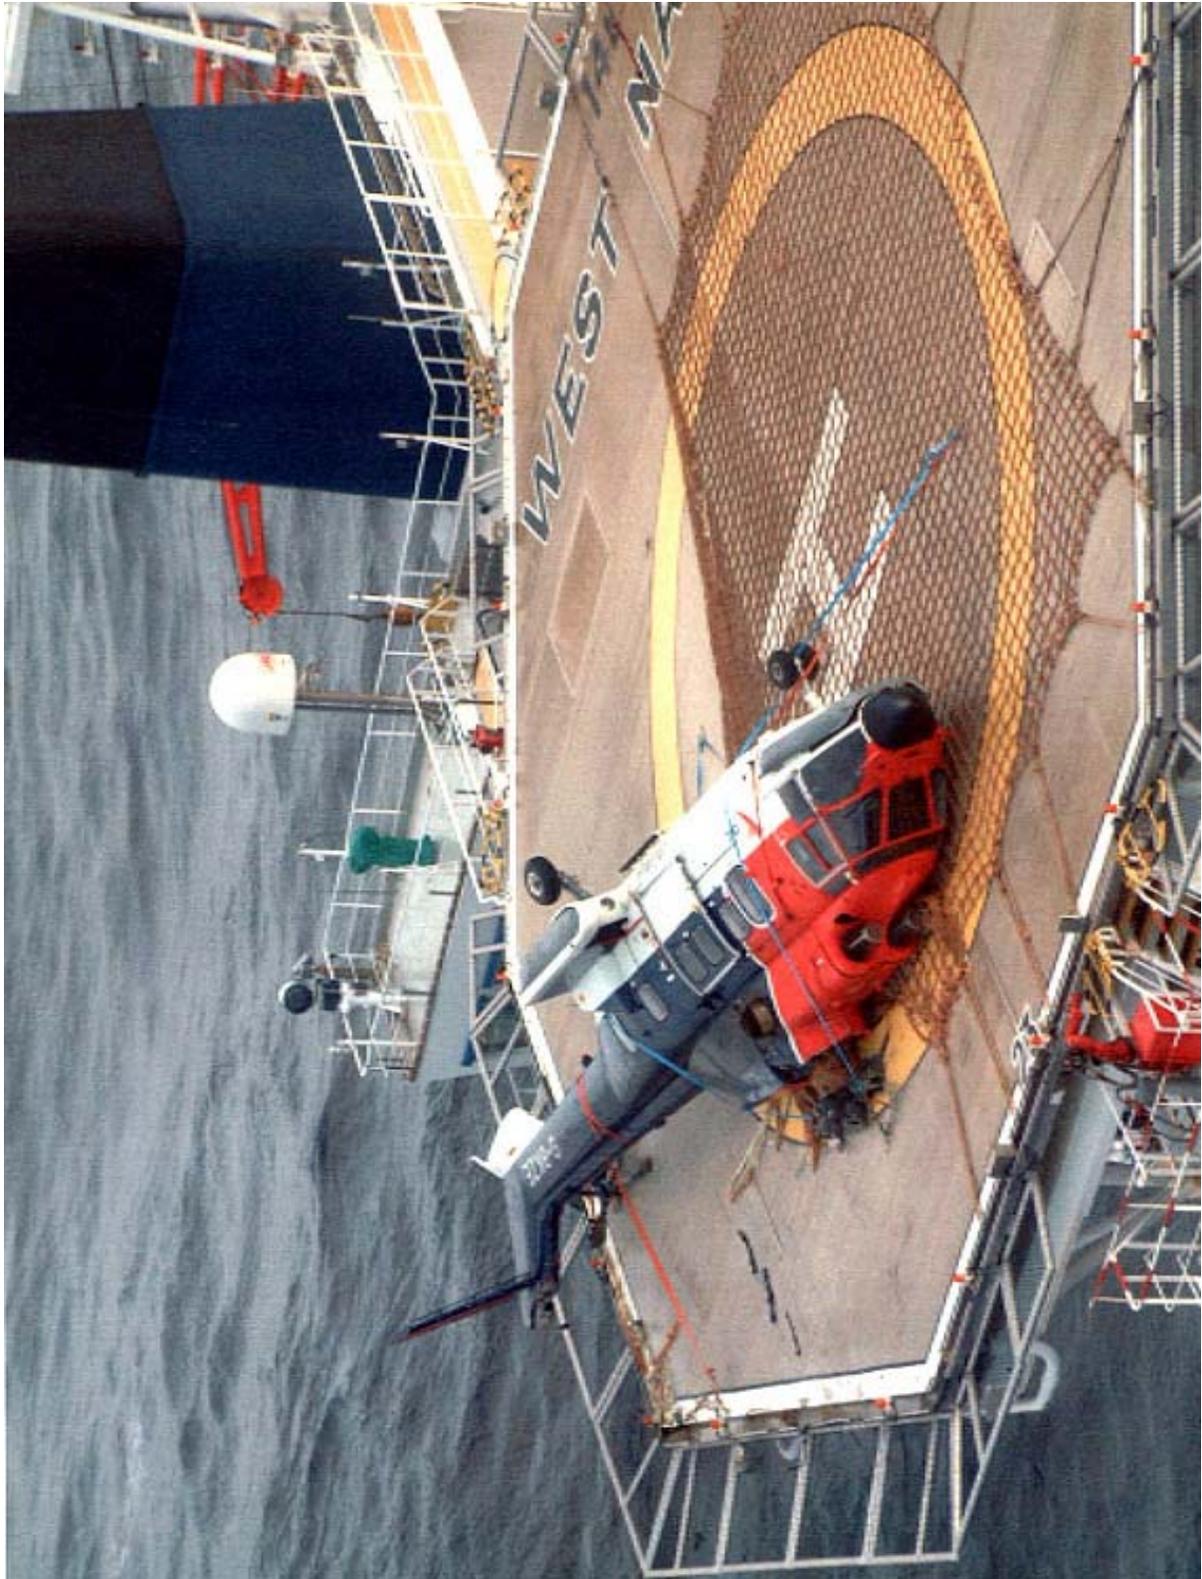
**General View of G-BKZE
Post accident**

The main rotor blades had become fragmented as they struck the helideck when the aircraft rolled over. Pieces of blade debris were recovered from various parts of the ship, although much of it undoubtedly went overboard. The rotor head, blade cuffs and pitch change linkages had also suffered severe damage. The tail rotor assembly, including the gearbox, had become detached and was found on the deck at the rear of the aircraft. Four of the five blades had suffered major damage as a result of contacting the deck. The aircraft was otherwise substantially intact, with no major structural damage immediately apparent. However, crushing damage to the right side of the fuselage had extended to the right windscreen, resulting in a gap that had allowed fire-fighting foam to enter the cockpit.

- 16 The helicopter's main rotor blades struck the helideck and fragmented. Flying debris injured the co-pilot and damaged parts of the ships' superstructure. The helicopter was substantially damaged.
