No: 8/89

Ref: EW/G89/05/08

Aircraft Type and Registration: Piper PA-23-250, G-AZBK

Nature of Damage: Damage to the right undercarriage, right engine, propeller and right wing

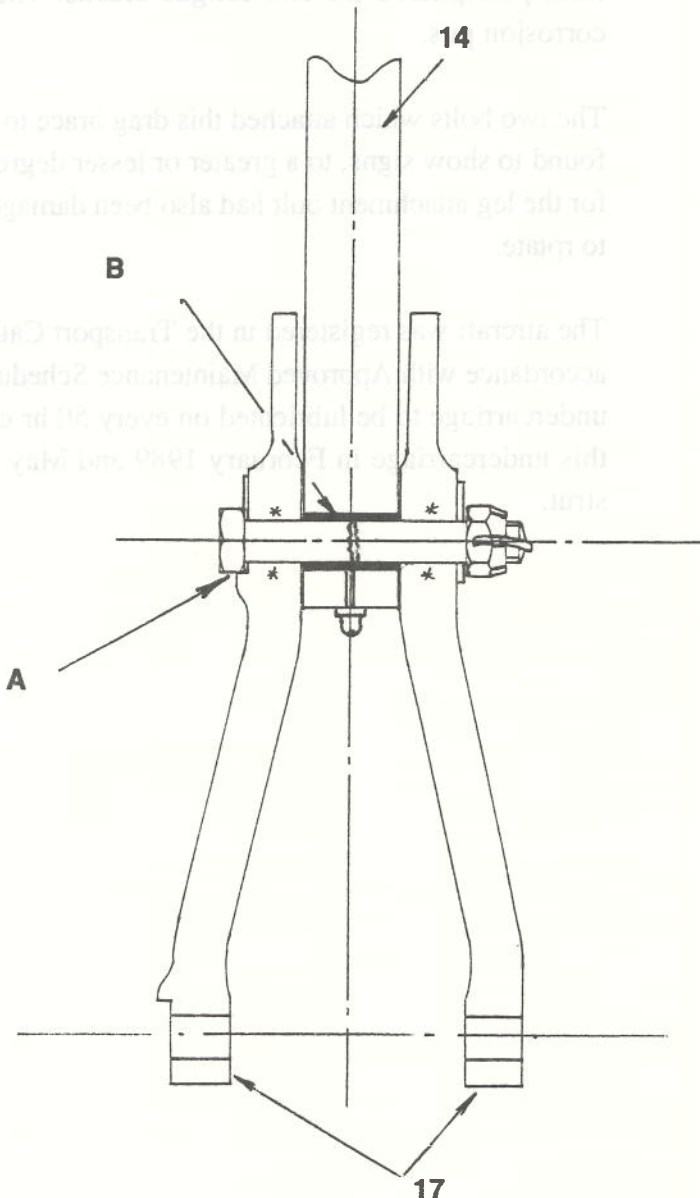
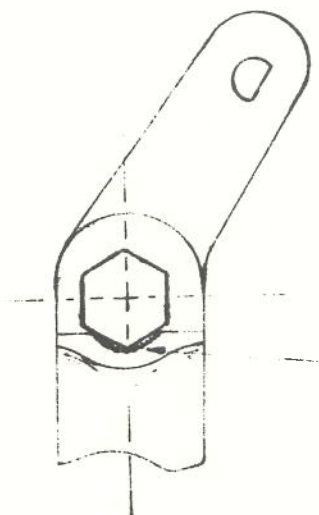
FIGURE 1

Figure 1 shows a cross section of the drag brace centre joint and, as may be seen, it is made up from three forged aluminum alloy links pivoted about a common 9/16" diameter bolt.

Detailed examination of this bolt revealed that it had failed in reverse bending fatigue and also that it was in poor condition generally. It was apparent that most of the shank showed signs of pitting corrosion

and there was surface damage consistent with the effects of the bolt rotating under load in the two cranked links. The bolt holes in these links (*) were oval. It was also apparent that the machined anti-rotation flat on the inboard link (A) had been damaged by the bolt head, such that bolt rotation was possible. Ovality was also present towards the outer ends of the bronze bush (B) in the centre link.

It was thus apparent that, after the flat had been damaged by bolt rotation, wear had taken place due to continued rotation in the unbushed and unlubricated holes in the cranked links. Once this had occurred, the bolt was no longer working purely in shear but could also experience bending stresses which, in turn, precipitated the two fatigue cracks. The origins of these cracks were centered on individual corrosion pits.

DAMAGE TO ANTI-ROTATION 'FLAT'
