Aircraft Type and Registration: Aerospatiale AS355F1 Ecureuil II, G-SASU

Date & Time (UTC): 7 July 1994 at 1620 hrs

Location: Stapleford Tawney Aerodrome, Essex

Nature of Damage: Substantial damage to lower fin and left skid

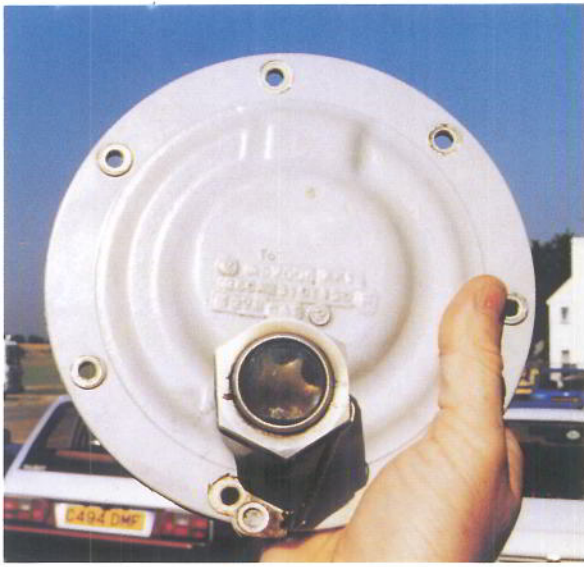
Plate 1

There was little evidence, on the inside of the casing, of the 'shellacking' which normally results from oil being overheated. The oil level sight glass was quite darkly discoloured just below the normal maximum level of the oil and this feature, together with the shape of the reflective plate within the sight glass assembly, was observed to give a strong illusion of a satisfactory oil level despite there being no oil in the glass at all. Subsequent tests to determine the visibility of various oil levels, using the same oil as was used by the operators, confirmed the indistinct and potentially misleading nature of the indication on this particular sight glass (see illustrations).

View of sight glass taken in bright sunlight demonstrating the sharp cutoff of the staining.

CAA Airworthiness Notice 12, Appendix 43, draws attention to the possibility that stained oil level sight glasses may give a misleading impression of the actual oil level and calls for their inspection, and cleaning, if necessary. The operator's maintenance staff were aware of the contents of this notice. There was, however, no procedure in the Maintenance Manual for the removal, cleaning and refitting of the sight glass. In the Overhaul Manual, which is held by the UK Main Agents, reference is made to a standard procedure for cleaning the sight glass during overhaul, if it is considered to be necessary. The Overhaul Manual was also the only place in which the oil level marking on the sight glass, which requires special tooling, was specified.

94-38 The French DGAC, together with the manufacturer, should review the information and procedures related to the lubrication of the tail rotor gearbox and their location within the various technical manuals for the AS350 and AS355 types.

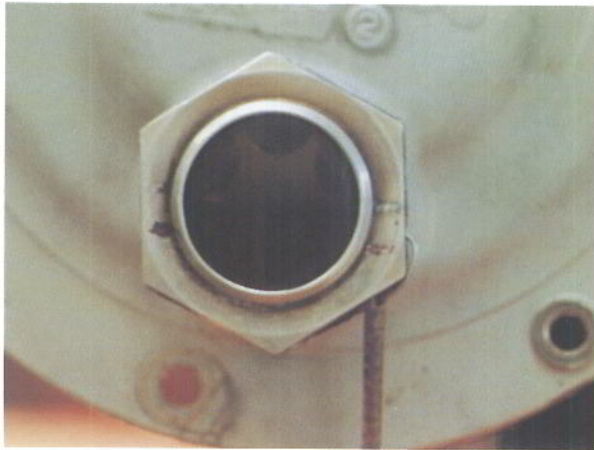
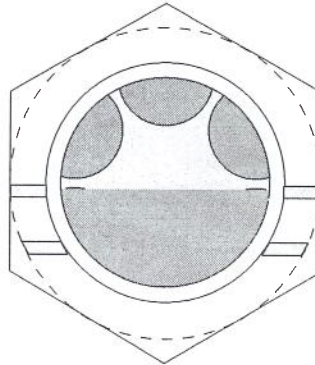
The three photographs shown below were taken during a controlled test in a brightly lit hangar and demonstrate the difficulty of discerning the oil level within the stained area.

A - Sight glass filled to maximum level mark

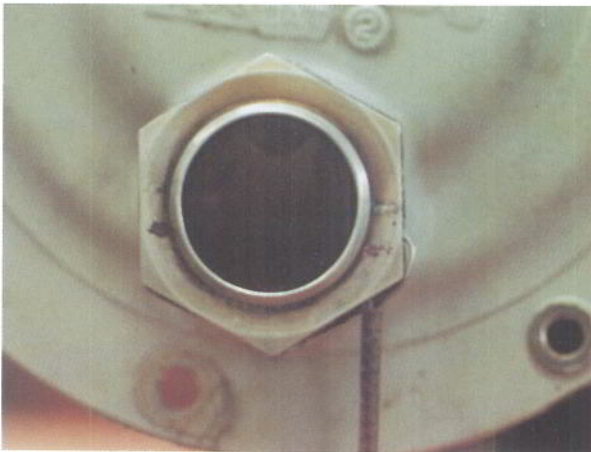
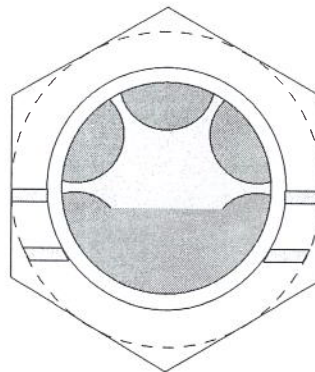
B - Sight glass filled to 1mm below maximum level

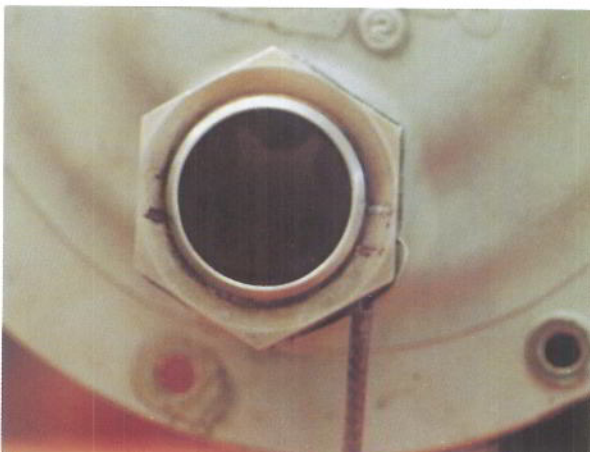
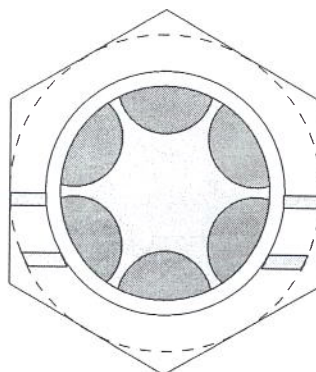
C - Sight glass empty
