## AIRCRAFT ACCIDENT REPORT NO 2/90

### REPORT ON THE ACCIDENT TO BOEING 747-121, N739PA AT LOCKERBIE, DUMFRIESSHIRE, SCOTLAND ON 21 DECEMBER 1988

**No:** 10/90      **Ref:** EW/G90/08/21      **Category:** 1a

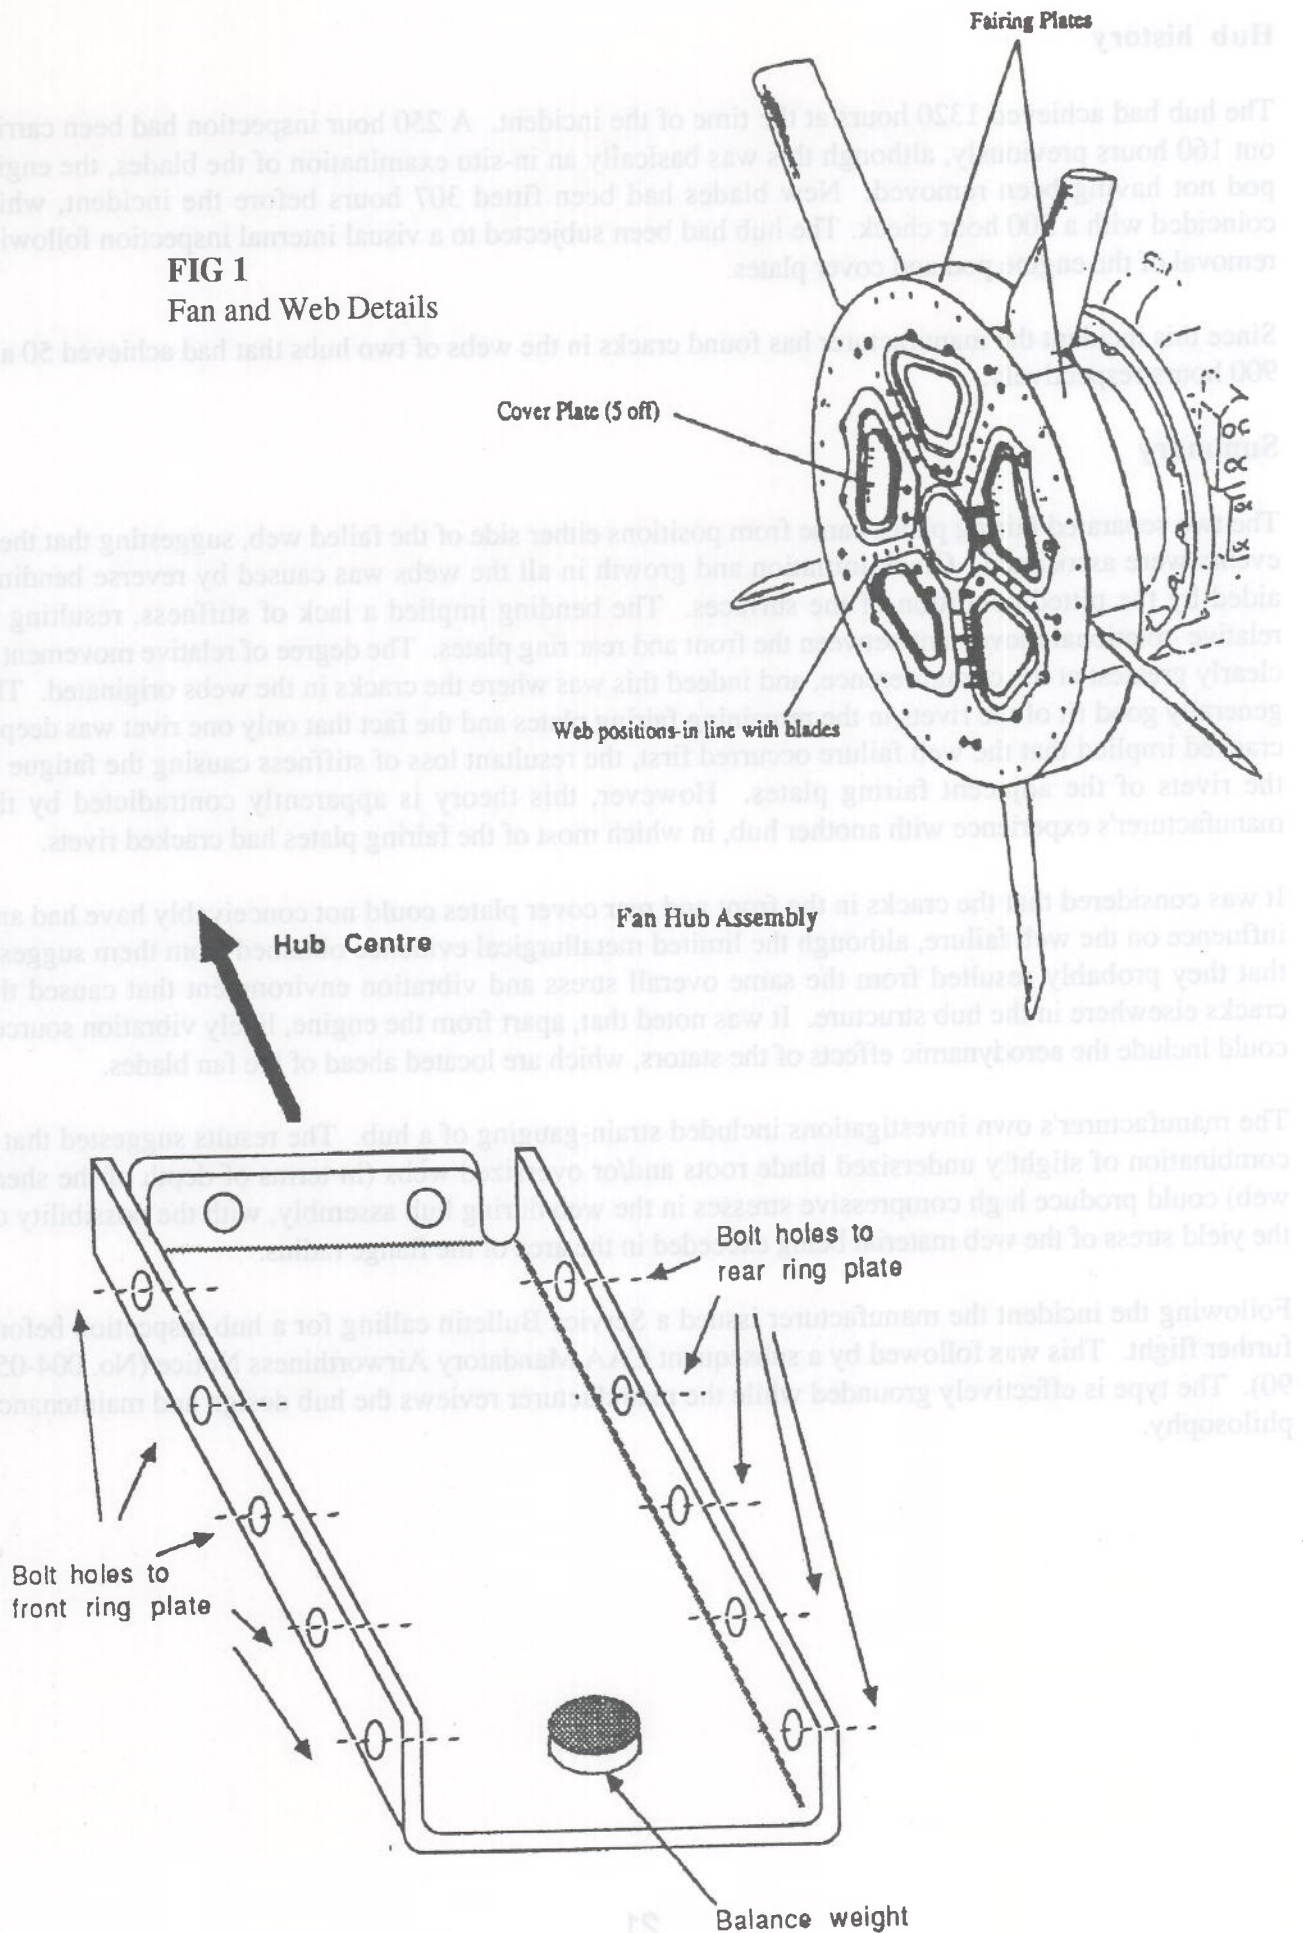
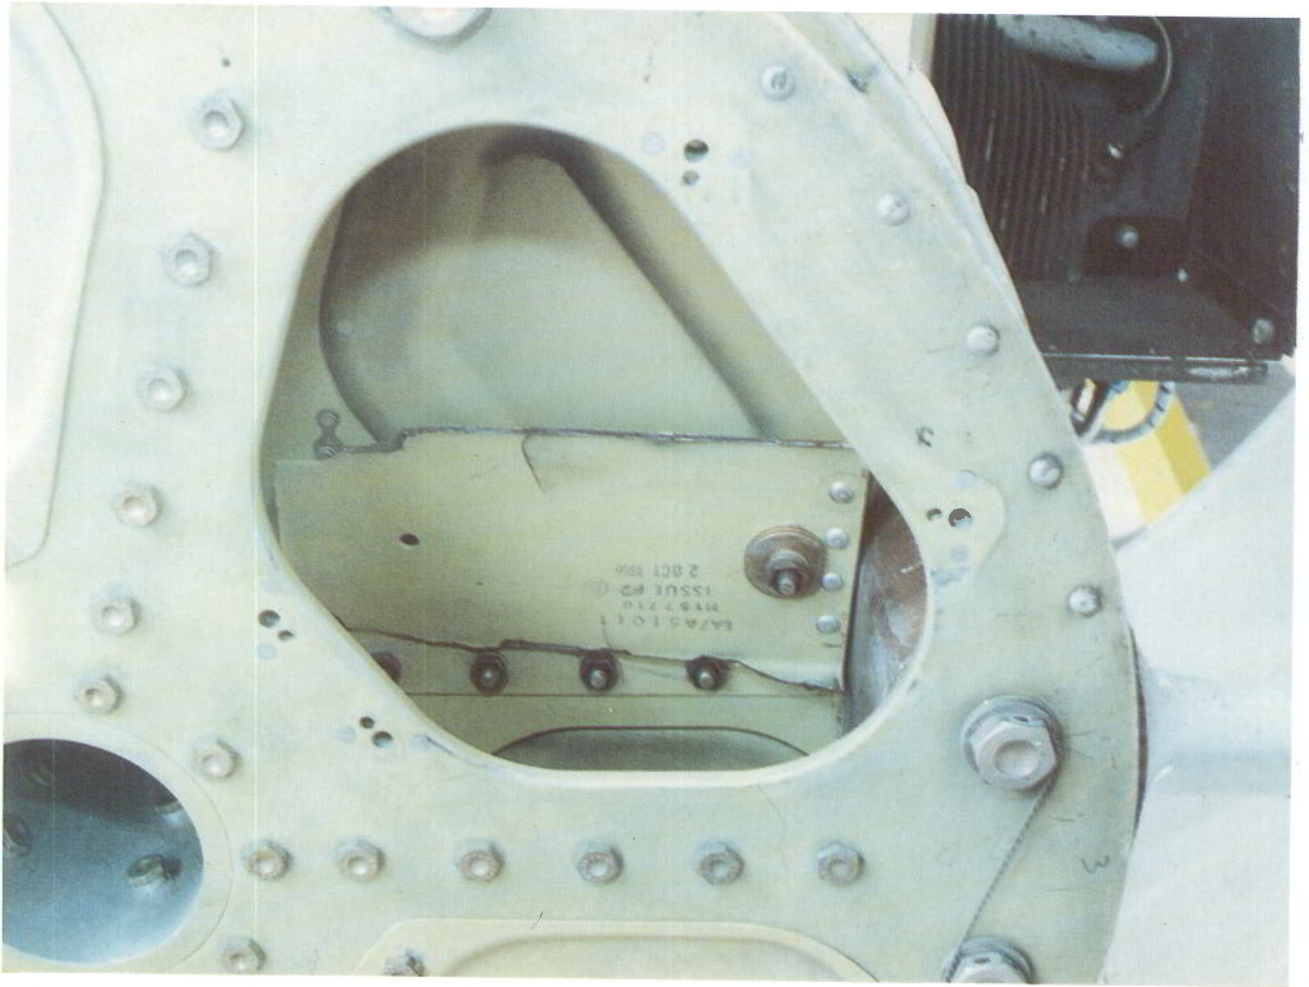
**FIG 2** View of failed web following removal of cover plate

The webs were subjected to a detailed metallurgical examination by the Materials and Structures Department at RAE Farnborough where it was discovered that all the cracks had developed by fatigue. On the forward side of the failed web the crack had started close to the outermost bolt hole, but the fracture had occurred along the flange radius. On the rear side, the crack had started close to the bolt hole and then run into the bend. The general appearance of the fractures and the evidence of cracking in other webs suggested that failure had originated at the outer ends of the flanges but, because of heavy rubbing damage in these areas, it was not possible to identify the precise positions of crack initiation. However, away from the outer ends, multiple origins were visible along both surfaces of each flange, indicating that crack growth had occurred under reverse bending conditions.

The cracks in the other webs typically passed close to the outermost bolt holes, forming tangents to the outer rims of the washers. On all the webs, fretting was observed along the lines of the cracks between the flanges and ring plates.

When the cracks were broken open, the surface features were consistent with fatigue growth from multiple origins on one or both surfaces of the flanges. Metallographic examination of a section from the region of a short crack in one of the webs revealed a number of microcracks originating from small, oxide filled pits in both surfaces. A hardness test showed that the tensile strength of the material was

The two separated fairing plates came from positions either side of the failed web, suggesting that these events were associated. Crack initiation and growth in all the webs was caused by reverse bending, aided by the pitted condition of the surfaces. The bending implied a lack of stiffness, resulting in relative rotational movement between the front and rear ring plates. The degree of relative movement is clearly greatest at the circumference, and indeed this was where the cracks in the webs originated. The generally good fit of the rivets in the remaining fairing plates and the fact that only one rivet was deeply cracked implied that the web failure occurred first, the resultant loss of stiffness causing the fatigue in the rivets of the adjacent fairing plates. However, this theory is apparently contradicted by the manufacturer's experience with another hub, in which most of the fairing plates had cracked rivets.

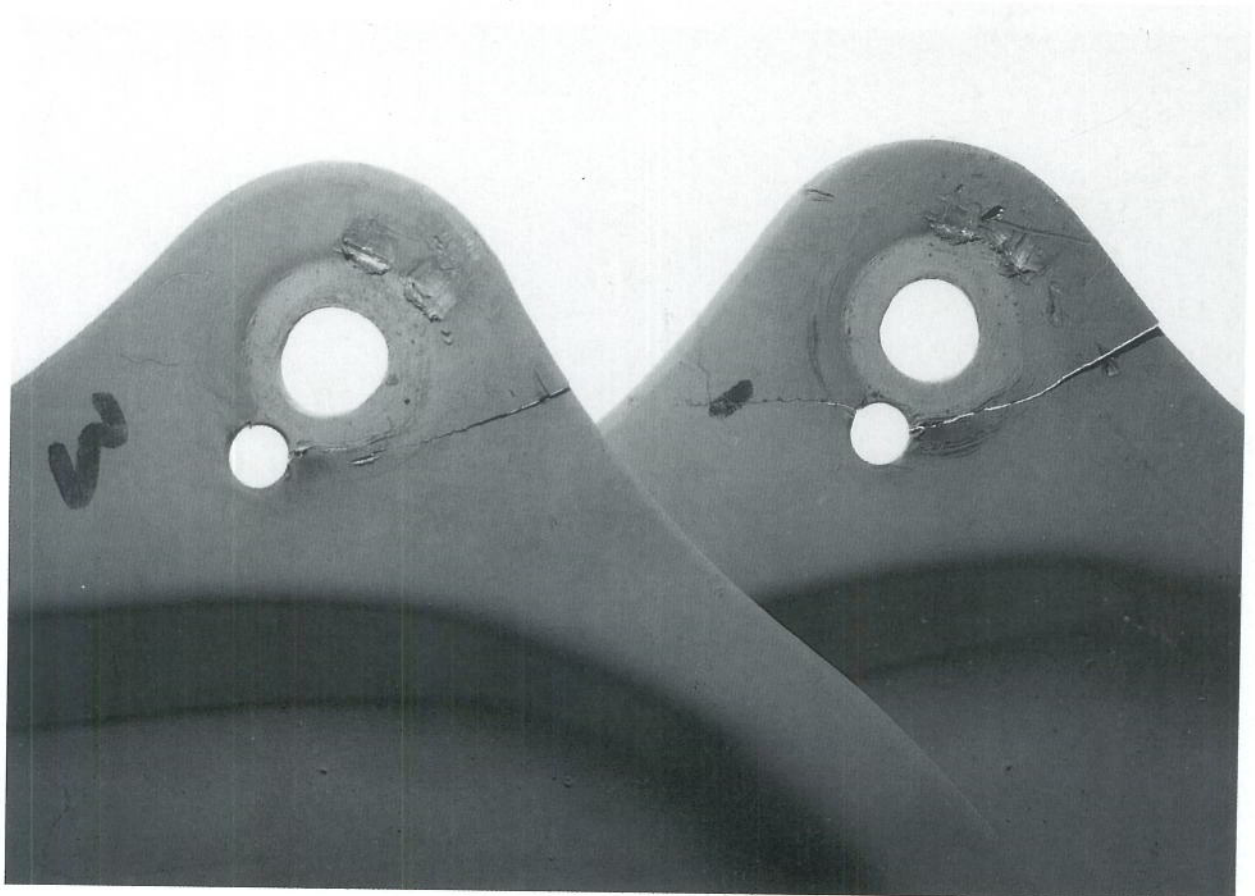
**FIG 3** Cracks around cover plate bolt holes

Finally, two each of the forward and rear cover plates were found to have cracks in the outboard lobes in which were drilled 5mm holes for the attachment bolts (see Fig 3). The cracks varied in length between 8.5 and 23mm and all initially followed the line of the edge of the washer beneath the bolt head, suggesting that their growth had been influenced by the local change of stiffness, particularly where the washer crossed an adjacent 3mm tab washer hole.

It was considered that the cracks in the front and rear cover plates could not conceivably have had any influence on the web failure, although the limited metallurgical evidence obtained from them suggests that they probably resulted from the same overall stress and vibration environment that caused the cracks elsewhere in the hub structure. It was noted that, apart from the engine, likely vibration sources could include the aerodynamic effects of the stators, which are located ahead of the fan blades.

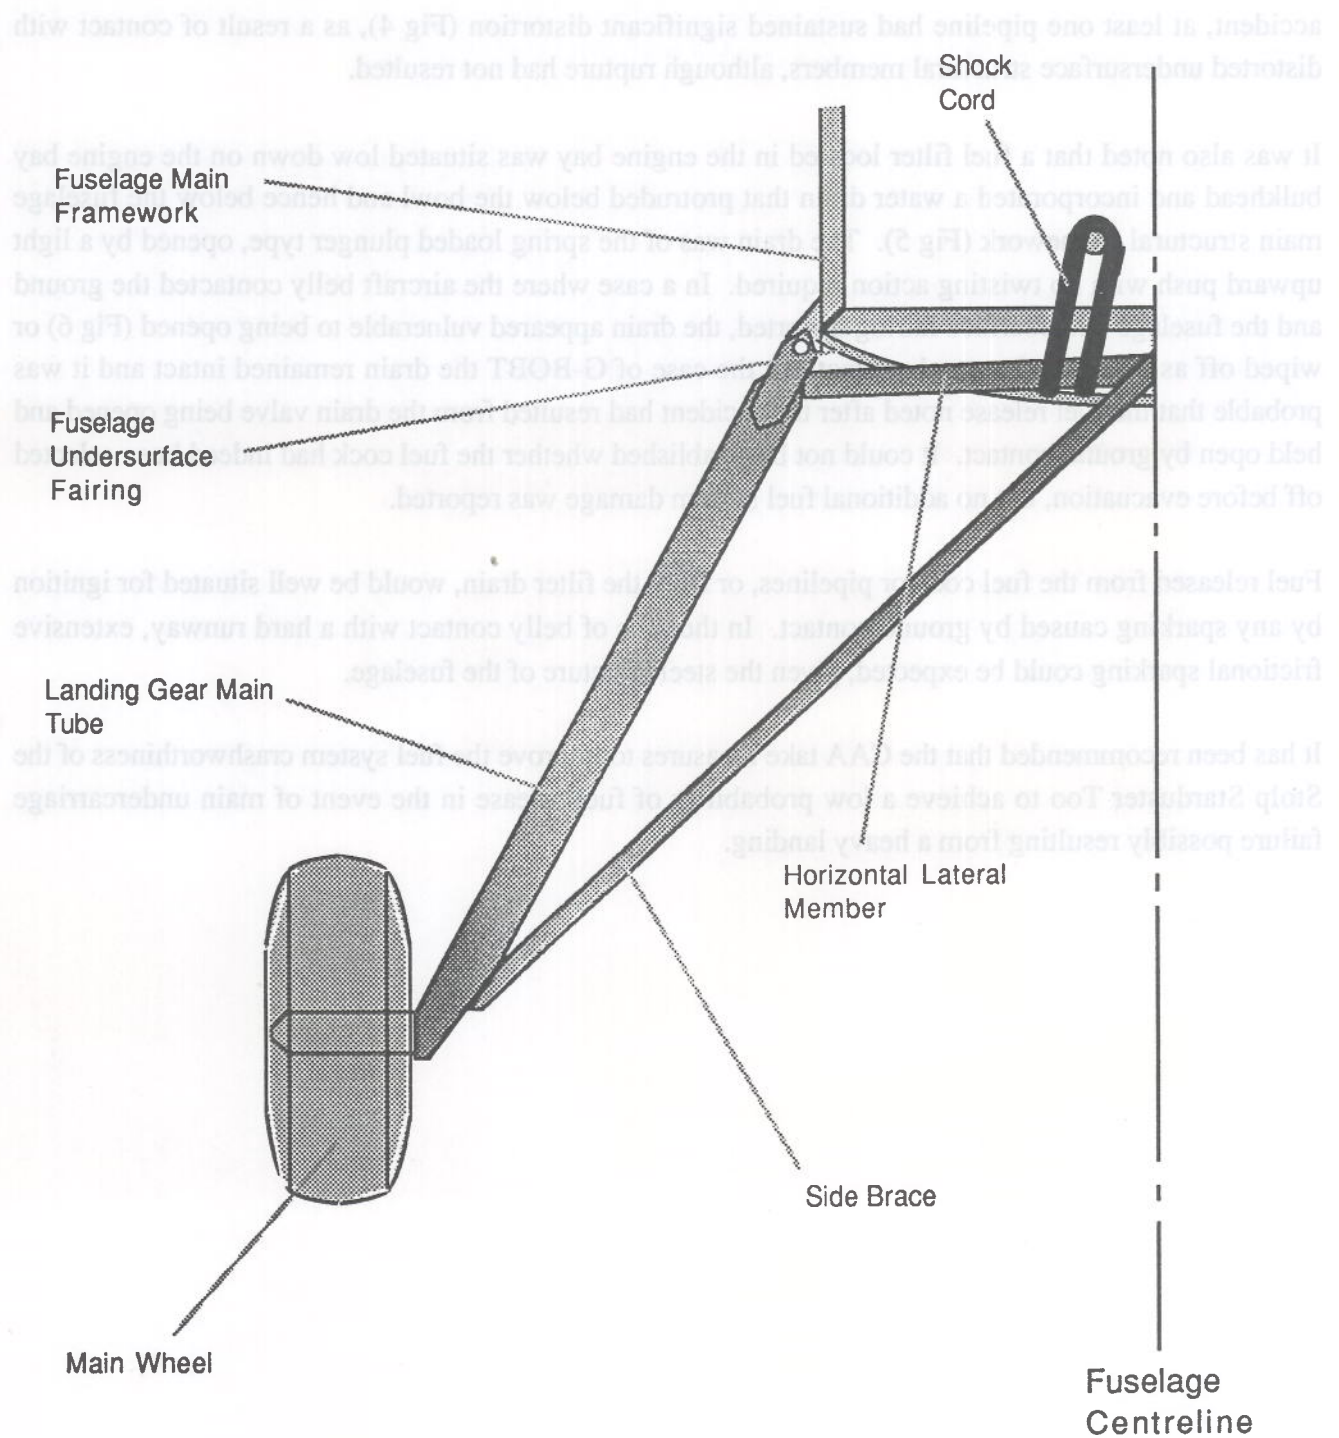
**FIG 1**

Failed Weld

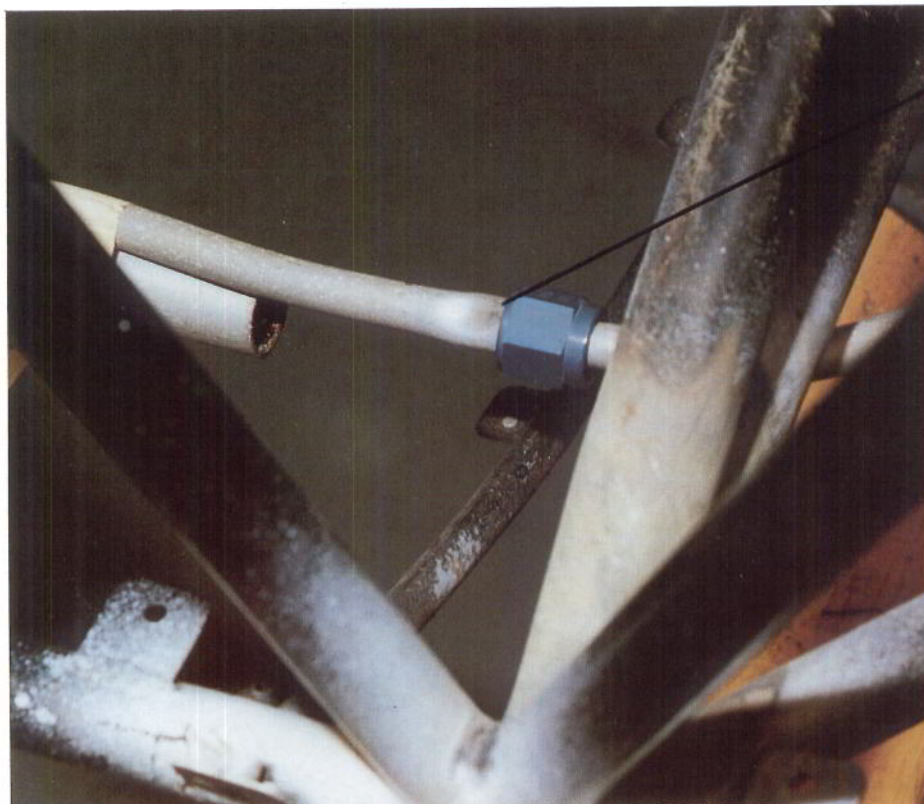
FIG 4

Damaged Pipeline
