INCIDENT

Aircraft Type and Registration:	Boeing 737-73V, G-EZKA	
No & Type of Engines:	2 CFM56-7B20 turbofan engines	
Year of Manufacture:	2003	
Date & Time (UTC):	28 December 2005 at 1840 hrs	
Location:	6 miles west of Newcastle, Northumbria	
Type of Flight:	Public Transport (Passenger)	
Persons on Board:	Crew - 5	Passengers - 128
Injuries:	Crew - None	Passengers - None
Nature of Damage:	None	
Commander's Licence:	Airline Transport Pilot's Licence	
Commander's Age:	47 years	
Commander's Flying Experience:	11,121 hours (of which 4,380 were on type) Last 90 days - 206 hours Last 28 days - 78 hours	
Information Source:	Aircraft Accident Report Form submitted by the pilot and subsequent enquires by the AAIB

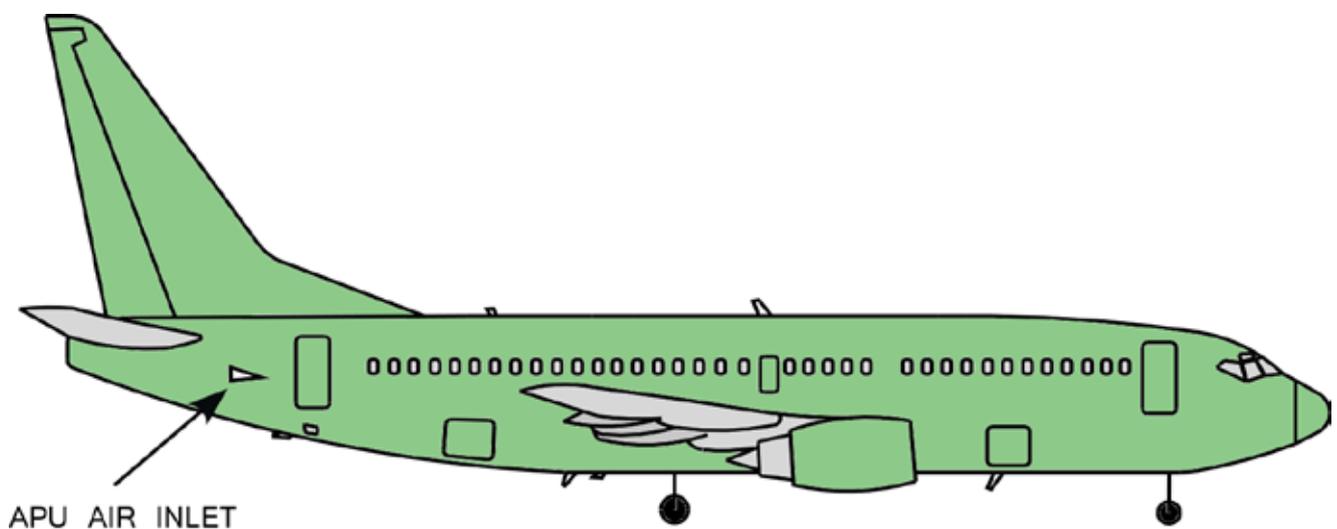
Figure 1

A review of the CAA's Mandatory Occurrence Report database revealed at least three previous occurrences of contaminated bleed air during the takeoff on Boeing 737 aircraft. In all three cases the cause was reported as excess de-icing fluid finding its way into the APU air inlet (Figure 1) during takeoff and climb.

Location of APU air inlet on Boeing 737-700

The most likely cause of the fumes and smoke that entered the cockpit and cabin was excess de-icing fluid finding its way into the APU air inlet (Figure 1) during the climb out. The de-icing fluid would then enter the hot sections of the APU, causing it to produce smoke and fumes which would then pass through to the air conditioning and into the aircraft. Performance limitations for this takeoff required that all available engine power be used, necessitating that the engine bleed air be switched off and the APU bleed air used for air conditioning and pressurisation instead.

The operator has undertaken to remind those who de-ice the aircraft about the need to take care when de-icing in the vicinity of the APU inlet on Boeing 737 aircraft.
