INCIDENT

Aircraft Type and Registration:	Piper PA-23-250 Aztec, G-BATN	
No & Type of Engines:	2 Lycoming IO-540-C4B5 piston engines	
Year of Manufacture:	1973	
Date & Time (UTC):	6 July 2010 at 1259 hrs	
Location:	Cambridge Airport, Cambridgeshire	
Type of Flight:	Training	
Persons on Board:	Crew - 1	Passengers - None
Injuries:	Crew - None	Passengers - N/A
Nature of Damage:	Propellers bent, nose cone and nose landing gear doors abraded	
Commander's Licence:	Airline Transport Pilot's Licence	
Commander's Age:	51 years	
Commander's Flying Experience:	7,146 hours (of which 79 were on type) Last 90 days - 39 hours Last 28 days - 14 hours	
Information Source:	Aircraft Accident Report Form submitted by the pilot and further enquiries by the AAIB

Synopsis

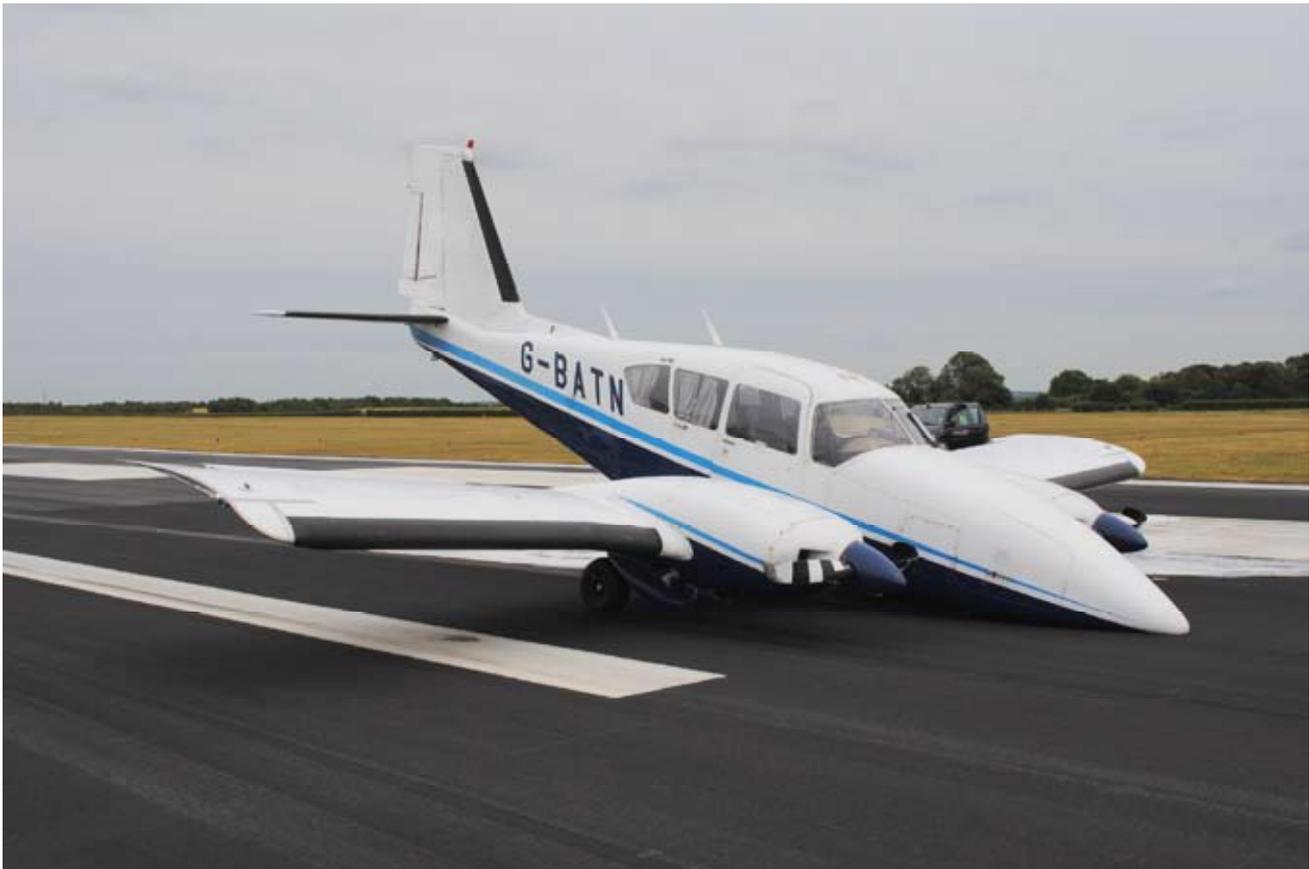
Figure 1

On the third of three planned landings the nose landing gear collapsed and the aircraft slid to a halt on its nose. The investigation revealed that a lack of lubrication on the link plate attachments that secure the downlock actuator to the downlock link is likely to have caused a restriction and prevented the complete engagement of the downlock. The pilot was unaware that the downlock had not engaged completely.

G-BATN on Runway 23

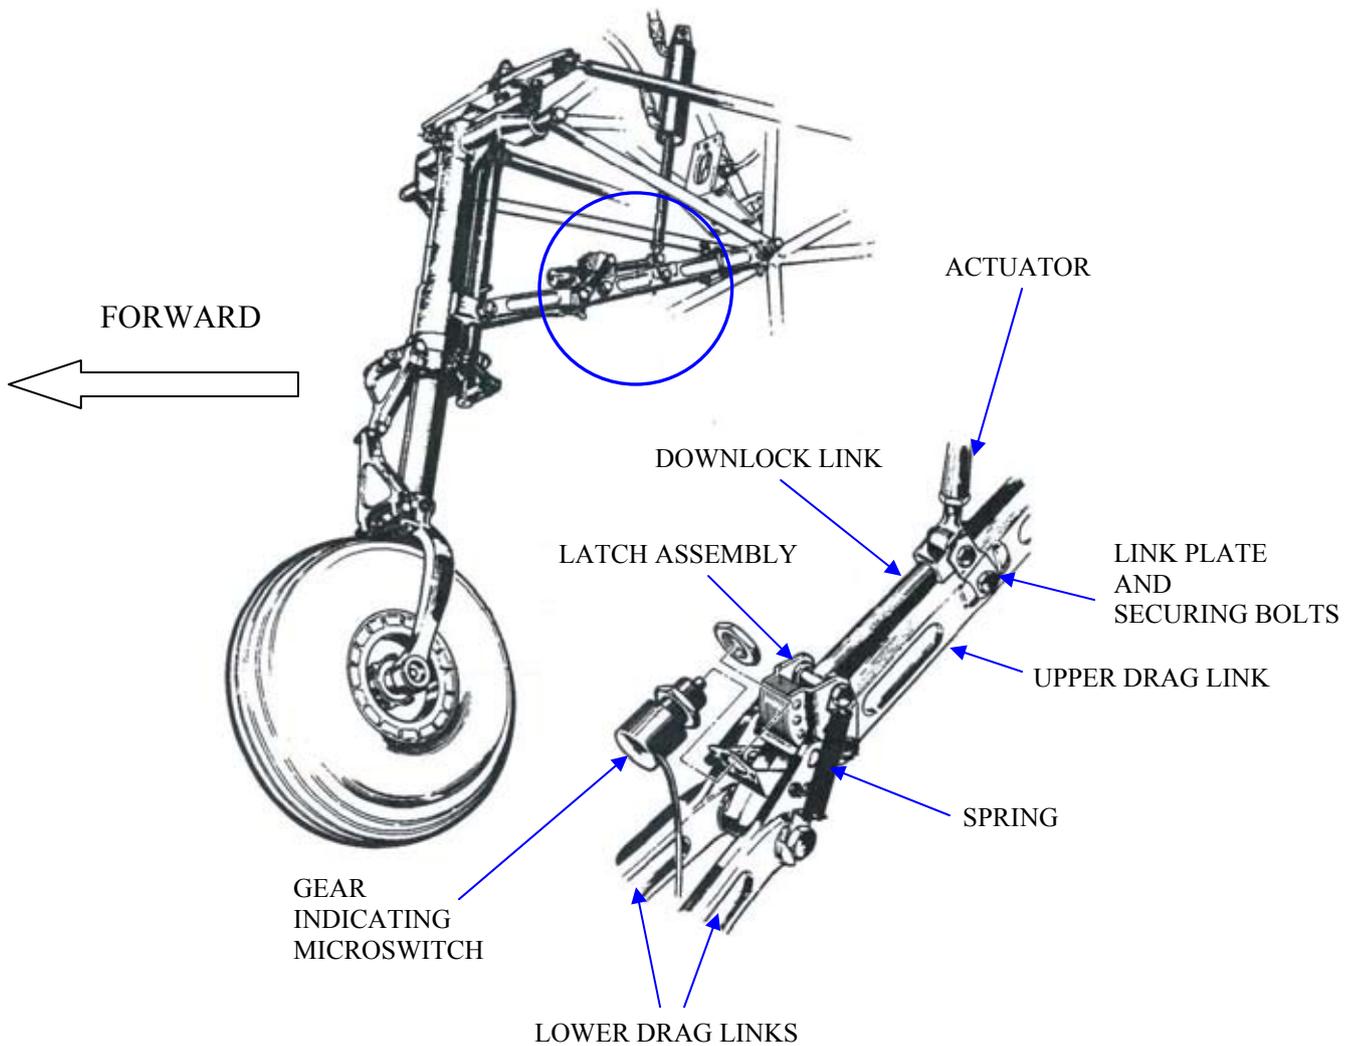
Figure 2

Nose gear leg assembly

The nose landing gear was inspected and the link plate attaching the actuator to the downlock link was found to be damaged. The bolts securing this link plate were removed and were reported to be:

'dry of lubricant and had visible surface rust on the bolt shank.'

The nose landing gear retracted on landing because it was not fully locked down. It was considered that a lack of lubrication on the shanks of the downlock link plate bolts caused sufficient restriction to prevent the complete engagement of the downlock. For reasons for which could not be established the pilot was unaware that the gear was not locked down and he stated that it would be “very unlikely” that the green light was not illuminated at touchdown and the gear unsafe horn was sounding but that he had failed to notice.

After straightening the link plate and reinstalling the bolts, using engine oil to lubricate the bolt shanks, further extension and retraction functional tests were performed. These were successful and the nose landing gear downlock pawl engaged successfully each time and the cockpit nose gear green light illuminated.

The aircraft manufacturer commented that since 1995 there had been no reported events with the same symptoms. However, since this event the operator is considering introducing an additional maintenance activity for the periodic removal and inspection of the bolts to ensure that lubrication has successfully penetrated to the bolt shank and that no corrosion has developed.
