AAIB Bulletin No: 8/94 **Ref:** EW/G93/12/02 **Category:** 1.3

Aircraft Type and Registration: Cessna F177RG Cardinal RG, G-AZTF
No & Type of Engines: 1 Lycoming IO-360-A1B6 piston engine
Year of Manufacture: 1972
Date & Time (UTC): 3 December 1993 at 1039 hrs
Location: 0.5 miles south west of Guildford, Surrey
Type of Flight: Private
Persons on Board: Crew - 1 Passengers - 3
Injuries: Crew - None Passengers - None
Nature of Damage: Substantial damage to fuselage, landing gear, right wingtip and horizontal stabiliser; internal damage to engine
Commander's Licence: Private Pilot's Licence
Commander's Age: 24 years
Commander's Flying Experience: 222 hours (of which 4 were on type)
Last 90 days - 4 hours
Last 28 days - 4 hours
Information Source: Aircraft Accident Report Form submitted by the pilot and additional AAIB enquiries

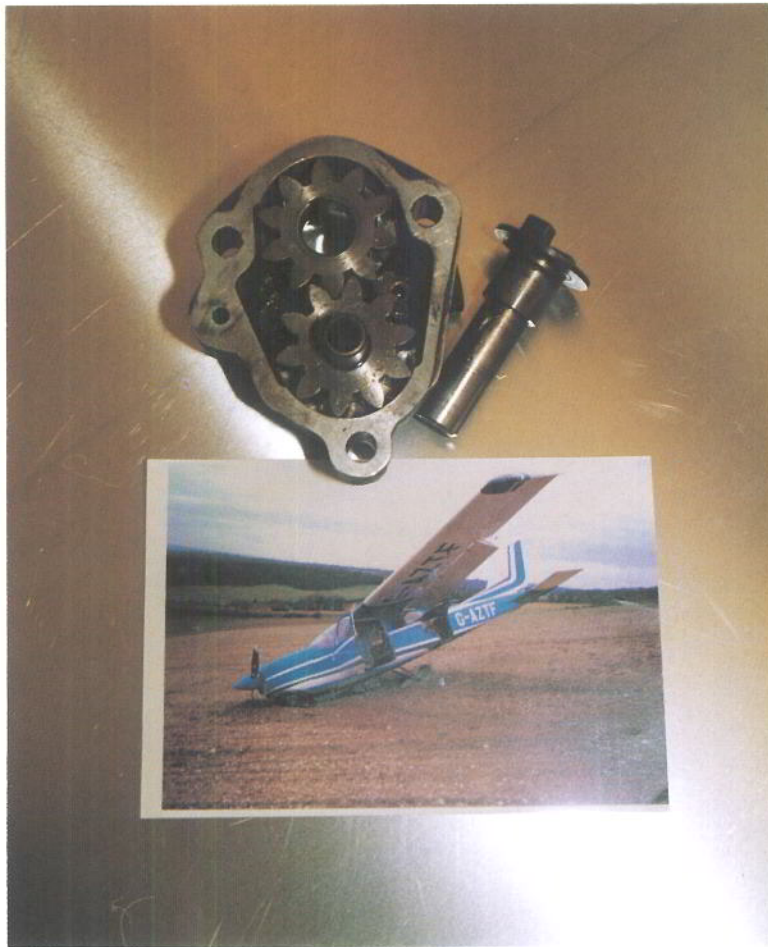
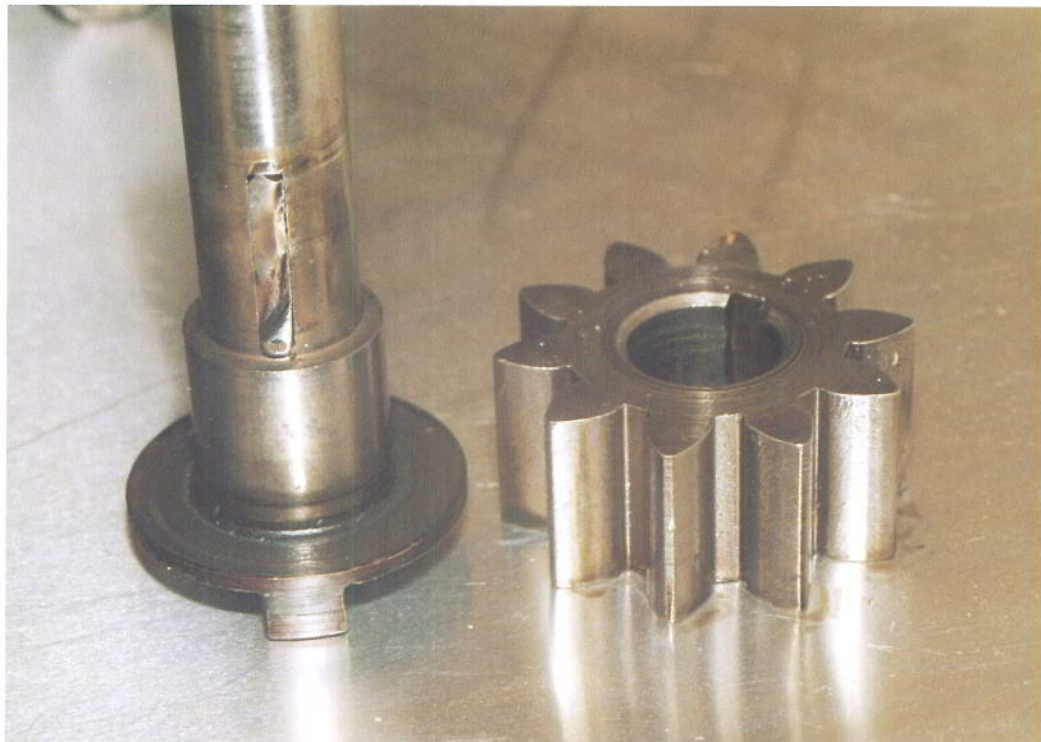
Subsequent examination of the engine revealed that the failure had been caused by a loss of drive to the oil pump due to a Woodruff key, on the pump impeller drive shaft, having completely worn away. The resultant loss of oil pressure had caused seizure of the main bearings and disintegration of the No 2 big end bearing. Photographs of the oil pump components are shown at Figure 1.

The engine from G-AZTF had achieved 1,970 hours at the time of the accident, and had the SI 1230 standard oil pump; SB 385 had not been embodied although, for reasons that could not be established, it was not applicable by serial number. The engine log book contained the incorrect statement to the effect that AD 81-18-04 was not applicable. In fact it would have been due at the 2,000 hour overhaul. However, had the engine been equipped with 'dual drive' magnetos, the work would have been required to have been accomplished within the next 25 hours.

It is thus apparent that there is some confusion amongst operators as to the applicability of the various SIs, SBs and ADs, together with their subsequent revisions. It is also apparent that there are engines in service that are equipped with the SI 1230 standard Woodruff key type oil pumps, and that their ability to continue in service until engine overhaul is questionable.

FIGURE 1. Oil pump from G-AZTF, showing worn Woodruff key

94-8 It is recommended that the CAA requires Lycoming piston engines to be inspected to ascertain the modification standard of associated oil pumps, and that all oil pumps to SI 1230 standard (ie Woodruff key drive types) are required to be replaced with pumps of the latest standard as soon as practicable to prevent related engine seizure due to a sudden loss of drive/oil pressure.
