INCIDENT

Aircraft Type and Registration: DHC-1 Chipmunk 22, G-ARGG

Nature of Damage: Propeller hub cracked

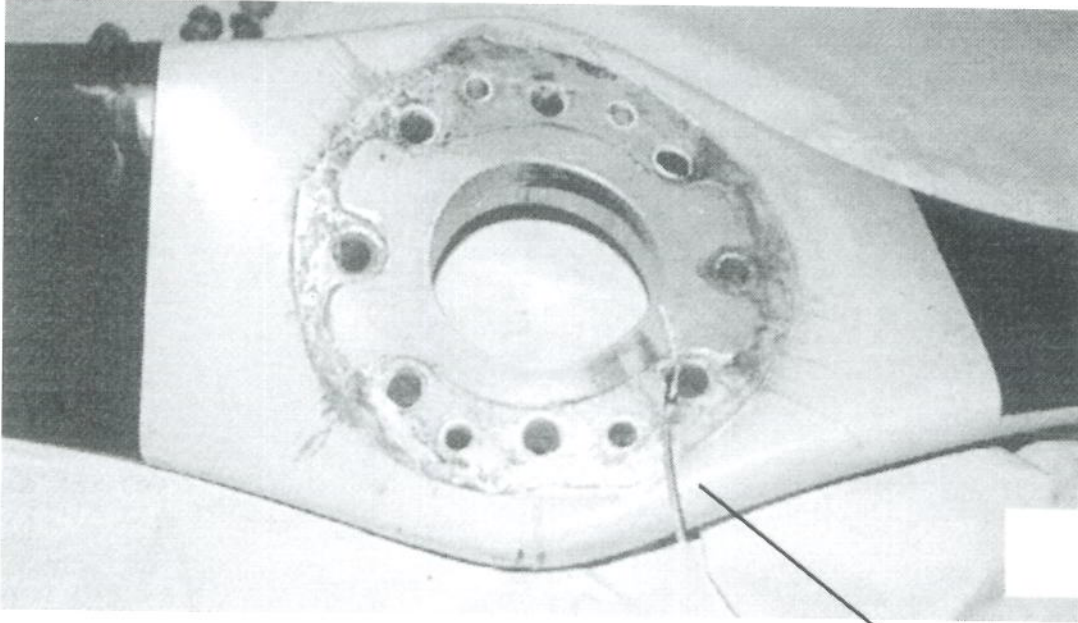
The blade was examined by AAIB and exhibited a crack through one of the bolt holes, this crack continued across both hub blocks. The cracked area was cut out of the blade to facilitate further examination, which showed that the crack was caused by fatigue.

Crack in Propeller hub

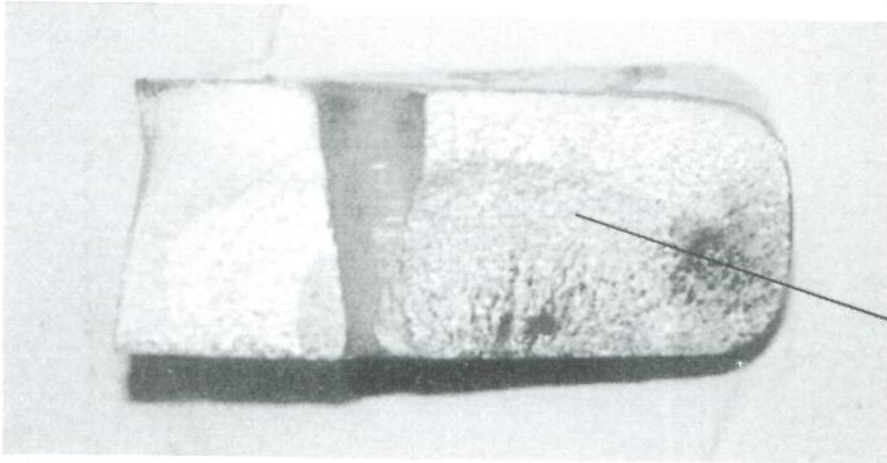
Area of fatigue cracking

Dye penetrant was present in the bore of the bolt hole but had not penetrated the crack. The last dye penetrant check had been carried out in accordance with Fairey Reed AD FRP-001, 70 hours prior to the incident.
