**ACCIDENT**

<b>Aircraft Type and Registration:</b>	Pegasus Quantum 15-912, G-BYNO	
<b>No &amp; Type of Engines:</b>	1 Rotax 912 piston engine	
<b>Year of Manufacture:</b>	1999	
<b>Date &amp; Time (UTC):</b>	5 April 2006 at 1225 hrs	
<b>Location:</b>	Clench Common Airfield, near Marlborough, Wiltshire	
<b>Type of Flight:</b>	Training	
<b>Persons on Board:</b>	Crew - 1	Passengers - 1
<b>Injuries:</b>	Crew - 1 (Serious)	Passengers - 1 (Serious)
<b>Nature of Damage:</b>	Aircraft destroyed; damage to other aircraft and barn roof	
<b>Commander's Licence:</b>	Private Pilot's Licence	
<b>Commander's Age:</b>	49 years	
<b>Commander's Flying Experience:</b>	14,000 hours approximately (of which about 600 were on type) Last 90 days - 22 hours Last 28 days - 8 hours	
<b>Information Source:</b>	AAIB Field Investigation, with the participation of the British Microlight Aircraft Association

**Synopsis**

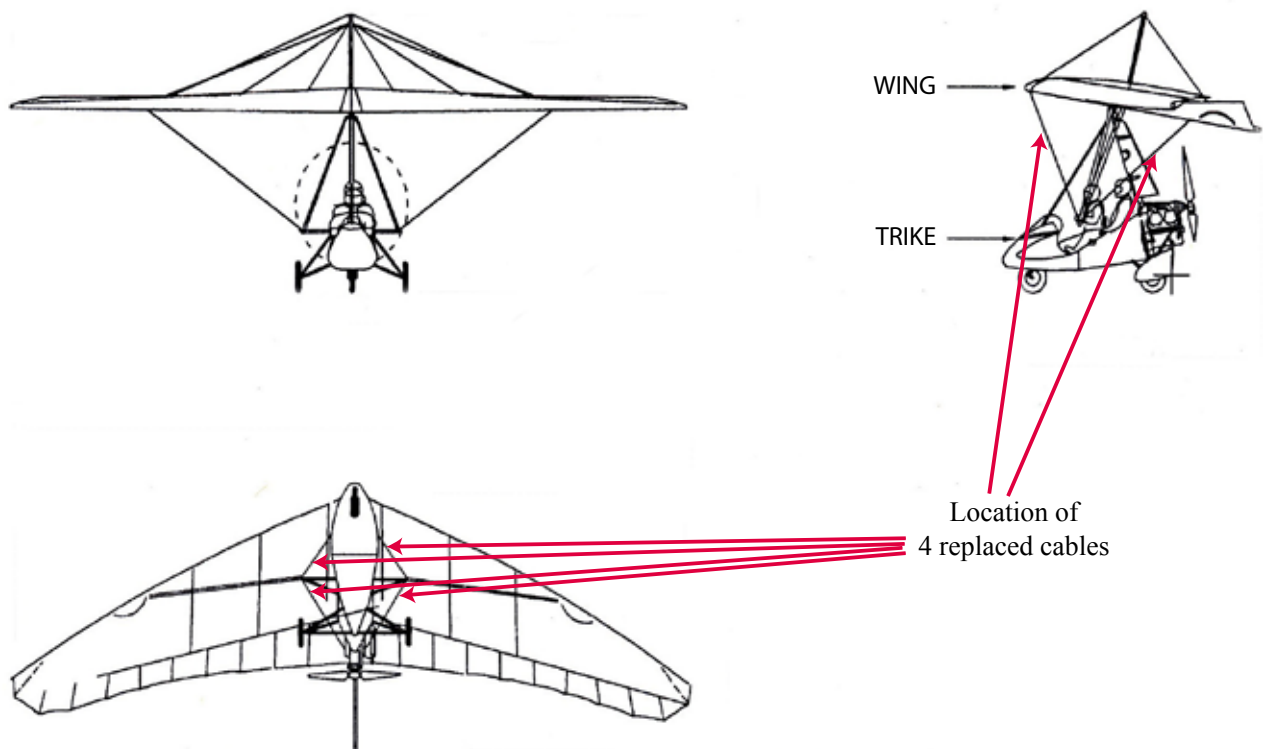
**Figure 1a**

Four rigging cables brace the control frame relative to the wing. Two cables run from the bottom of the left control frame, one forward and one rearwards, and similarly, two cables run from the bottom of the right control frame, one forward and one rearwards (see Figures 1a and 1b). These cable assemblies consist of

Aircraft layout and location of replaced cables

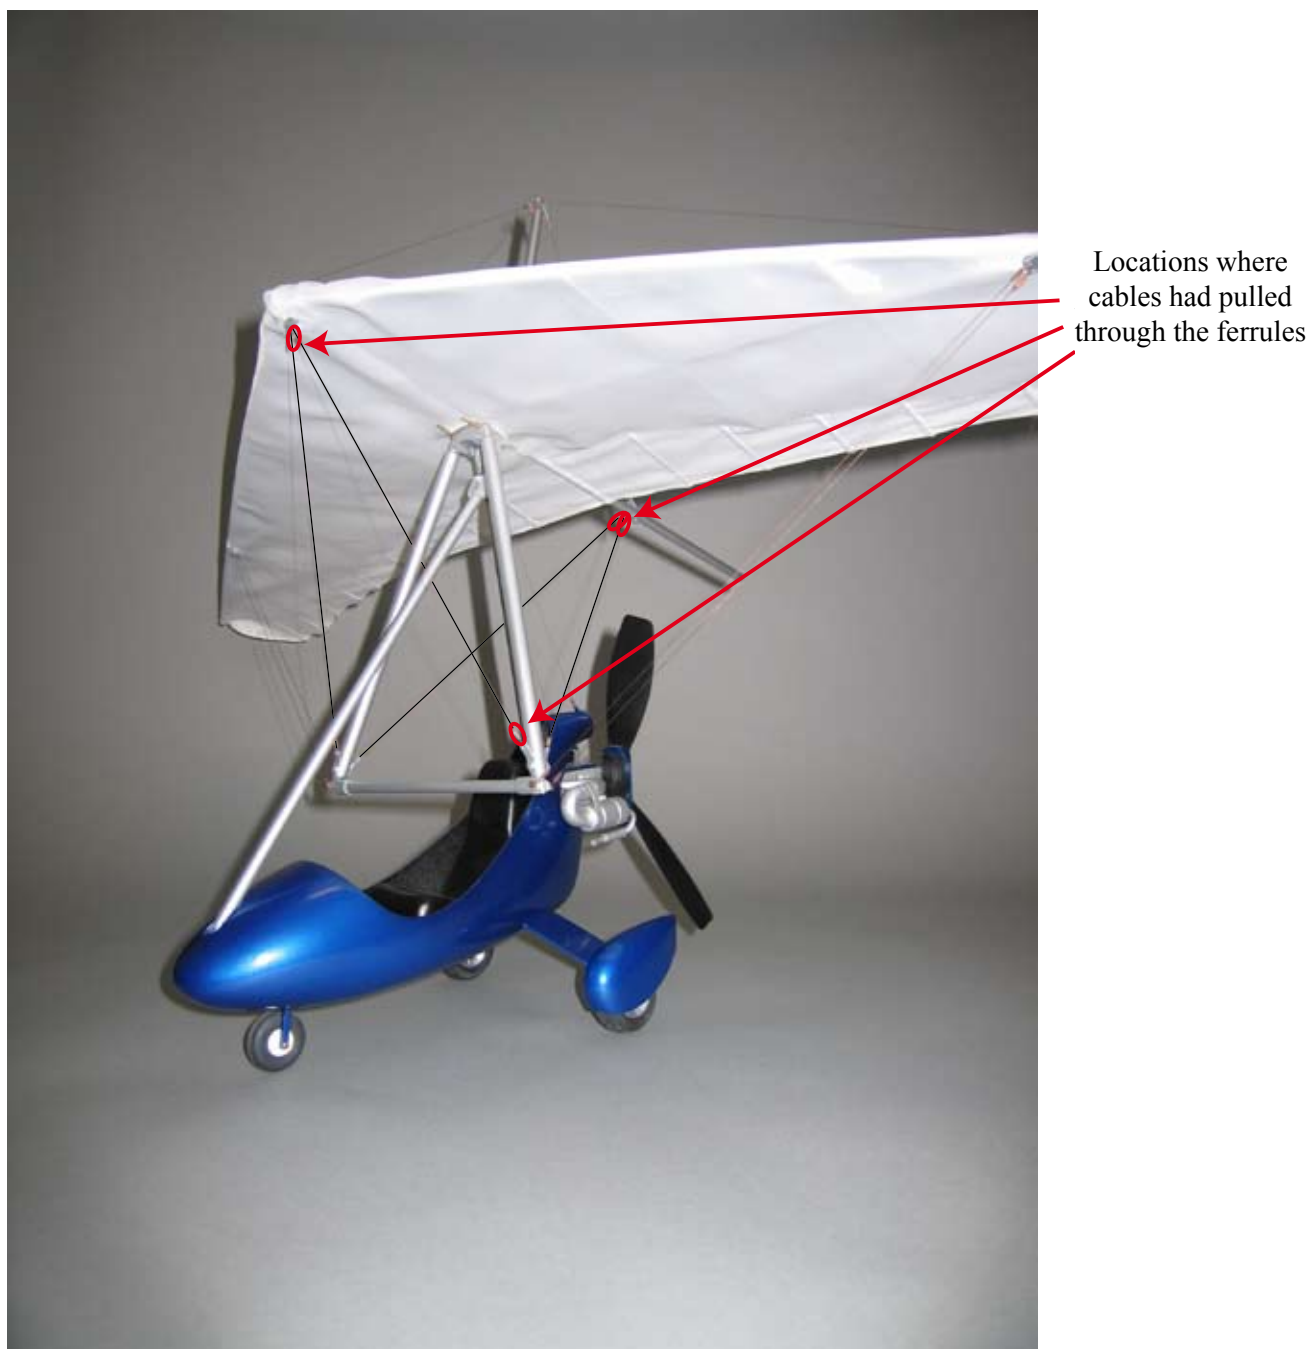
**Figure 1b**

Location of the failures in the cable assemblies  
(Note: generic microlight model shown)

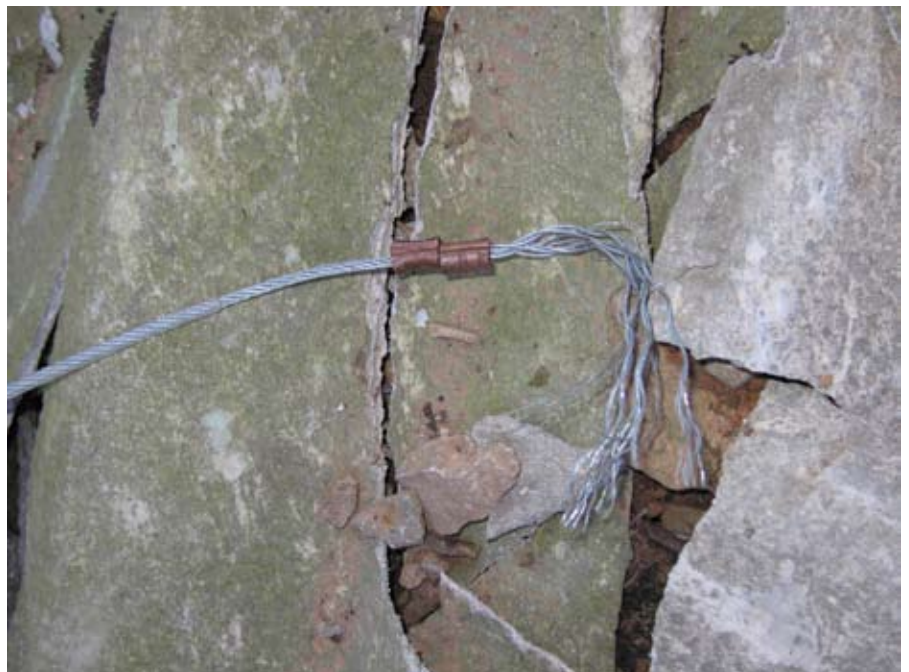
**Figure 2**

During the initial examination, failure of the ferrules to grip the wire rope at one end of each of the four rigging cable assemblies was evident. See Figure 2 for an example of failed ferrules (note the wire rope has pulled through the ferrules) and Figures 1a and 1b for a diagram showing the location of the four cables. No ferrules or plastic shrouds were found on the rear ends of the two

rear cables and these cable ends had damage consistent with having been struck by the propeller.

The G-BYNO cables pulled through the ferrules, indicative of insufficient purchase by the ferrules, without the wire rope failing. The two results for G-BYNO cables show significant variation and, importantly, it should be noted that the other ends of the cables tested must have failed on the aircraft at lower loads than those achieved during the tests. The destructive tests on the G-BYNO cables resulted in the appearance of the cable ends being similar to that found on the failed cables ends at the wreckage site - see Figure 2.

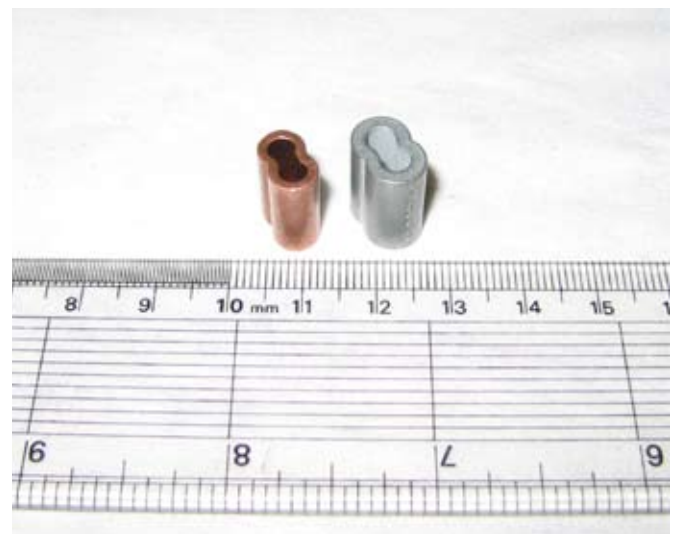
**Figure 3**

A comparison was made between the cable assemblies fitted to G-BYNO and a new set supplied from the manufacturers. The only discernable difference was the type of ferrule used; see Figure 3 for a comparison of uncrimped ferrules, and Figures 4a and 4b for a comparison of the end of cable assemblies. The following comparisons were made:

Two unused ferrules, one of the type used on G-BYNO and one of the type used in factory-supplied cables, were obtained. The widths, before crimping, were 11.0 mm and 13.2 mm respectively. Thus the effect of crimping the ferrules in G-BYNO was to reduce the width of the ferrule, ie produce a neck, in two places, typically from 11.0 mm to 8.5 mm; a compression of 2.5 mm. For the

manufacturer's supplied cables the reduction was from 13.2 to 9.2 mm; a compression of 4.0 mm.

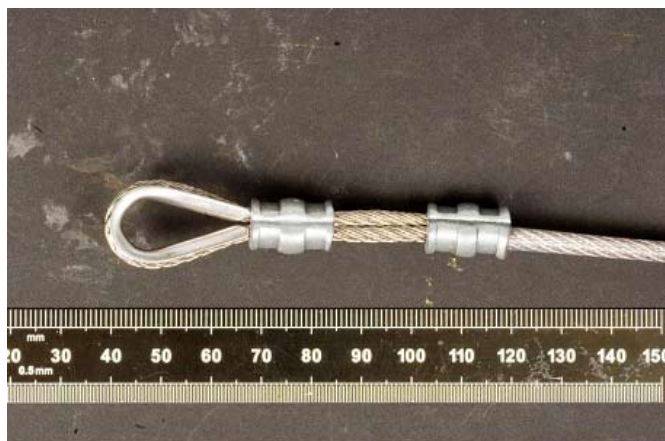
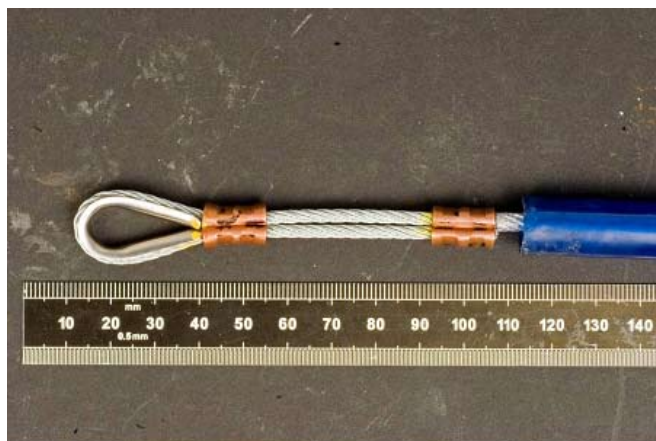
**Figure 4a**

End of cable assembly (factory-supplied)

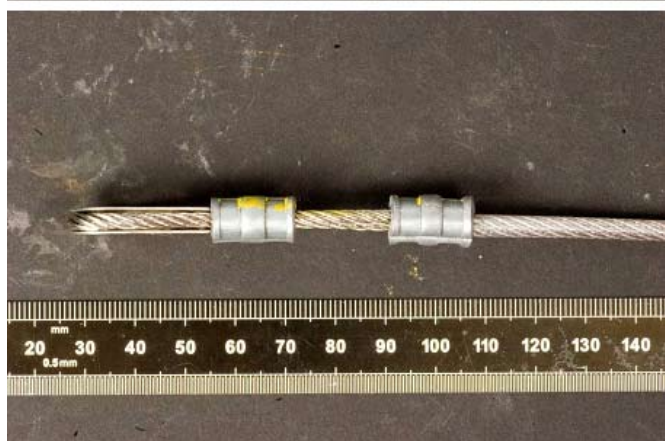
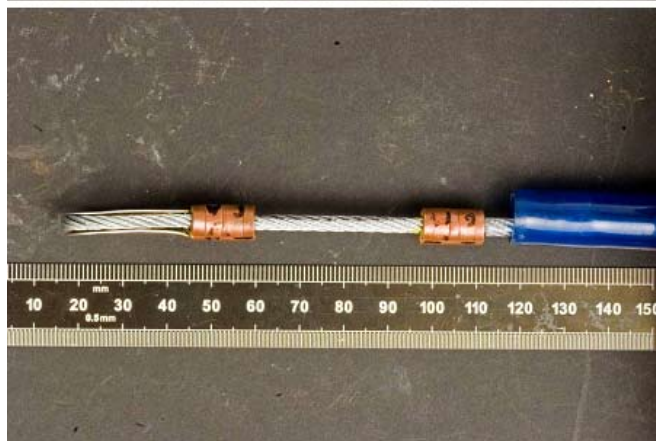
**Figure 4b**

End of cable assembly (G-BYNO)

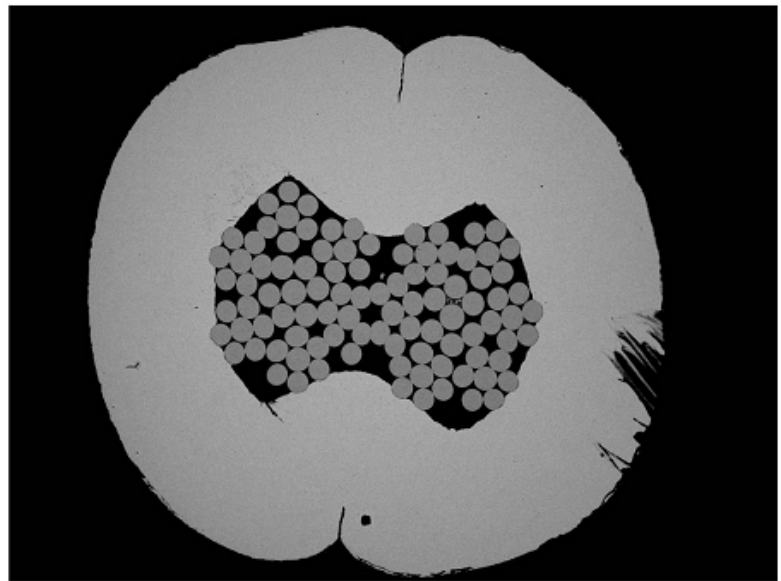
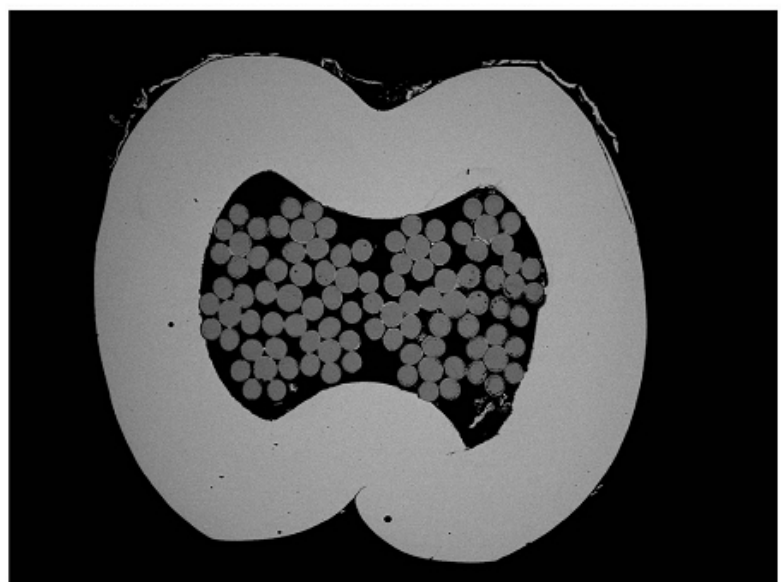
**Figures 5a (top) and 5b (bottom)**  
Sections through crimped ferrules

The end of one cable assembly from G-BYNO that did not fail, and a comparable factory-supplied item were sectioned and polished. The sections were made through the ferrules and wire rope in the region of the neck produced by crimping. Figure 5a and Figure 5b show the sections from the factory-supplied cables and G-BYNO respectively. Comparing the two sections it is evident that for the factory-supplied items there is:

- more contact between strands of the wire rope and the ferrule;
- more contact between the strands and other strands of wire rope;
- less void space.

These tests also confirmed that the tested cables from G-BYNO failed as a result of the wire rope pulling through the ferrules. This resulted in the cable ends having a similar appearance to those found at the wreckage site. The lower wall thickness of the ferrules used for the G-BYNO rigging cables appears to have resulted in reduced grip on the wire rope and this conclusion is supported by the comparative photographs of the sections through the cable assemblies. The copper used in the ferrules for G-BYNO was harder
