SERIOUS INCIDENT

Aircraft Type and Registration: Boeing 757-28A, G-STRY

No & Type of Engines: 2 Rolls-Royce RB211-535E4 turbofan engines

Date & Time (UTC): 25 August 2010 at 0025 hrs

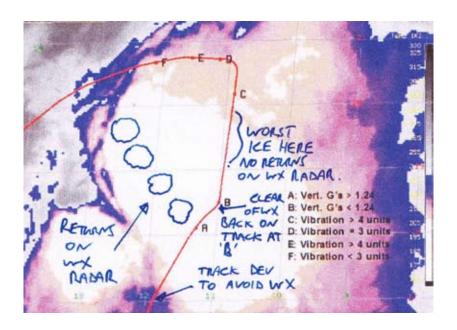
Figure 3

Infrared satellite image with sketch of en-route weather (for scale, each vertical graticule is 60 nm ie the distance from A to C is approximately 120 nm)

An analysis of the weather radar identified two Mesoscale Convective Systems¹ (MCS) along the route flown by the aircraft. The total distance the aircraft flew within one of the two systems was more than 500 nm, over a two hour period.

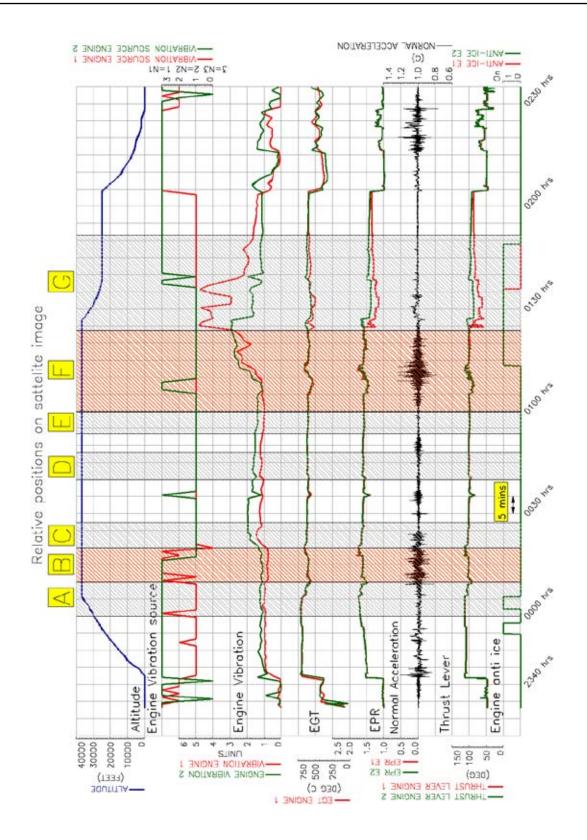
Figure 4
Flight from Lungi Airport (Sierra Leone) to Nouakchott Airport (Islamic Republic of Mauritania)

The takeoff was uneventful, with the aircraft initially tracking northwards along the west coast of Guinea, to waypoint GIA, before routing inland to waypoint NASLO. During the climb, EAI was selected ON between FL227 and FL270 and then again between FL320 and FL365. As the aircraft climbed through FL290, it entered the first MCS (see Figures 4 and 5). The first MCS was approximately 230 nm in length and 170 nm wide. At 0006 hrs, the aircraft levelled off to cruise at FL370. The SAT had gradually reduced from 25°C, at takeoff, to -48°C. Four minutes later, the aircraft entered the area with the highest cloud tops within the MCS (see Figures 4 and 5 – area B) and there was an increase in normal acceleration activity, indicative of moderate turbulence. Shortly after, as the aircraft approached waypoint NASLO, the flight crew altered track approximately 35 nm to the east, routing away from the core of the MCS.

After the takeoff at 2343 hrs, the engine vibration levels remained at about 0.9 units for the left engine and 1.2 units for the right, with N_1 shaft vibration predominantly recorded for the left engine and N_3 for the right. However, at 0020 hrs, just at the aircraft was resuming its northerly track to waypoint UBATA, the N_1 shaft vibration level on both engines started to increase. The aircraft was still in turbulent air at the time and the EPR on both engines was just reducing from 1.75 to 1.65. At 0028 hrs the aircraft exited the MCS. The left engine N_1 shaft vibration had now stabilised at just less than 1.2 units, and the right engine N_1 shaft vibration at 2 units. The aircraft had flown for about 200 nm whilst in the MCS.

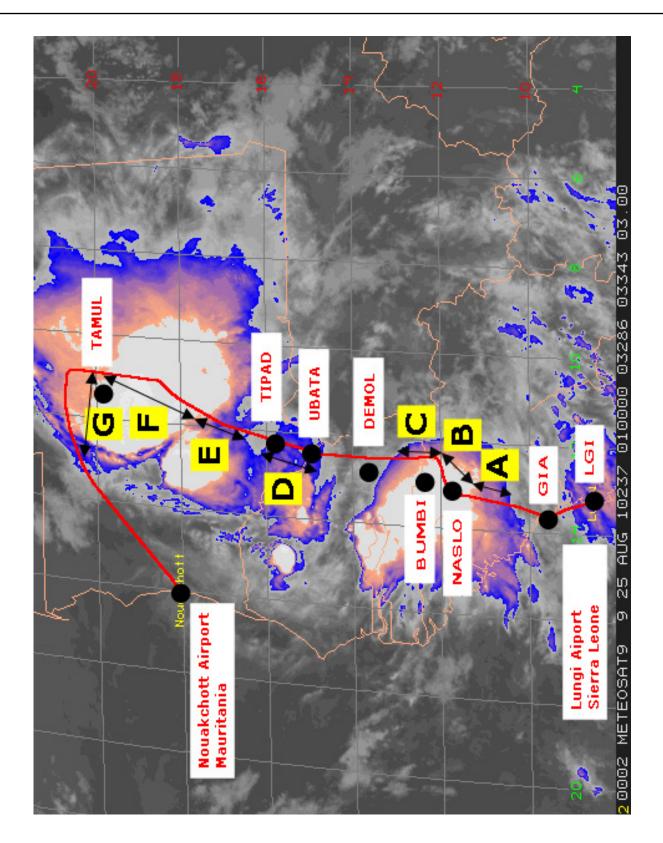
Figure 5
Satellite image of MCS areas over Africa and G-STRY flight track and waypoints (Points A to G refer to the relative aircraft positions detailed in Figure 4)

At 0041 hrs, as the aircraft approached waypoint UBATA (situated near to the border between Senegal and the Islamic Republic of Mauritania), it entered the southern tip of the second MCS. The MCS extended to the north by approximately 480 nm and was between 170 nm and 350 nm wide. Twenty minutes later, the aircraft entered the area of the MCS having the highest clouds (see Figures 4 and 5 - area F) and there was an increase in turbulence. Several minutes later, the EPR on both engines was progressively reduced, from 1.6 to 1.4. This was accompanied by a reduction in right engine vibration, with the N₃ shaft becoming the source of maximum vibration at 1.1 units. During the next four minutes, as the autothrottle attempted to stabilise the airspeed, the EPR on both engines was progressively increased to 1.7. As EPR increased, the right engine maximum vibration source changed to the N₁ shaft and there was an increasing trend in both left and right engine N₁ shaft vibration levels. As the left engine reached 2 units and the right 2.5 units, the flight crew selected both EAI systems to ON. Both engine N₁ shaft vibration levels continued to increase, before stabilising at about 2.6 units. The trend over the next five minutes was a slight reduction in the left engine N₁ shaft vibration, before both engine N₁ shaft vibration levels further increased to 3 units. The aircraft was just leaving the highest cloud level within the MCS at this time (see Figures 4 and 5 – area G).

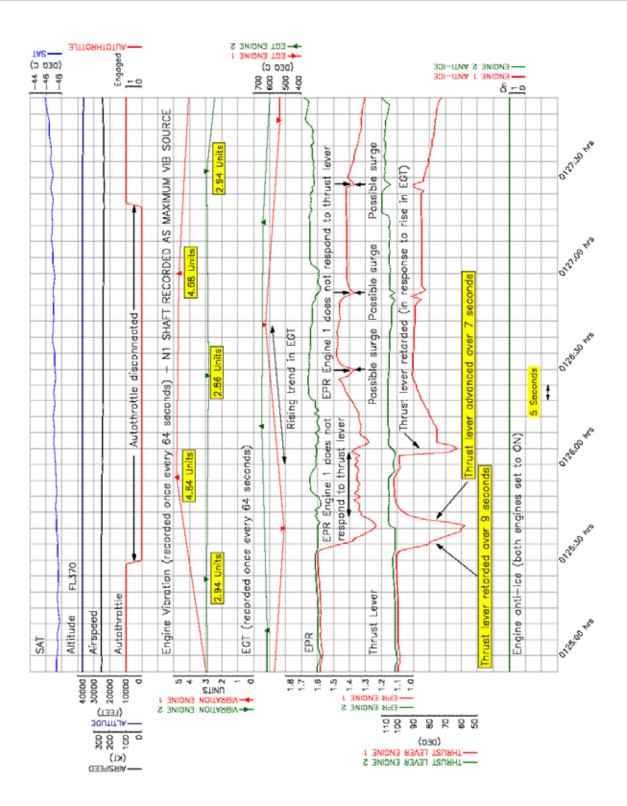
Figure 6
Recorded data during period of manual thrust reduction whilst in the cruise

A few minutes later, at 0125 hrs, the autothrottle was disconnected by the flight crew and over a nine second period, the left engine thrust lever was manually retarded to an intermediate position above idle, with the EPR reducing to 1.2 (see Figure 6). The left thrust lever was then advanced, without delay, to its previous cruise position over a seven second period. The left engine initially responded, before stabilising at about 1.3 EPR, which was below that being commanded. The right engine N₁ shaft vibration had remained stable at about 3 units; however, the left engine N₁ shaft vibration increased to 4.8 units. This was accompanied by a recorded rise in left engine EGT, to a maximum of 630°C2. The left thrust lever was quickly retarded and then gradually advanced over a further 30 second period. The left engine EPR initially tracked the increasing thrust command but the EPR then rapidly reduced before increasing again. During the following minute the left thrust lever was advanced and retarded twice. On both occasions, the left engine EPR failed to respond correctly (see Figure 6). Shortly before the last of these two thrust lever movements, the autothrottle was re-engaged as the flight crew initiated a descent to FL250 and altered track to the south-west, towards Nouakchott Airport. Since entering the cruise, the SAT had remained predominantly stable at about -48°C. As the aircraft descended, the SAT gradually increased.

As thrust was reduced for the descent, there was a slight stagger in the position of the left and right thrust levers, with the right leading the left. The right engine thrust was reduced to 1.4 EPR and its N_1 shaft vibration level subsequently reduced from 3 to 1.7 units. The left engine stabilised at a lower EPR of about 1.2, although its N_1 shaft vibration remained at about 4 units. Over the next

The root cause of the left engine surge or stall condition was considered by the engine manufacturer to have been the result of the deceleration and sudden re-acceleration of the engine.

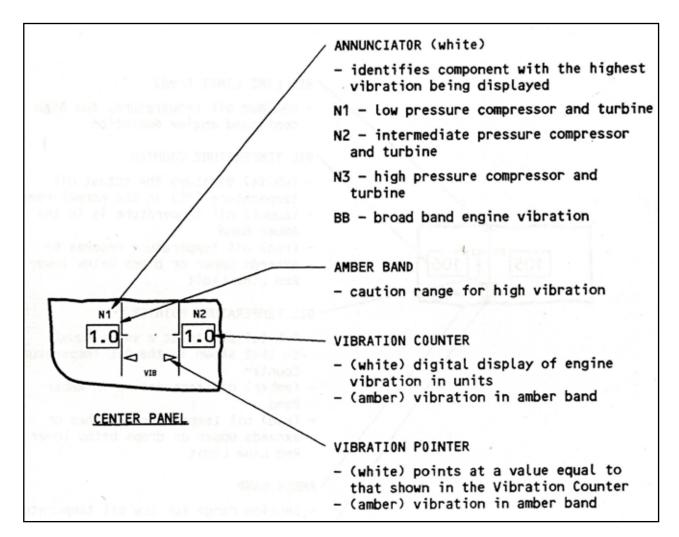
The aircraft has an airborne vibration monitoring system that monitors engine vibration levels. The sensors measure vibration in a radial direction on each engine (ie out of balance forces) and the vibration indications are displayed on the secondary engine display on the lower left side of the lower EICAS screen (see Figure 7). The amber alert level is at 2.5 units. The maximum continuous EGT is 795°C, at the start of amber caution area, and the maximum takeoff limit is 850°C, at the red line.

Figure 7EICAS Engine vibration display
