Aero Vodochody L-39C Albatros, G-BZVL

AAIB Bulletin No: 7/2003	Ref: EW/C2002/06/02	Category: 1.3
Aircraft Type and Registration:	Aero Vodochody L-39C Albatros, G-BZVL	
No & Type of Engines:	1 Ivchenko A1-25TL turbofan engine	
Year of Manufacture:	1977	
Date & Time (UTC):	2 June 2002 at 1248 hrs	
Location:	Duxford Airfield, Cambridgeshire	
Type of Flight:	Private	
Persons on Board:	Crew - 2	Passengers - None
Injuries:	Crew - 1 (Fatal)	Passengers - N/A
		1 (Uninjured)
Nature of Damage:	Severe damage to both wings, landing gear and forward fuselage	
Commander's Licence:	Airline Transport Pilot's Licence	
Commander's Age:	39 years	
Commander's Flying Experience:	4,300 hours (of which 142 were on type)	
	Last 90 days - 148 hours	
	Last 28 days - 45 hours	
Information Source:	AAIB Field Investigation

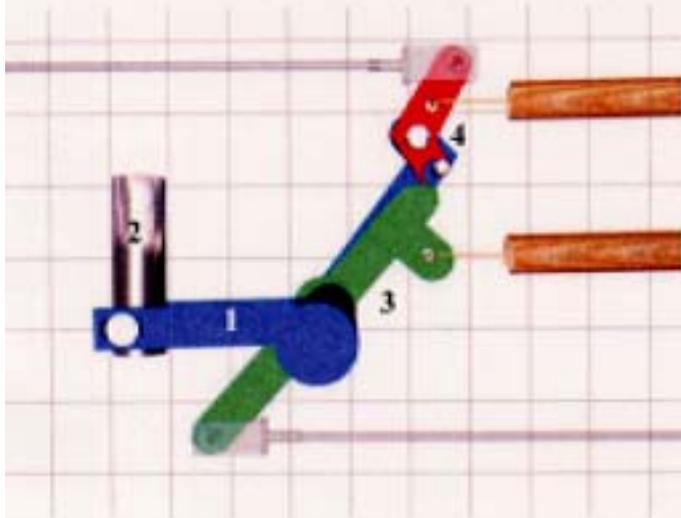
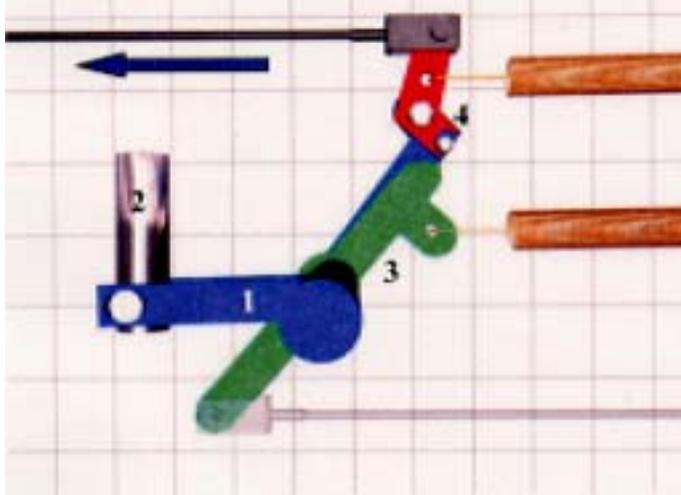
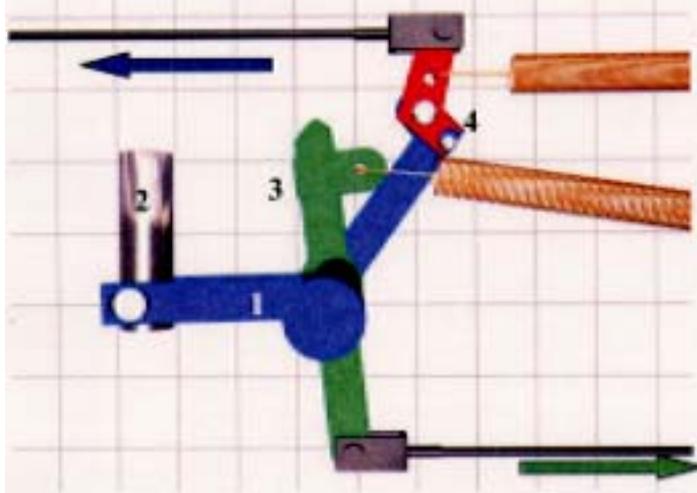
Figure 1

At rest – no input from either pilot

Initial rear seat brake application rotates fork fitting (4) anti-clockwise, separating lever (3) from lever (1)

Full input by front pilot has no effect on brake application. Rear seat pilot only can now apply brakes, rotating lever (1) anti-clockwise.

G-BZVL – schematic illustration of Aero L-39 rear-cockpit priority brake over-ride mechanism

shows how this is achieved: the rear seat lever cable is linked via fork fitting (4) to the arm (1) which is in turn directly connected to the spool valve (2) which ports fluid to the brakes. Thus movement of the rear seat lever will always apply the brakes in a normally-functioning system. The same is not true for the front seat lever because the arm (3) to which the front seat cable is connected can rotate freely about its common pivot point with arm (1). If there is no input from the rear seat, then the shaped tongue at the top of (3) abuts the fork fitting (4) and the two arms move together to apply the brakes. However, if there is any input from the rear seat, the fork fitting (4) first rotates anti-clockwise and releases arm (3) from arm (4); regardless of how much brake lever pressure the front-seat pilot applies, he no longer has any input to the BCV. The only way that brake control can be

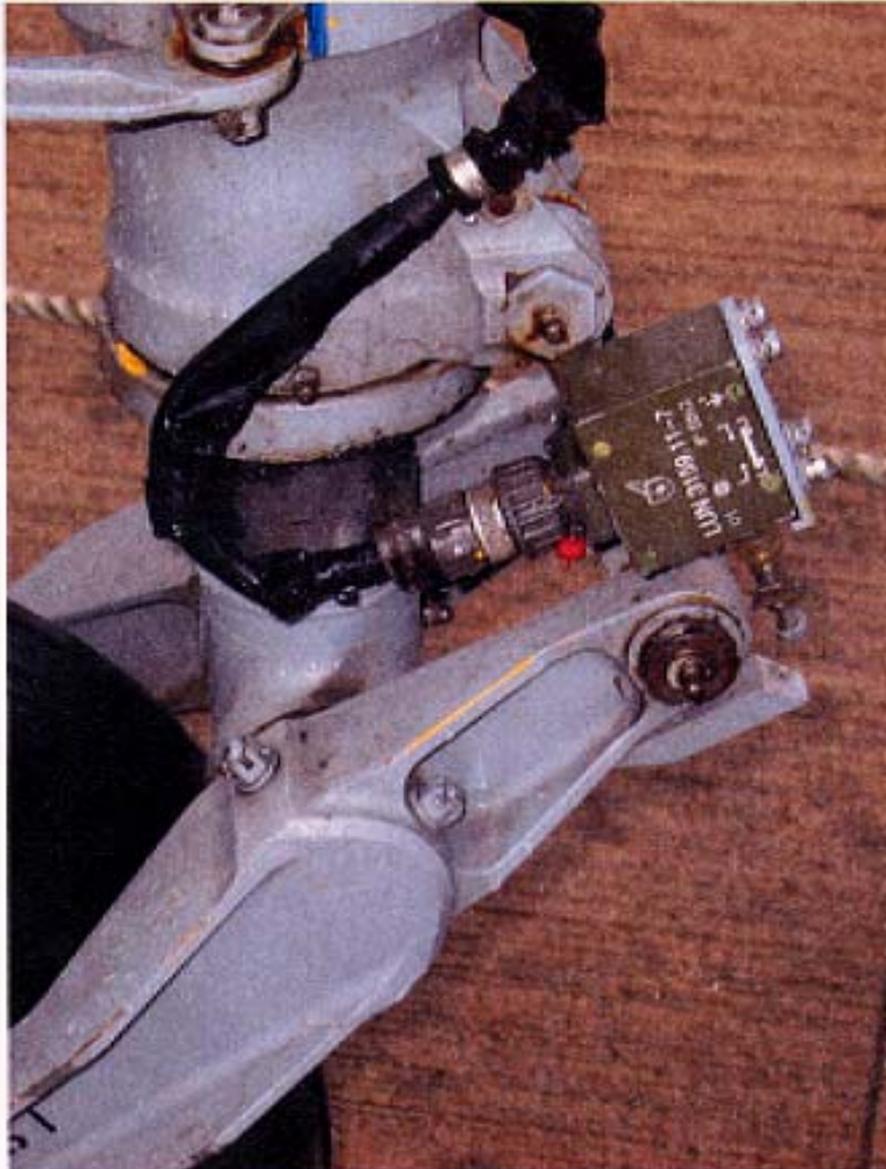
Figure 2

G-BZVL - photograph of L39 aircraft NLG microswitch which provides air/ground sense information to a number of systems, including the Normal wheel brakes

Impacts on the nose landing gear had badly damaged the NLG weight-on-wheel switch, detaching it from its mounting and breaking off the striker plate. It was found, however, that the switch plunger, although bent, still functioned sufficiently for it to simulate the air/ground condition by depressing and releasing the plunger by hand. Some repairs to the wiring were required due to damage on both this and the anti-skid circuits before testing could commence. Repeated applications of the Normal brakes from both cockpits were then carried-out with no anomalies apparent. The operation of the 'priority' mechanism for the rear cockpit was also checked, with release of the front-seat input occurring at the expected times. After a further re-pressurisation of the accumulators, the Emergency

The NLG microswitch was subjected to laboratory examination to check for any evidence that it may have been sticking or in any other way intermittent in operation. The switch assembly was found to be in good condition internally and the microswitch itself functioned normally. The fact that the plunger was bent and yet the assembly still operated was found to be due to distortion of the bronze bush in which it ran.

Since there appeared to be a complete absence of retardation when the brakes were applied from either cockpit, attention was focussed on the NLG microswitch as being the most likely reason for the failure. Anecdotal evidence was heard that other aircraft had experienced Normal braking system problems in service due to factors such as the student not applying sufficient forward pressure on the control column after landing or a misrigging of the microswitch and striker plate. It was even suggested that the difference in fuel weight before and after a long sortie could explain why the brakes might function during taxi for takeoff, but fail upon landing at a lighter weight. The attitude of the aircraft however, subjectively assessed from the eyewitness video, did not suggest other than that the nosewheel was firmly on the ground and the microswitch thus in the 'ground' condition.

Regarding the two earlier (unreported) cases of brake failure, in the first instance, when the pilot encountered a lack of Normal system braking upon landing and applied Emergency system braking successfully, the NLG microswitch plunger had been bent, possibly when the aircraft was towed from the hangar. Consideration of the system operation shows that, for normal braking action to take place during taxi and takeoff, the bend must have occurred with the plunger extended and that striker plate pressure to depress it after lift-off must have caused the deformed plunger to jam in its bush in the 'air' sense after landing. It is possible that G-BZVL suffered a similar microswitch jam after takeoff but there was no evidence to suggest that there was any pre-existing switch damage. The damage discovered after the accident did not jam the microswitch but it should be noted that the nose landing gear had probably undergone at least three impacts (perimeter fence, central reservation barrier and the road) during the accident. It is possible that pre-existing distortion of the plunger may have been overlaid by these impacts and gross damage to the bush freed a pre-existing jammed condition.
