AAIB Bulletin No: 1/94

Ref: EW/C93/3/2

Aircraft Type and Registration: Fokker F27 Mark 100 Friendship, G-BLFJ
No & Type of Engines: 2 Rolls-Royce Dart 514-7 turboprop engines
Year of Manufacture: 1959
Date & Time (UTC): 11 March 1993 at 1923 hrs
Location: Stand 6, Edinburgh Airport
Type of Flight: Public Transport (Scheduled Passenger)
Persons on Board: Crew - 4 Passengers - 15
Injuries: Crew - None Passengers - None
Other - 1 Fatal
Nature of Damage: Right propeller blades and engine mounts severely damaged, right main landing gear damaged
Commander's Licence: Airline Transport Pilot's Licence
Commander's Age: 32 years
Commander's Flying Experience: 3,475 hours (of which 526 were on type)
Information Source: AAIB Field Investigation

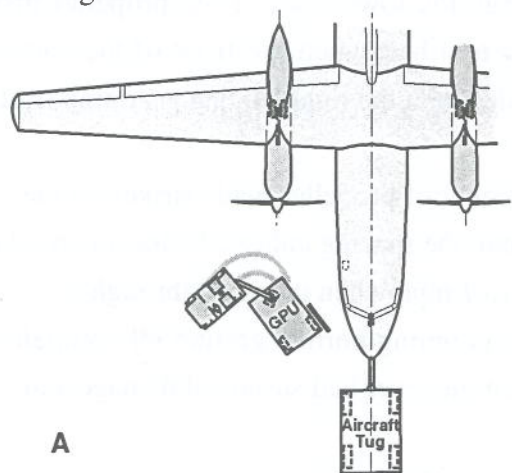
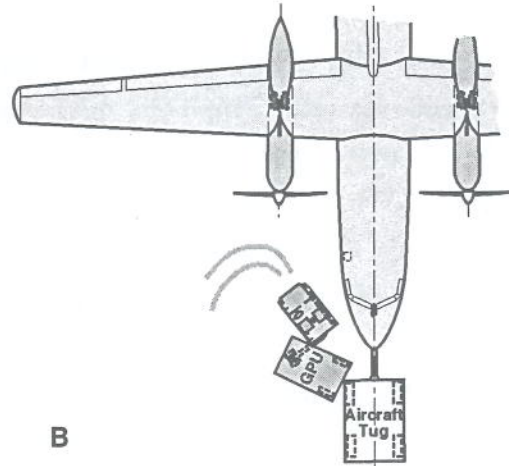
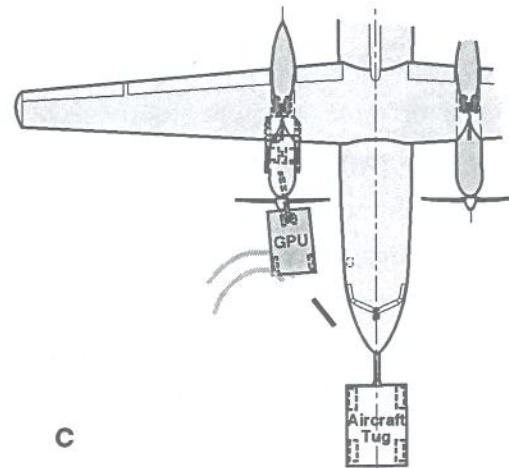
Detailed examination revealed wheel tracks and a rubber deposit on the concrete forward of G-BLFJ's right engine and contact markings on the tractor, the tractor towbar, the GPU and the aircraft tug (Fig 2). These indicated that with the rig in its initial position the tractor had probably been pointing away from the aircraft approximately as at A.

The tractor then reversed and turned left, causing the back of the GPU to collide with the left forward corner of the tug while the rig jack-knifed until locked with the towbar across the GPU and the left rear corner of the tractor in contact with the right side of the GPU (B). The rubber deposit on the concrete suggested that the right rear wheel of the tractor had spun while continuing to drive rearwards with the GPU hard against the tug; this was in agreement with eyewitness evidence. In this position the tractor was approximately 1 to 2 metres from the right side of the forward fuselage. Its front was 4 metres forward of the right propeller disc.

The final orientation of the vehicles and the characteristics of the propeller markings were consistent with the tractor having then travelled forwards, causing the rig to straighten out, before heading nearly parallel with the fuselage axis and passing almost centrally through the lower part of the propeller disc. The rig came to a halt when the front of the damaged tractor collided with the right landing gear drag strut (C).

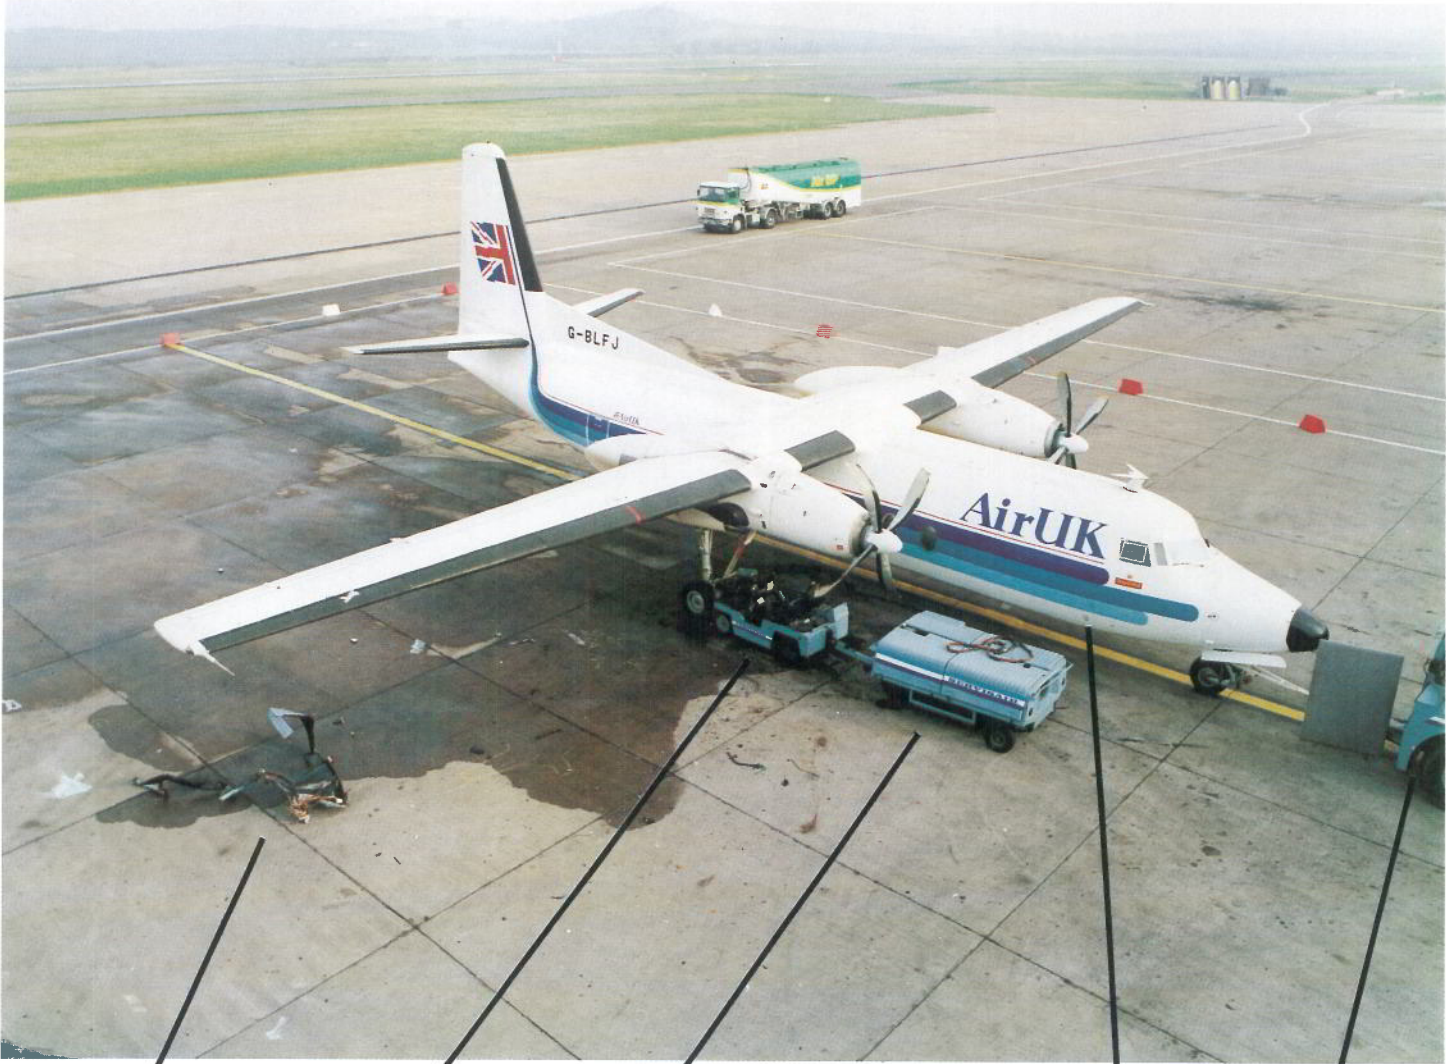
Fig 1

The tractor unit (Reliance Mercury Type 401), is a four wheel, cabbed vehicle with a nominal weight of 2,610 kg (Fig 1). It stands 1.1 metres high at the bonnet and 1.75 metres high at the cab. The diesel powerplant is rated at a maximum output of 47 bhp, and drives the tractor rear wheels via an automatic gearbox with a torque converter and three forward and one reverse ratios. Nominal performance includes a drawbar pull of 4,000 lb and a top speed of 15 mph. It was not licensed for use on public roads.

The rig came to rest with the tractor beneath G-BLFJ's right engine and the front of the tractor in contact with the right main landing gear drag strut. Inspection showed that contact of the rotating propeller with the tractor had caused detachment of the tractor's bonnet, cab structure and steering wheel. Components in the upper part of the engine compartment, the instrument panel and the seats had also been damaged. Damage to the aircraft had been confined to the right powerplant and associated airframe structure and the right landing gear drag strut. Each of the four propeller blades had bent and twisted, and the outer 6 to 7 inches had broken off. The engine mounts and local mounting structure had distorted and/or cracked in a number of areas and the lower strap holding the engine fuel collector tank had fractured. The drag strut for the right landing gear sustained localised impact distortion. Wreckage was thrown over a wide area of the concrete apron to the right side of the aircraft.

GENERAL VIEW OF ACCIDENT SITE

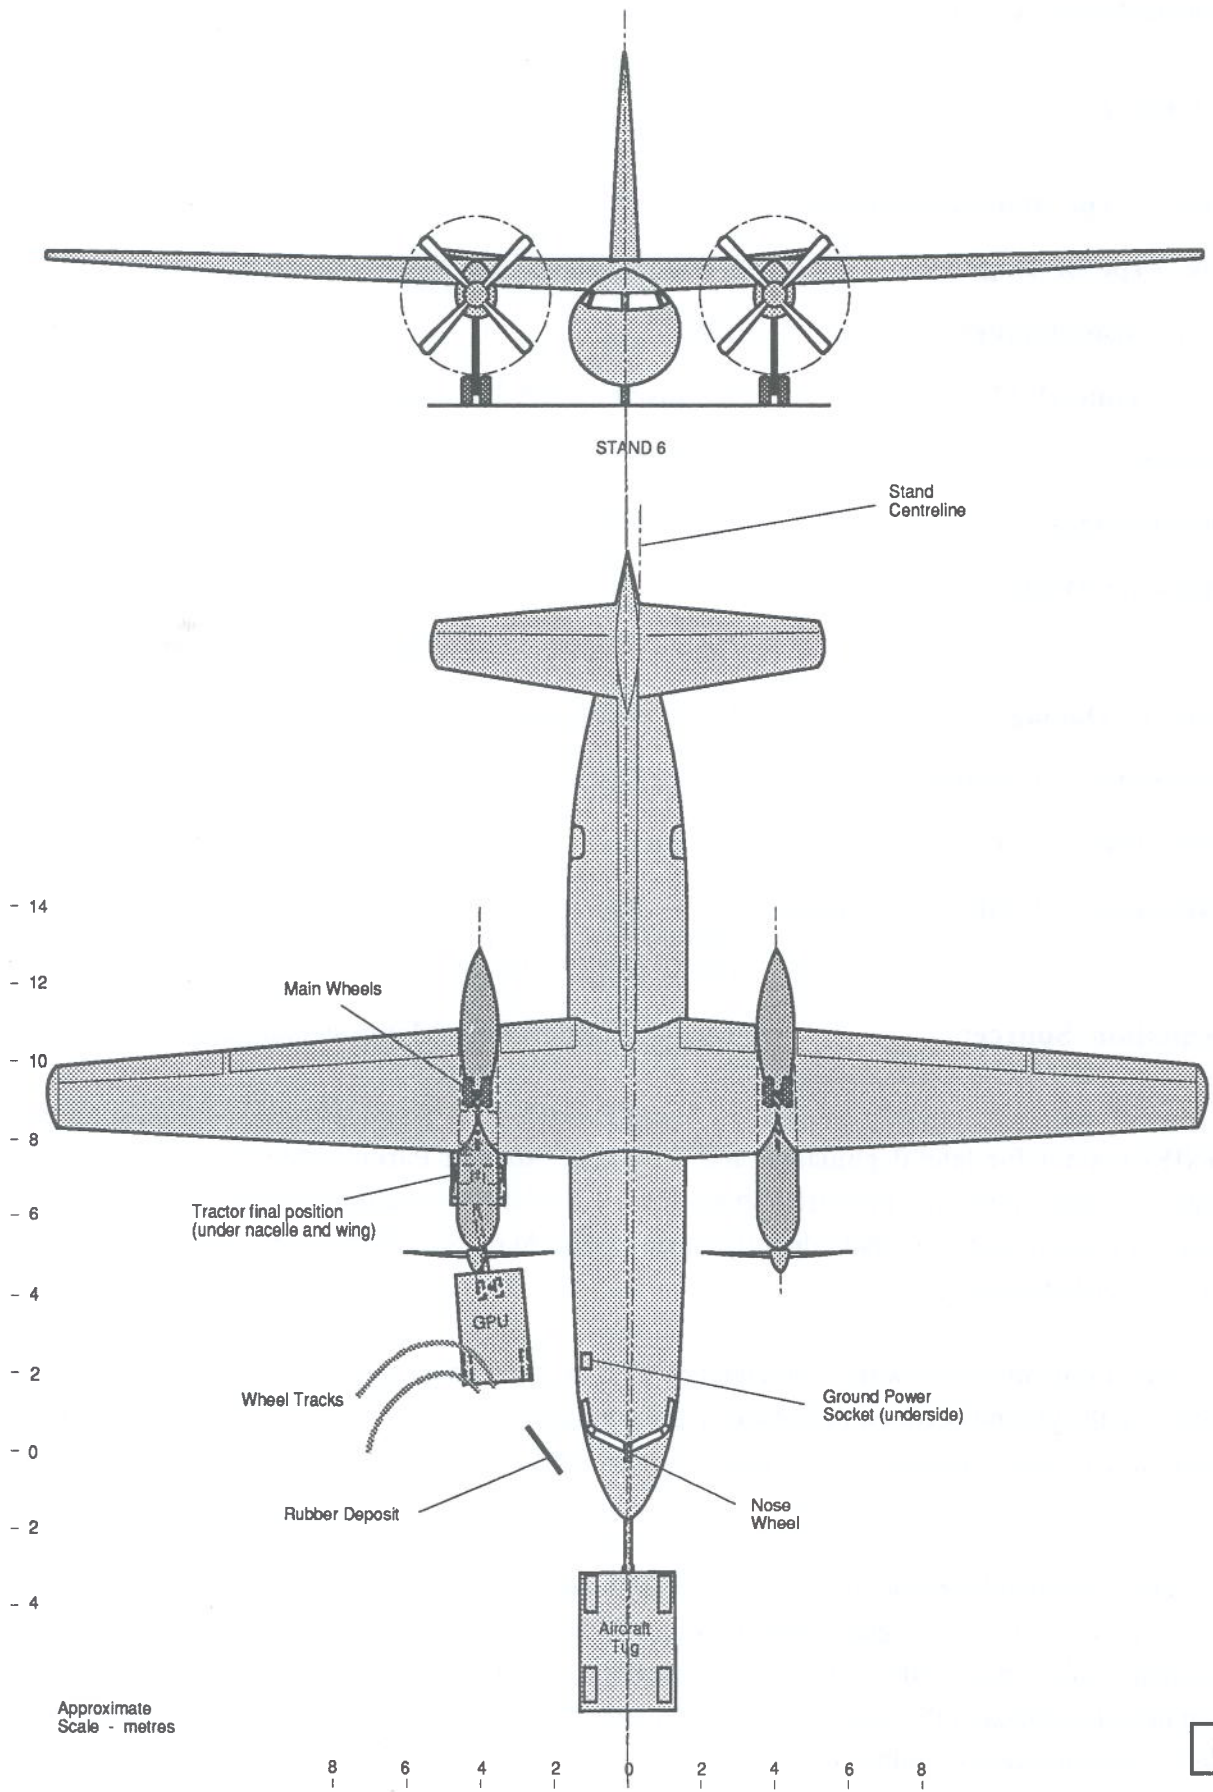
Fig 2

GENERAL PLAN VIEW OF SITE
