## ACCIDENT

<b>Aircraft Type and Registration:</b>	Midget Mustang, G-IIMT
<b>No &amp; Type of Engines:</b>	1 Continental Motors Corp O-200-A piston engine
<b>Year of Manufacture:</b>	2005
<b>Date &amp; Time (UTC):</b>	24 August 2011 at 1500 hrs
<b>Location:</b>	Gloucester Airport, Gloucestershire
<b>Type of Flight:</b>	Private
<b>Persons on Board:</b>	Crew - 1                      Passengers - None
<b>Injuries:</b>	Crew - None                      Passengers - N/A
<b>Nature of Damage:</b>	Damage to landing gear structure and wing
<b>Commander's Licence:</b>	Airline Transport Pilot's Licence
<b>Commander's Age:</b>	39 years
<b>Commander's Flying Experience:</b>	9,815 hours (of which 52 were on type) Last 90 days - 173 hours Last 28 days - 61 hours
<b>Information Source:</b>	Aircraft Accident Report Form submitted by the pilot and further enquiries by the AAIB

## Synopsis

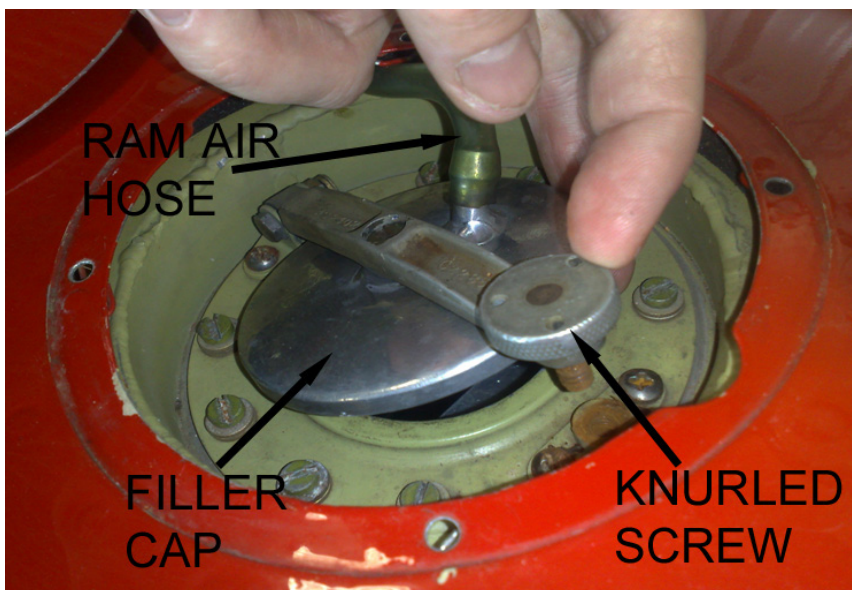
**Figure 2**

When the pilot first examined the aircraft after the accident he discovered that the knurled screw was loose and the filler cap was no longer sealing the tank. This would have resulted in the loss of ram air pressure

and reduced the fuel header pressure. The pilot reported that although he normally turned on the electric fuel pump for takeoff he could not recall if he had done so on this occasion. Further examination of the aircraft and fuel system by the LAA inspector did not reveal any further anomalies. The LAA inspector reported that without the ram air pressure the fuel pressure was probably insufficient to allow the fuel to flow through a potential vapour lock or build up of vapour around the fuel pipe loop near the electric fuel pump. He also stated that because the aircraft

Fuel Filler Cap arrangement on G-IIMT

had been on the ground for about 40 minutes this could have provided sufficient time for vapour to build up inside some of the un-insulated fuel lines in the engine compartment.

Apart from the loose fuel filler cap, no other faults with the aircraft were found. It is therefore probable

that a fuel vapour lock resulted in the loss of power during takeoff due to insufficient header pressure in the tank to clear it. It is also possible that the electric fuel pump had not been turned on and this contributed to the reduced fuel pressure.
