**INCIDENT**

<b>Aircraft Type and Registration:</b>	Boeing 757-236, G-BMRE	
<b>No &amp; Type of Engines:</b>	2 Rolls-Royce RB211-535C-37 turbofan engines	
<b>Year of Manufacture:</b>	1988	
<b>Date &amp; Time (UTC):</b>	30 July 2005 at 0819 hrs	
<b>Location:</b>	Nottingham East Midlands Airport, Derbyshire	
<b>Type of Flight:</b>	Training	
<b>Persons on Board:</b>	Crew - 4	Passengers - None
<b>Injuries:</b>	Crew - None	Passengers - N/A
<b>Nature of Damage:</b>	Damage to No 3 wheel and brake assemblies	
<b>Commander's Licence:</b>	Airline Transport Pilot's Licence	
<b>Commander's Age:</b>	58 years	
<b>Commander's Flying Experience:</b>	18,000 hours (of which 8,000 were on type) Last 90 days - 30 hours Last 28 days - 14 hours	
<b>Information Source:</b>	Operator's Safety Department Investigation Report and Aircraft Accident Report Form submitted by Operator's Flight Safety Officer

**Synopsis**

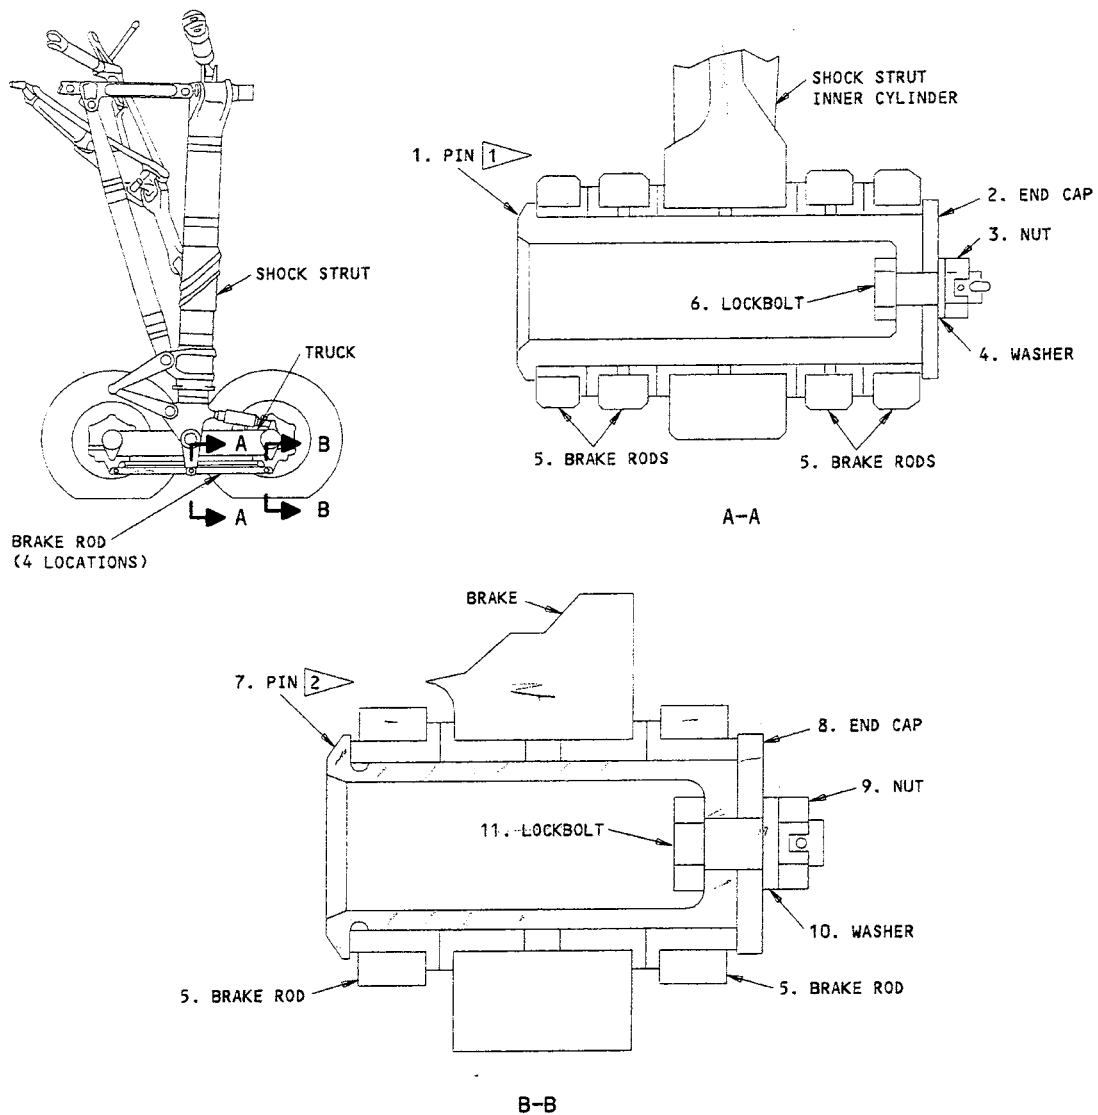
**Figure 2**

The fire was later attributed to a failure in the No 3 brake unit. This was caused by the end cap of the brake torque rod not being refitted during the maintenance activity, thus allowing one end of the brake torque rod to become detached and scrape along the ground during the landing. The brake unit rotated with the wheel during the rollout, causing damage to the wheel, severance of the brake hose and damage to the brake temperature monitoring components.

The brake rods are attached to the brake units by means of a pin, end cap, lockbolt and a nut, and their installation is illustrated in Figure 2.

It was established that the brake rod pin end cap had not been fitted, which resulted in a situation in which the pin worked its way free from the brake assembly. This allowed the brake rod to hang vertically downwards and impact the ground during a landing, and the brake assembly to rotate and sever hydraulic and electrical lines. This sequence of events is corroborated by the operator's report in which it was stated that:

Detail of Boeing 757 Main Gear Brake Installation showing attachment of brake rod. Note end cap (item 8)

- The authority to change the established maintenance programme, to include additional activities, should be reviewed and 'risk managed'.
- Maintenance personnel should be reminded of the need to review maintenance procedures before carrying out maintenance tasks.
- Whilst there is no requirement for a duplicate inspection following a brake unit change, consideration should be given for the need to conduct an independent check following such activity.
- Additional or refresher training for engineering Supervisors should be considered to ensure that correct maintenance procedures are followed at all times, and to make such personnel more aware of the pitfalls of conducting maintenance activity in poor environmental conditions, including poor lighting.
