ACCIDENT

Aircraft Type and Registration:	Beech B200 King Air G-PCOP	
No & Type of Engines:	2 Pratt & Whitney Canada PT6A-42 turbo-prop engines	
Year of Manufacture:	2004	
Date & Time (UTC):	28 March 2006 at 0832 hrs	
Location:	Within the Scottish Terminal Manoeuvring Area	
Type of Flight:	Private	
Persons on Board:	Crew - 1	Passengers - 2
Injuries:	Crew - None	Passengers - None
Nature of Damage:	Overstress damage to outer wings and engines	
Commander's Licence:	Airline Transport Pilot's Licence	
Commander's Age:	55 years	
Commander's Flying Experience:	6,524 hours (of which 180 were on type) Last 90 days - 131 hours Last 28 days - 34 hours	
Information Source:	AAIB Field Investigation

Synopsis

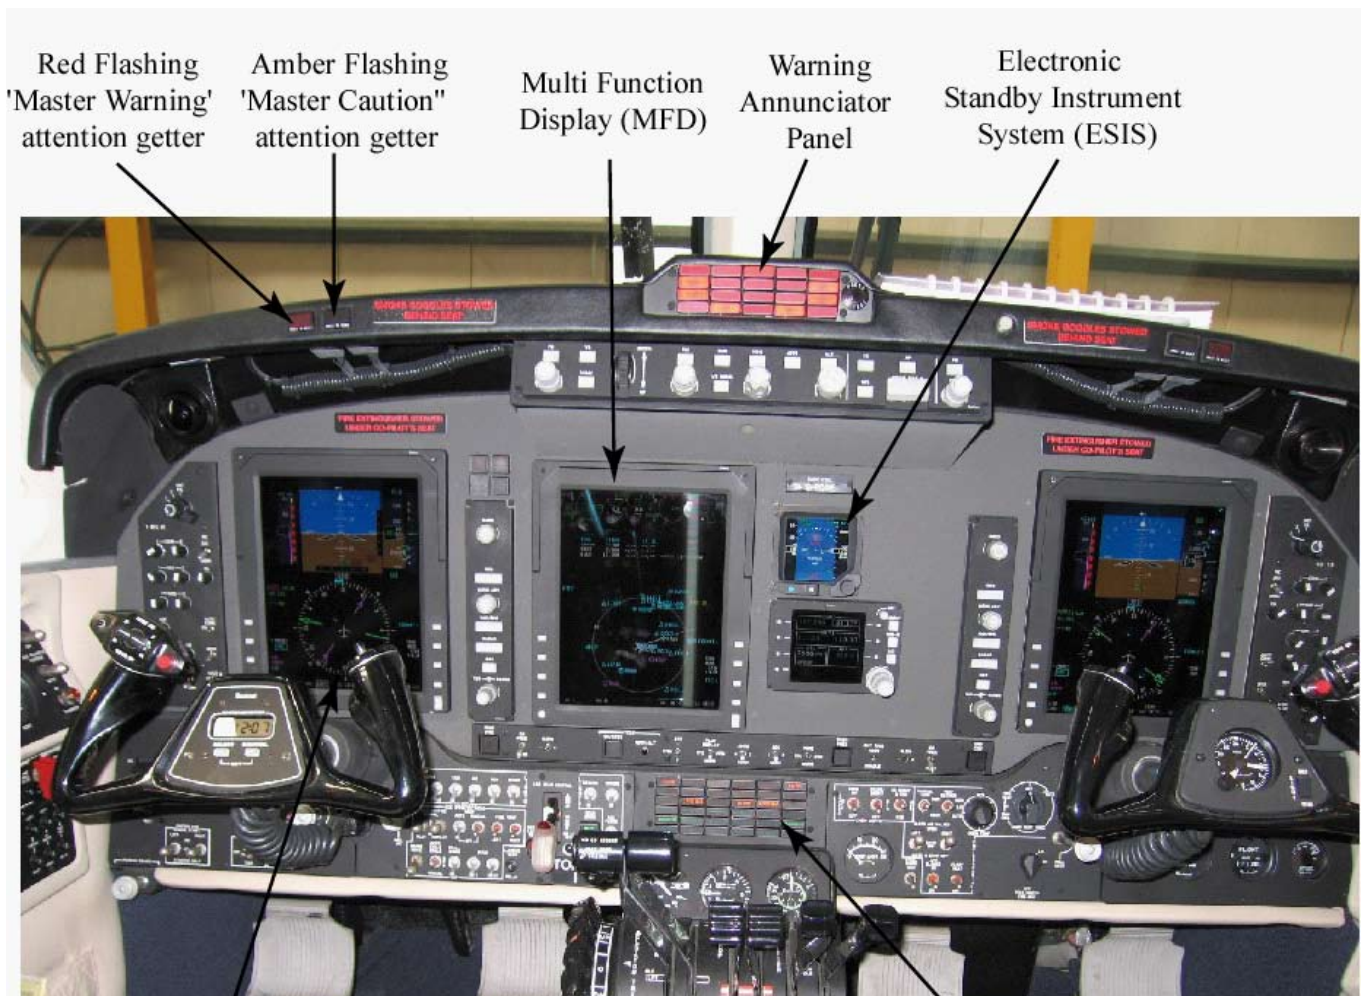
Figure 1

G-PCOP's instrument panel

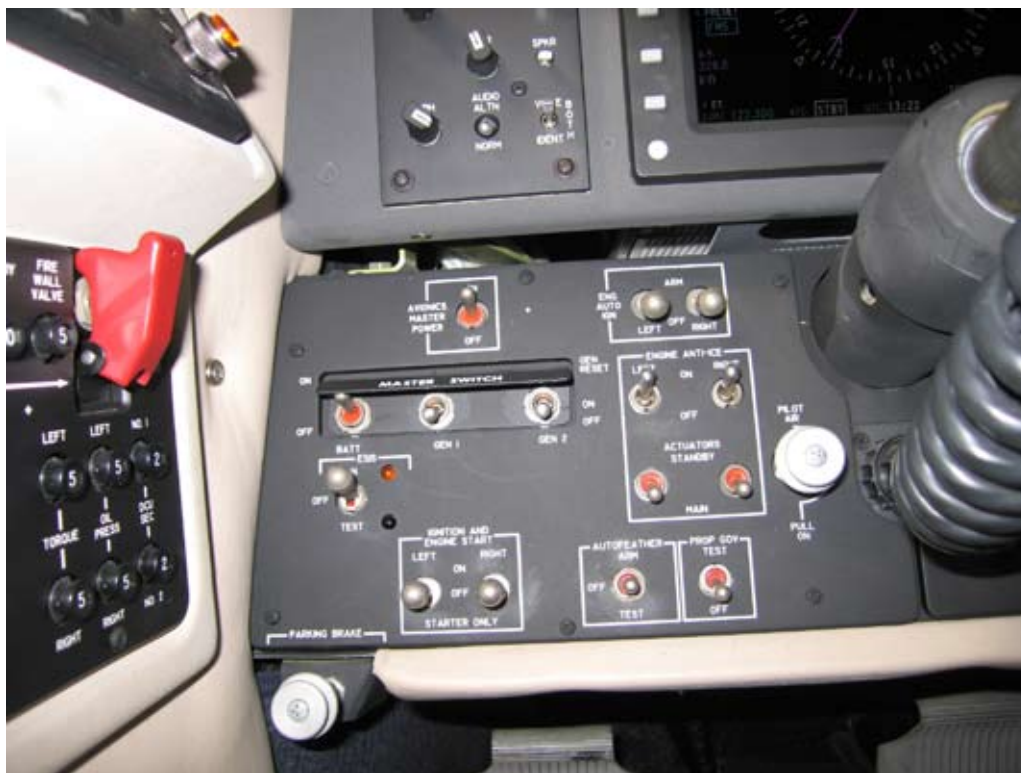
Figure 2

Lower left instrument panel switches

On the pilot's left subpanel there were two switches that control the auto ignition system. These were surrounded by a white border line and labelled ENG AUTO IGN (see Figure 2). Below and to the left of these switches were two other switches, again surrounded by a white border and labelled IGNITION AND ENG START. Both sets of switches were of similar design and operated in the same sense. The auto ignition switches were normally selected to the ARM position immediately before takeoff. With the engines running, operation of the IGNITION AND ENG START switches would engage the starter circuit and would also trip both DC generators off-line, illuminating the flashing master caution light and the respective caution captions.

However, if during the pre-takeoff checks, the IGNITION AND ENGINE START switches had been selected to 'ON' rather than the ENG AUTO IGN switches, the result would have been that the generators would have been tripped off-line. This action would have resulted in the battery being unable to support the aircraft systems within about six to seven minutes. Examination of the radio recording indicates that the aircraft radios were inoperative some five minutes after takeoff. Although this timing would support the hypothesis, the inadvertent tripping of the generators would still have illuminated the master caution lights on the glareshield and the associated L GEN and R GEN amber annunciator lights. However, depending on when any incorrect switch selection was made, the illumination of amber caution lights would not cause the same concern as the illumination of red warning lights. It was possible that the commander may have cancelled the caution as a reflex action and then did not critically examine the lights on the caution panel. Tests indicated that these lights would have dimmed within about five minutes of the generators going off-line.

The commander stated that he attempted to reset the generators just prior to landing at Leuchars. If the problem was caused by having the start switches in the ON position, then he would have been unable to reset the generators until he noticed his mistake and selected the start switches to the OFF position. This factor lends further credence to the scenario that the generators were tripped off-line just before takeoff by the pilot inadvertently operating the IGNITION AND ENGINE START switches instead of the ENG AUTO IGN switches.

The Raytheon Aircraft Company should amplify the information in the Beech 200 series Airplane Flight Manuals to reflect that the generators can be reset regardless of battery voltage but they cannot be reset if the IGNITION AND ENGINE START switches are in the ON position.

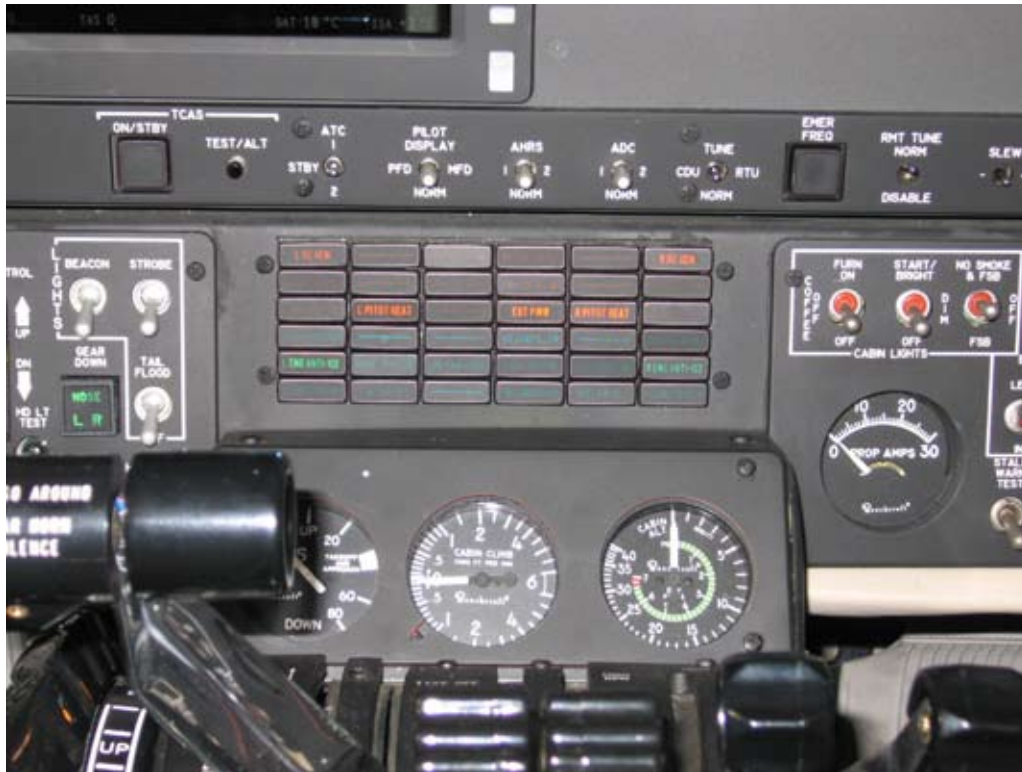
Figure 3

The aircraft was fitted with an un-dimmable multi-caption warning panel on the top of the instrument panel glare shield, together with a red master warning light in front of each pilot. An additional and dimmable caution/advisory annunciator panel was installed centrally below the MFD, see Figure 3. This panel contained amber caution captions, linked to a master caution light next to the master warning light, and green advisory captions.

Caution/Advisory annunciator panel

Irrespective of the causal factors in this accident, other aspects raised legitimate concerns. Firstly, the aircraft did not meet the CAA and EASA airworthiness requirements with respect to generator warning systems. After being briefed by the AAIB shortly after the accident, in

June 2006 the CAA made a safety recommendation to the EASA. The Authority recommended that the EASA should release an Airworthiness Directive to ensure that the aircraft type complies with the requirements of EASA CS 23.1309(b)(3) and 23.1353(h) by providing red warning annunciations when both generators are off-line, and a 'low volts' warning when the aircraft battery is supporting any part of the aircraft's electrical load. The AAIB fully supports this recommendation which is being actively considered by the EASA.
