AAIB Bulletin No: 10/93

Ref: EW/G93/05/25

Aircraft Type and Registration: Casa 1-131E Series 2000 Jungmann, G-BEDA

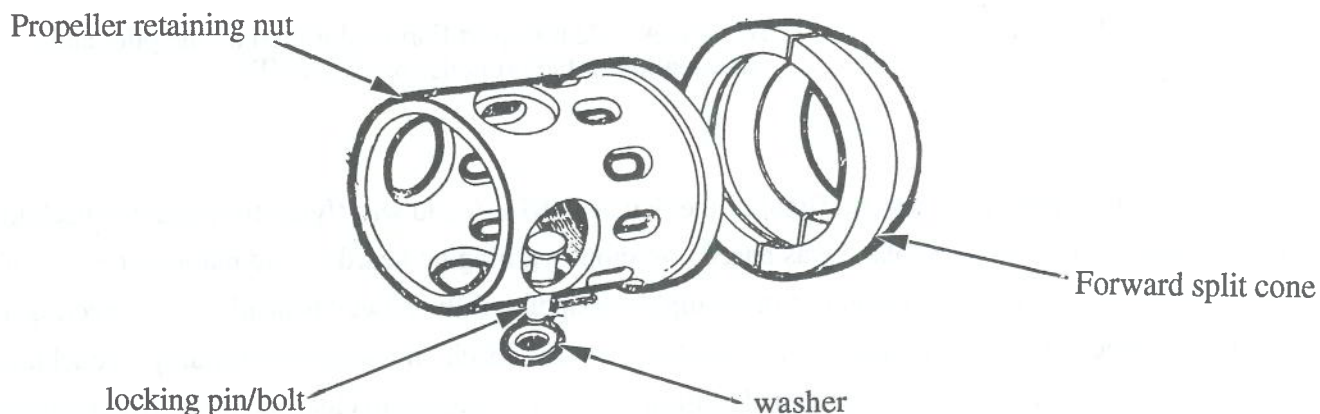
exposed the nut used to secure the propeller onto the crankshaft (see diagram). The propeller is retained by two sets of split cones which grip the propeller hub as the nut is tightened (only the front cones are shown). The end of the crankshaft is hollow and has holes drilled which are designed to allow 'Vernier' alignment with the holes in the nut so that a locking pin can be inserted after the correct torque is achieved. The original pin was a form of clevis and used a split pin and washer to retain it. It has become common practice to replace this with a bolt and stiffnut and the inspector with responsibility for the aircraft reported that G-BEDA had the latter method installed.

There were no signs of any distress to the thread of the main propeller hub nut which appeared merely to have come undone. Equally, no sign was found of the locking bolt or pin or any of its attaching parts. It is possible for the parts to have fallen out after propeller detachment if they had been present but loose but it would appear more likely that at least the stiffnut would have remained in the spinner. The pilot reported that he had done a general check of the propeller as part of his pre-flight checks and that the nut itself would have been checked in July 1992 when the aircraft had had its last Permit-to-Fly renewal.

G-BEDA: Diagram showing method of locking Hoffmann propeller nut
