## ACCIDENT

<b>Aircraft Type and Registration:</b>	Dyn'Aero MCR-01, 21-YV (callsign F-JQHZ)	
<b>No &amp; Type of Engines:</b>	1 Rotax 912 piston engine	
<b>Year of Manufacture:</b>	1997	
<b>Date &amp; Time (UTC):</b>	11 April 2008 at 1620 hrs	
<b>Location:</b>	Highclere, Hampshire	
<b>Type of Flight:</b>	Private	
<b>Persons on Board:</b>	Crew - 1	Passengers - None
<b>Injuries:</b>	Crew - 1 (Serious)	Passengers - N/A
<b>Nature of Damage:</b>	Aircraft destroyed	
<b>Commander's Licence:</b>	Private Pilot's Licence	
<b>Commander's Age:</b>	40 years	
<b>Commander's Flying Experience:</b>	950 hours (of which 60 were on type) Last 90 days - 16 hours Last 28 days - 7 hours	
<b>Information Source:</b>	AAIB Field Investigation

## Synopsis

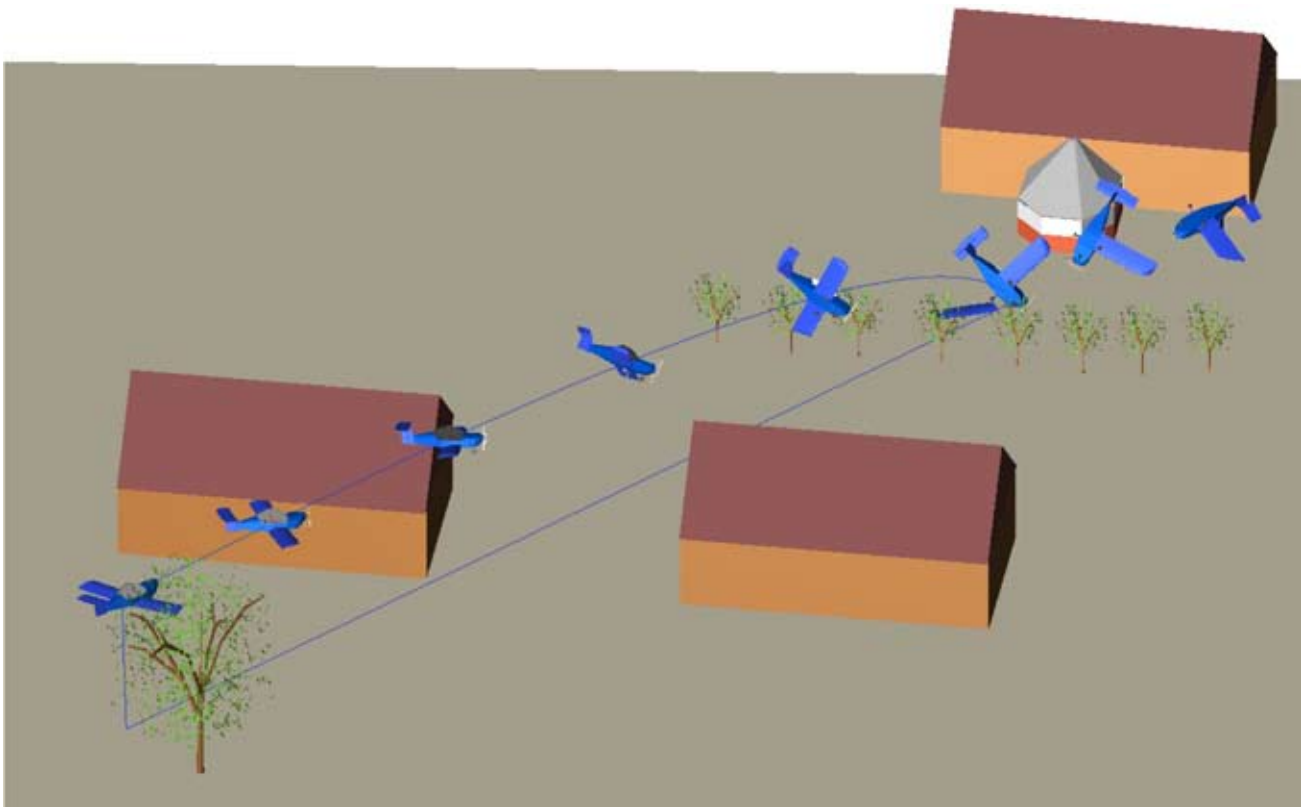
**Figure 1**

The distribution of debris and ground marks, together with inferences drawn from a three-dimensional CAD reconstruction of the impact sequence (using suitably scaled representations of the aircraft and principal ground features and objects), suggested that the aircraft was banked slightly left and travelling at significantly high speed, with a slightly upwards trajectory, at the instant it struck the tree. The impact between the right wing tip and the tree caused it to yaw violently to the right and, thereafter, it appears to have followed a slightly lofting trajectory whilst rolling left and pitching nose-down. Just before impact with the ground, the left wing tip struck the small tree bounding the garden into which it finally crashed. This sequence, taken from the CAD reconstruction, is shown in Figure 1.

CAD representation of the impact sequence

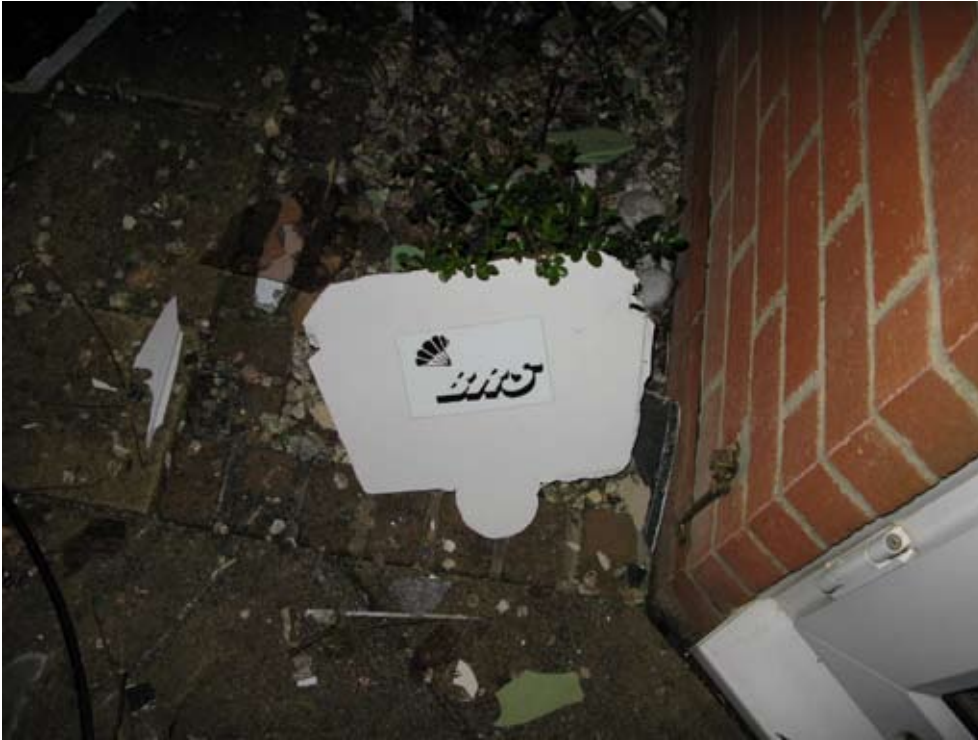
Two warning placards were displayed on the exterior of the aircraft; a BRS parachute logo on the parachute compartment cover, Figure 2, and a small red triangle on the fuselage top surface just aft of the parachute

Figure 3. Neither contained any explicit reference to pyrotechnic or projectile hazards. The BRS logo was also displayed on the top surface of the parachute within the compartment, Figure 3.

**Figure 2**  
Parachute compartment cover displaying the BRS placard

of the potential danger. For the latter, there is a clear requirement for highly visible warnings to be placed on the aircraft, at positions where they are likely to be seen, regardless of the aircraft's orientation on the ground, capable of indicating to a lay-person both the nature of the hazard, the location and likely direction of discharge of any associated projectiles. Currently, there are no formal requirements concerning information placed on aircraft fitted with such devices. 21-YV displayed only a BRS parachute logo on the parachute compartment cover and on the top surface of the parachute within, neither of which contained any explicit reference to pyrotechnic or projectile hazards. The red triangle on the fuselage top surface, just aft of the parachute compartment, which bore the legend, '*DANGER FUSEE DEXTRACTION PARACHUTE* (DANGER ROCKET EXTRACTION PARACHUTE)', was small and not considered to be visually compelling.

It is recommended that the International Civil Aviation Organisation publish a Standard which defines internationally agreed warning placards for application to all aircraft fitted with ballistic parachute recovery systems, that give as clear an indication as possible at the greatest distance reasonable of the dangers posed to first responders to an accident aircraft fitted with a ballistic parachute recovery system.

It is recommended that the Federal Aviation Administration, the Civil Aviation Authority and European Aviation Safety Agency, cooperate to require the application of warning placards of a common agreed standard, to be applied to all aircraft fitted with ballistic parachute recovery systems for which they have airworthiness responsibility, to maximise the possibility of first responders being made aware of the danger posed by a live system following an accident. These placards should be applied in such a manner that at least one such placard should remain visible regardless of the stationary attitude of the aircraft.

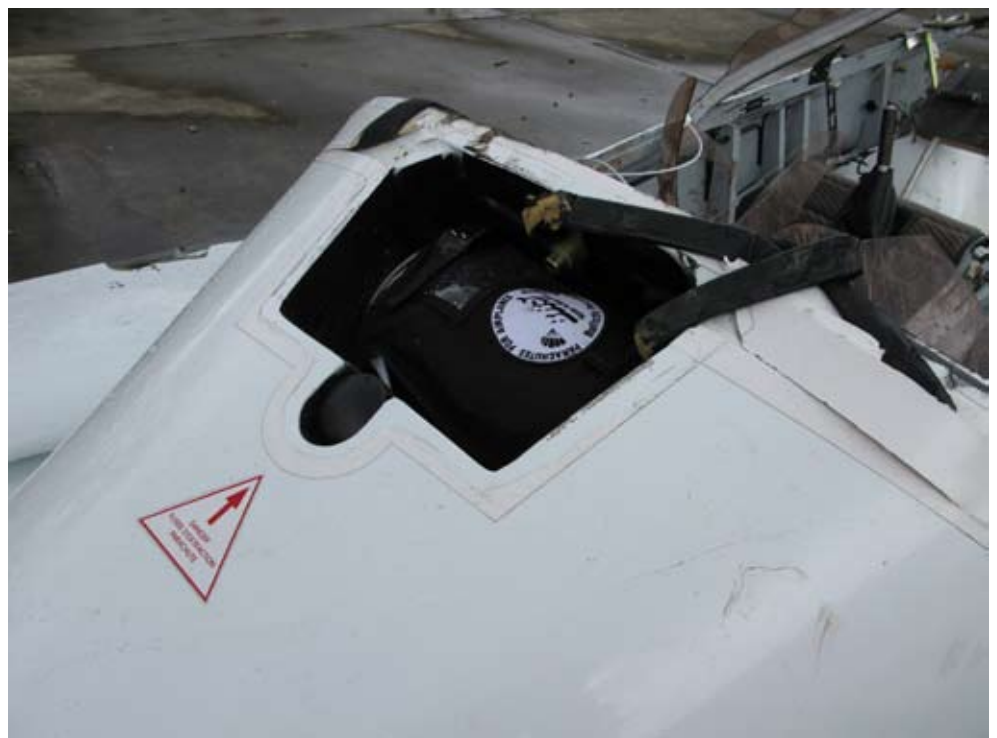
compartment, bearing the legend, '*DANGER FUSEE DEXTRACTION PARACHUTE*' (*DANGER ROCKET EXTRACTION PARACHUTE*), with an arrow pointing towards the parachute compartment,

**Figure 3**  
Red warning triangle and  
BRS placard (displayed on  
the parachute)

Various documents, such as BCAR Section S (Sub-section K), ICAO State Letter No AN6/26-05/46, and BMAA TIL No 16, contain information relating to warnings that should be applied to aircraft fitted with a ballistic recovery system, but the format of such warnings is not specified. It is, however, a CAA requirement that a warning placard relating to an installation must be visible on the outside of a microlight aircraft close to the '*stored energy device*'. The small red decal on 21-YV was not readily visible to rescue personnel due to the attitude of the fuselage, and was not considered to be visually compelling.

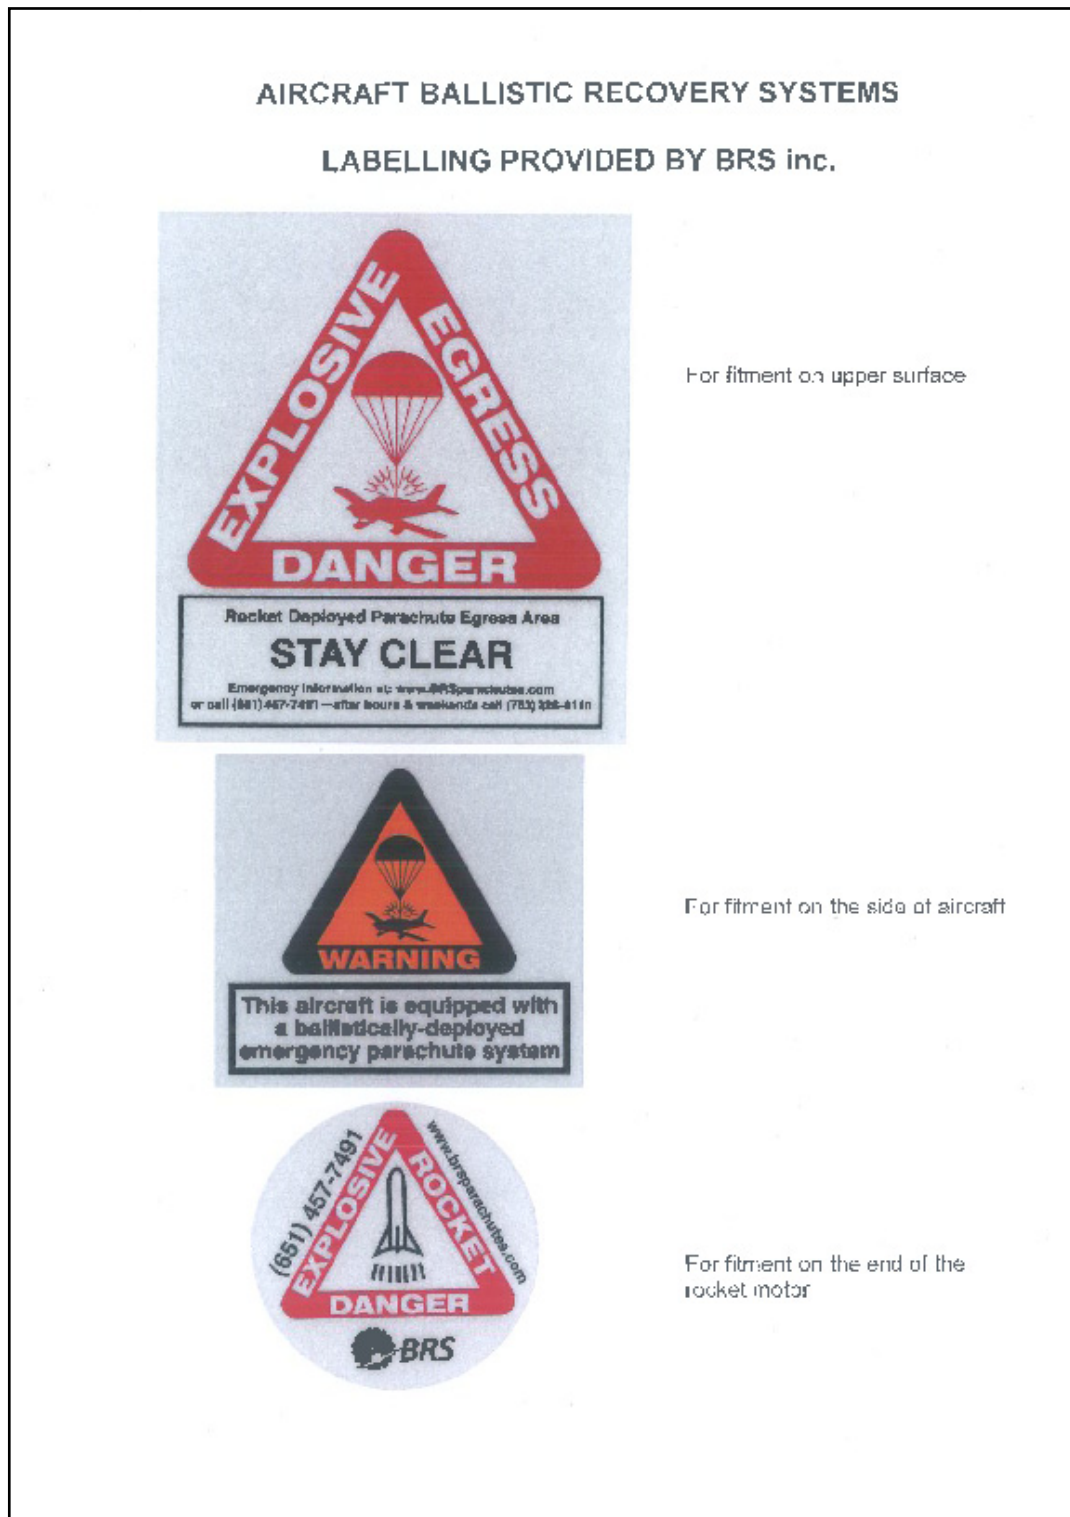
The SAIB provided an example of suitable placards, available from the manufacturer of the system fitted to 21-YV. These placards are not dissimilar to those used to mark ejector seat systems on military aircraft and are shown in Figure 4.

**Figure 4**  
Placards provided by BRS Inc.

*'We recommend that all make/model airplanes (so affected) be equipped with the ASTM<sup>1</sup> conforming placards suitable to draw the attention of first responders. ASTM F 2316-06 specifies that the aircraft should be externally marked with one danger placard at the exit point of the rocket/parachute and another warning placard on either side of the aircraft that is visible to those entering or approaching the aircraft.'*
