ACCIDENT

Aircraft Type and Registration:	Stolp Acroduster Too SA750, G-BUGB	
No & Type of Engines:	1 Lycoming O-360-A1D piston engine	
Year of Manufacture:	1997	
Date & Time (UTC):	26 July 2008 at 1457 hrs	
Location:	Near Farthing Corner (Stoneacre Farm) Airfield, Kent	
Type of Flight:	Private	
Persons on Board:	Crew - 1	Passengers - None
Injuries:	Crew - 1 (Serious)	Passengers - N/A
Nature of Damage:	Aircraft destroyed	
Commander's Licence:	Airline Transport Pilot's Licence	
Commander's Age:	52	
Commander's Flying Experience:	9,738 hours (of which 174 were on type) Last 90 days - 137 hours Last 28 days - 47 hours	
Information Source:	AAIB Field Investigation

Synopsis

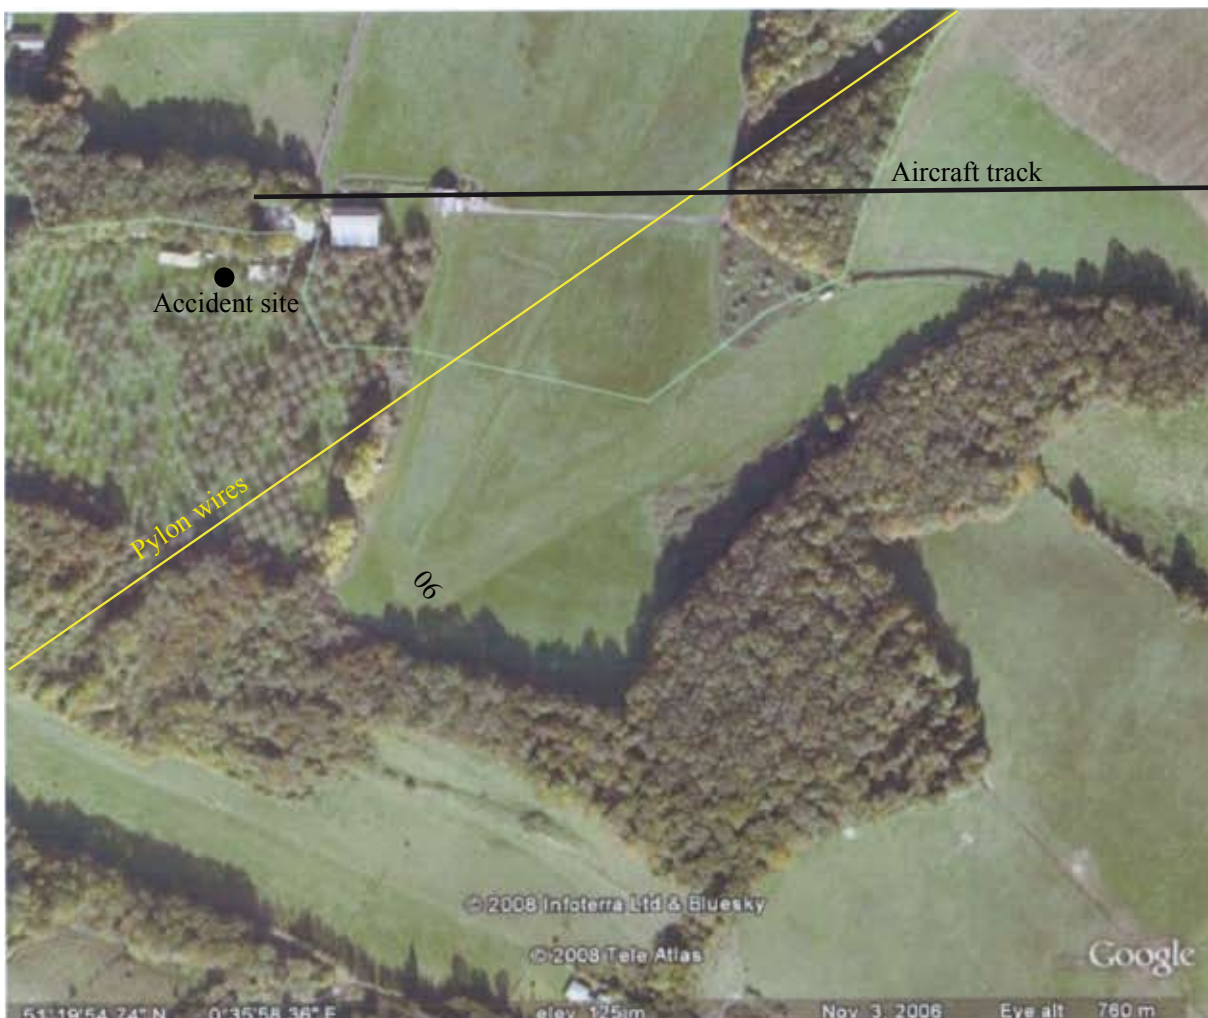
Figure 1

The aircraft had come to rest in a disused orchard close to the farmhouse witnesses. It had clipped the top of some trees, without incurring any significant damage, before impacting the ground heavily in a nose-down attitude on the main landing gear and engine, collapsing the former. The line between the tree and ground impact showed it had been travelling approximately on a heading of 180°, although it was found pointing 225°. Rescuers later explained that the aircraft had been dragged into this position to try and protect the pilot from the flames and had originally come to rest on a more southerly heading. Fire had consumed much of the aluminium and fabric structure forward of the rear cockpit.

Before it came to rest, the aircraft's wings had struck three apple trees which had severely damaged both upper and lower wings on both sides. This had a fortuitous effect since it had slowed the aircraft rapidly before the fuselage could have struck another tree. The total ground slide had been only three fuselage lengths. The propeller had shed about 30 cm of the tip of one blade as it struck the ground, indicating significant power at impact with the hard ground.
