No: 3/90

Ref: EW/C1143

**Aircraft Type
and Registration:**

Shorts SD 3-60-100, G-OLTN

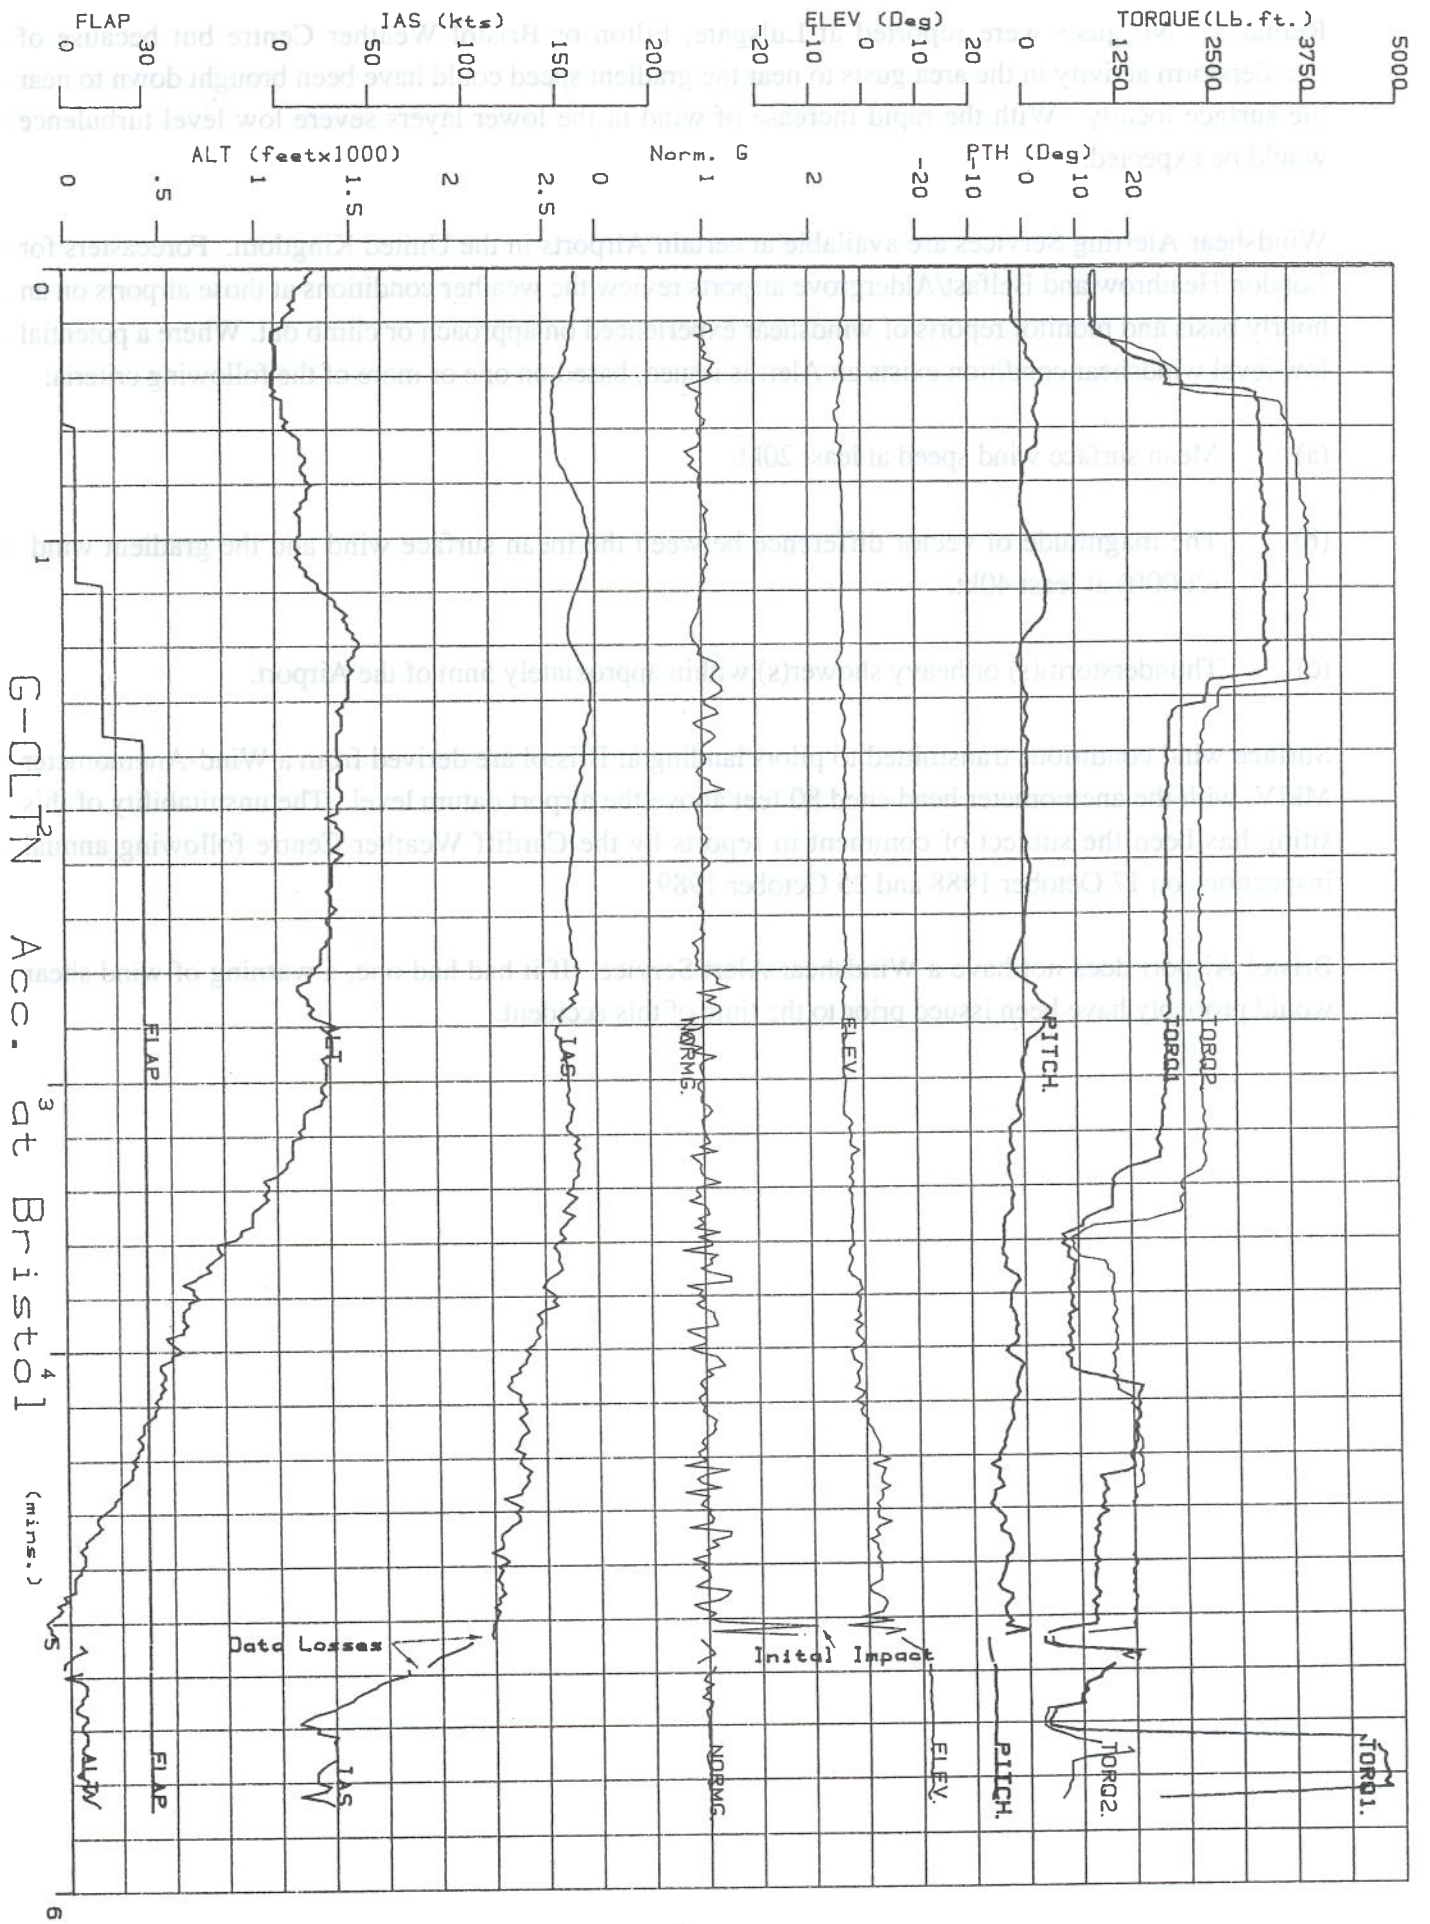
The FDR was a Plessey 1584G-DFDR which recorded 17 analogue parameters and 8 discrete events. The quality of data retrieved was good except that there was some loss of data immediately after touch down. A summary of data relevant to the final stages of the approach and the landing is included in graphical form at the end of this report. Analysis of this data resulted in the following conclusions:

- (a) Engine power. The difference between the torque recorded during the approach confirms the throttle stagger reported by the flight crew.

(b) Airspeed. The rapid fluctuations in the airspeed trace indicate gusty conditions and turbulence. Touchdown airspeed is calculated to have been 114 knots, however this is subject to a possible error of + or - 5 knots.

(c) Elevator demands. The elevator position channel shows increasing nose down demands shortly before touch down. (N.B. Nose down demands shown as positive on the graph.)

(d) Pitch. The nose down pitch on the approach is maintained until touch down which is at 4 degrees nose down.

(e) Vertical acceleration. The vertical acceleration or 'g' line indicates moderate turbulence throughout the approach. It also shows two 'spikes' where the first and second touch-downs occurred. The first shows a peak of 2.2g followed, 1.5 seconds later, by a peak of 1.8g. Both these peaks are co-incident with a pitch attitude of 4 degrees nose down.
