Airbus A320-212, G-DACR, 28 April 1996

AAIB Bulletin No: 8/96 Ref: EW/C96/4/12 Category: 1.1

Nature of Damage: Commander's windscreen cracked

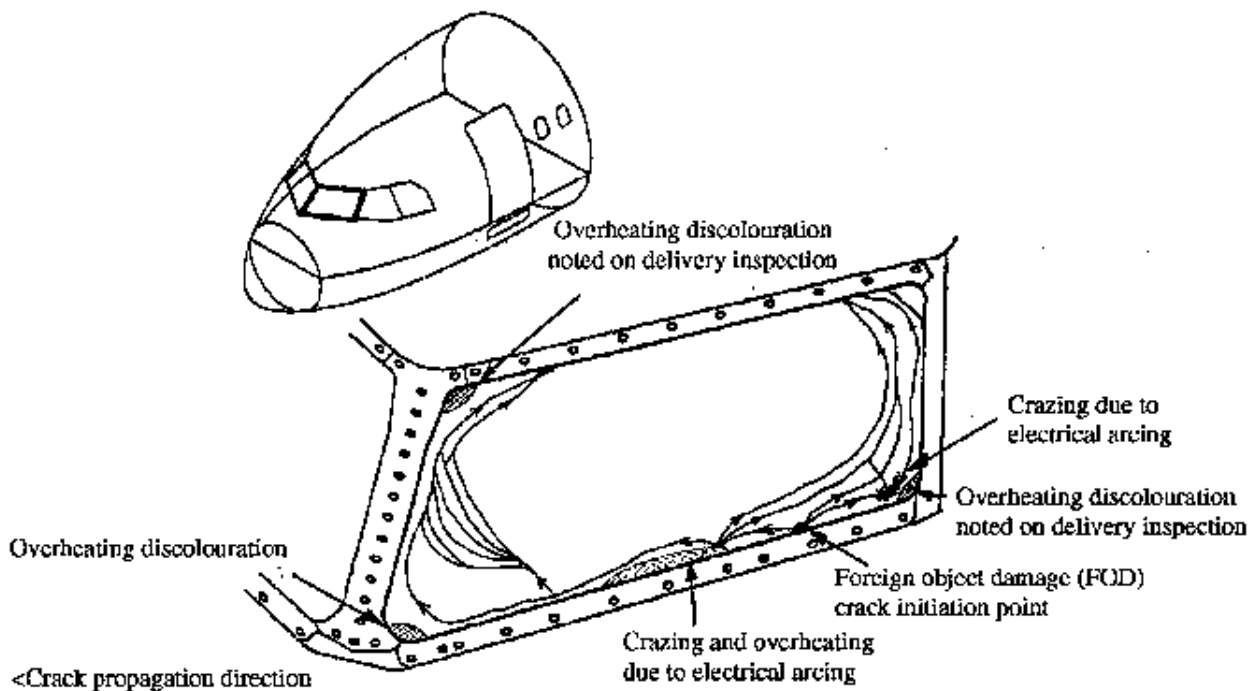
Examination of the windscreen revealed that foreign object damage (FOD) was present on the rear lower edge on the outer surface of the outer glass pane (figure 1) and had occurred prior to the incident flight. There was no evidence that the FOD had caused overheating or arcing in the underlying electrical junction between the windscreen heating conductor film and the busbar. Cracks in the outer glass pane had progressed from the FOD both forward and rearward along the bottom edge of the windscreen. The crack that ran forward from the FOD exhibited extensive crazing, overheating and arc damage. This damage was most severe in the area that was adjacent to the FOD and was a result of the crack causing delamination and local disturbance in the electrical continuity between the busbar and the conducting film. Where the rearward running crack ran close to the overheating discoloration in the bottom right-hand corner of the windscreen, crazing due to electrical arcing had also occurred. From the ends of both the forward and rearward running cracks numerous cracks fanned out and ran almost right around the outer pane of the windscreen.

Two areas of discoloration damage to the windscreen were noted when the aircraft was received by the operator in February 1996 (figure 1) but the examination concluded that these damaged areas did not contribute to the damage investigated.

Figure 1 Damage to the windscreen
