**INCIDENT**

| <b>Aircraft Type and Registration:</b> | i) Boeing 747-200, LV-MLP<br>ii) Boeing 737-59D, G-BVKD |
| <b>Location:</b> | 3 nm northeast of Ockham VOR, over Cobham, Surrey |

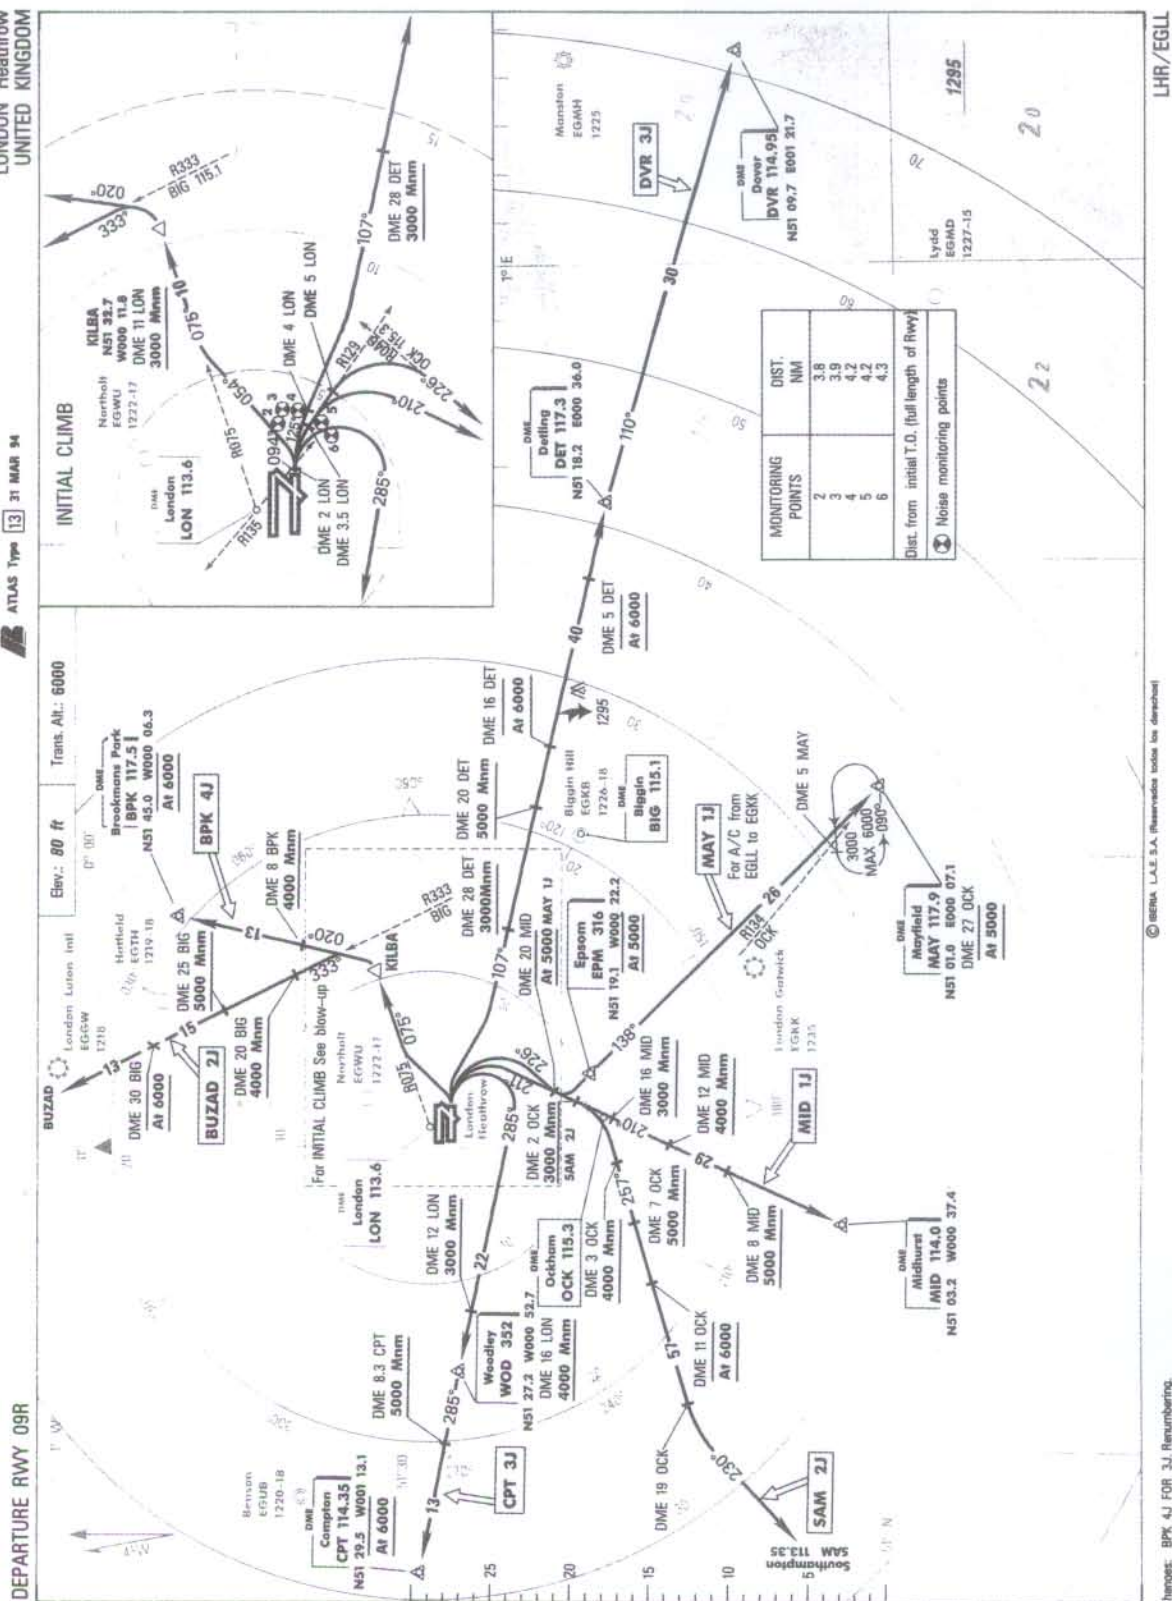
Figure 1

The Atlas chart shows all of the 09R departures in one diagram on a fold-out A4 page (see Figure 1). A written description is shown on another A5 page. On the version of the Atlas chart dated 31 March 1994, which was in use at the time, all the other SID's track diagrams show an Altitude Limit, but the Midhurst departure did not. Atlas have since rectified this omission. Atlas's written description of the procedure dated 2 February 1995, also in use at the time of the incident, differs from the 'UK Aeronautical Information Publication' wording, by describing the various check altitudes en route to Midhurst as, for example, "at 5000 Mnm", rather than "above 5000". The Midhurst 1J departure is described thus:

Note in particular the layout of the paragraph is such that the "Mnm", referring to the previous check altitude (DME 8 MID), is carried over to the next and final line, which then reads "Mnm. MID at 6000".

Immediately following this incident, the operating company, of the Boeing B747 issued a Fleet Bulletin to all B747 crews reminding them to be aware of and strictly comply with published SID

procedures, particularly altitude restrictions. The company are also examining the possibility of substituting the existing (Atlas) charts for ones which appear to be more easily interpreted.
