**SERIOUS INCIDENT**

<b>Aircraft Type and Registration:</b>	Airbus A330-243, G-OJMC	
<b>No &amp; Type of Engines:</b>	2 Rolls-Royce RB211 Trent 772B-60 turbofan engines	
<b>Year of Manufacture:</b>	2002	
<b>Date &amp; Time (UTC):</b>	28 October 2008 at 0426 hrs	
<b>Location:</b>	Sangster International Airport, Montego Bay, Jamaica	
<b>Type of Flight:</b>	Commercial Air Transport (Passenger)	
<b>Persons on Board:</b>	Crew - 13	Passengers - 318
<b>Injuries:</b>	Crew - None	Passengers - None
<b>Nature of Damage:</b>	None	
<b>Commander's Licence:</b>	Airline Transport Pilot's Licence	
<b>Commander's Age:</b>	47 years	
<b>Commander's Flying Experience:</b>	14,500 hours (of which 3,000 were on type) Last 90 days - 170 hours Last 28 days - 40 hours	
<b>Information Source:</b>	AAIB Field Investigation

**Synopsis**

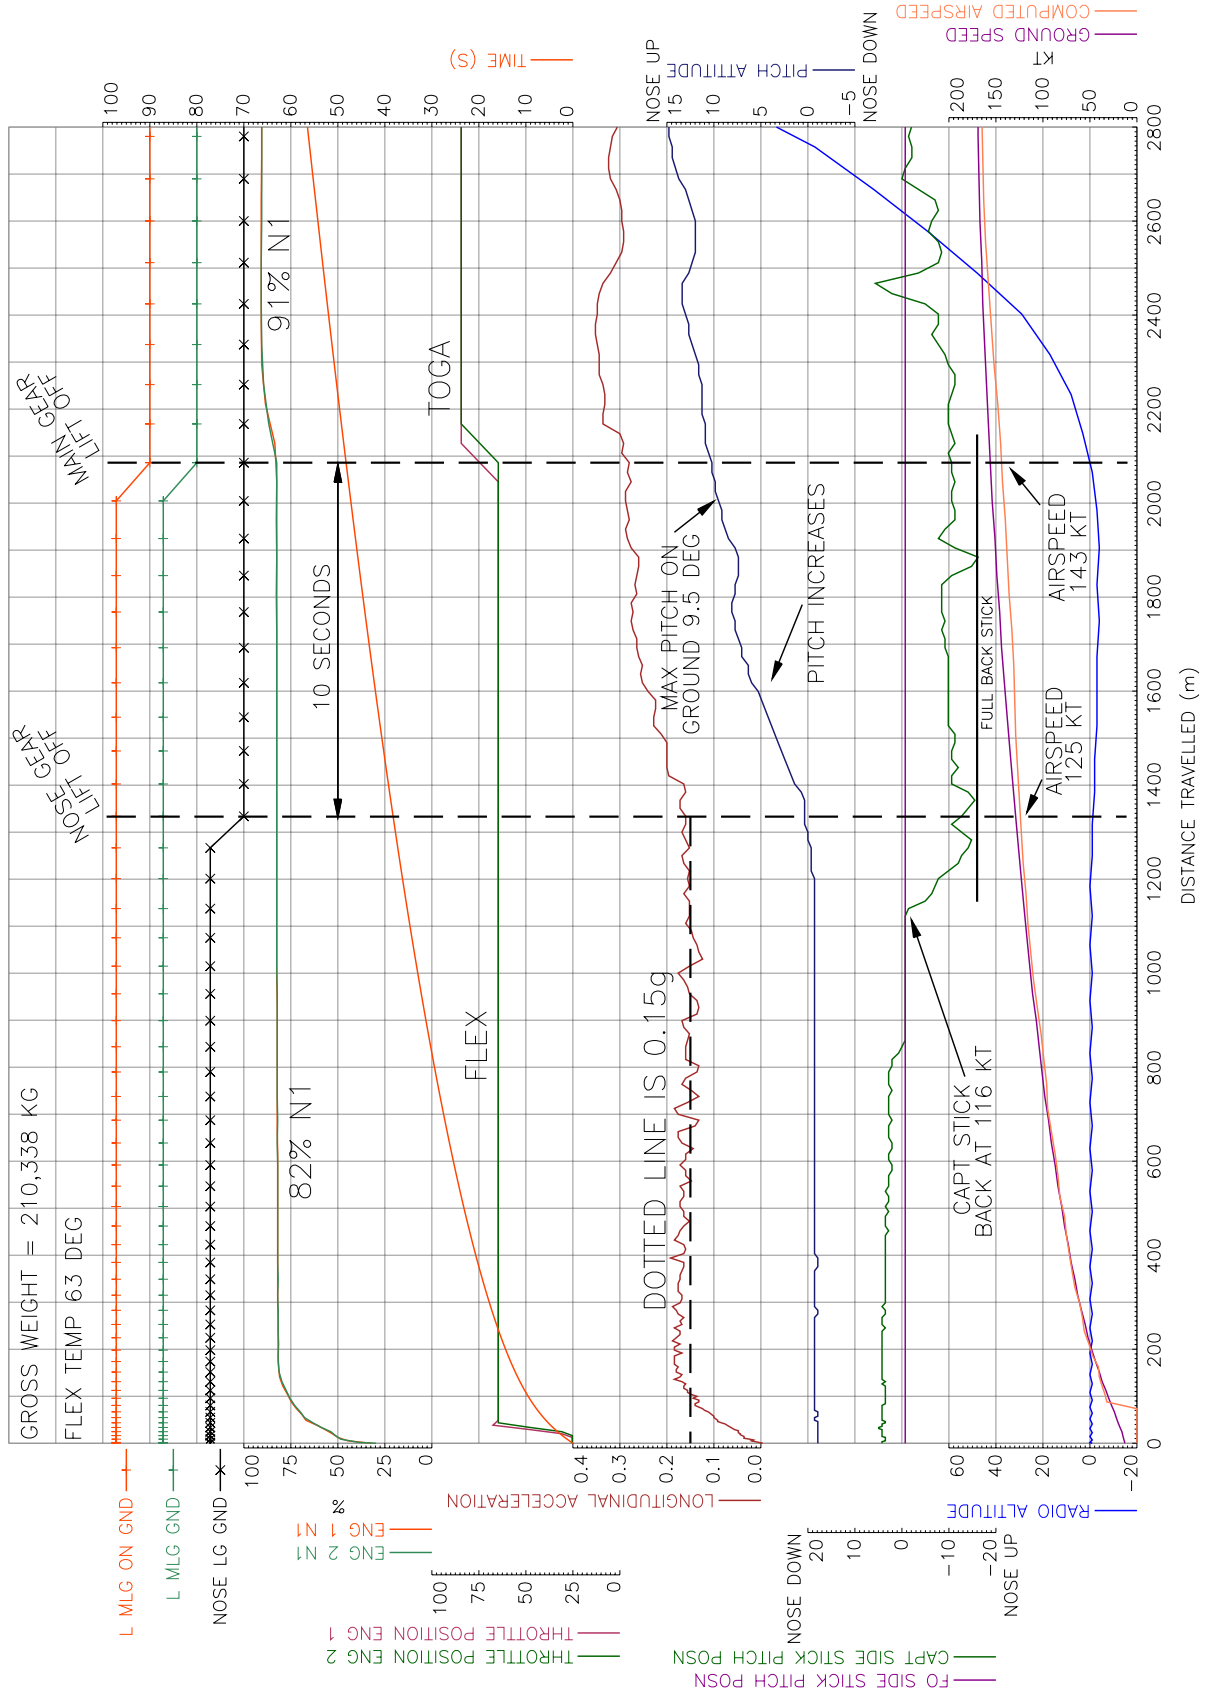
**Figure 1**  
Relevant G-OJMC FDR Parameters

Data presented in Figure 1 shows recorded aircraft parameters plotted with respect to the G-OJMC's estimated position on the runway. As the aircraft latitude and longitude was only recorded every four seconds, position on the runway was established by integrating the longitudinal acceleration and assuming that the aircraft started rolling at the runway threshold.

As the aircraft accelerated through an airspeed of 116 kt, over a two second period, the commander pulled back on the sidestick to  $-14.8^\circ$  to command the aircraft to pitch up. Figure 1 shows this command was then reduced to  $-10.6^\circ$  and then back up to  $-15.5^\circ$  over the next second. The nose gear left the ground three and a half seconds

after the pitch up command began, at an airspeed of 125 kt. The commander then reduced the sidestick position to around  $-9^\circ$  pitch up command but the aircraft pitch attitude continued to increase.

Ten and a half seconds after the initial pitch up command, as the aircraft accelerated through 138 kt, the main landing gear was still on ground and the commander applied a further pitch up command by pulling fully back on the sidestick to  $-16.3^\circ$ . Two seconds later as pitch attitude increased further, the main landing gear squat switches registered that the main gear had extended. The pitch attitude at this time was  $10.2^\circ$ , airspeed 143 kt and the approximate runway distance covered was 2,086 m. Maximum aircraft pitch attitude on the ground with the main gear compressed was recorded as  $9.5^\circ$  nose-up.

As the aircraft became airborne, the thrust levers were advanced to the TOGA position and the recorded engine  $N_1$  increased to 91%. Aircraft pitch attitude continued to increase until, at a radio altitude of 40 feet and  $13.4^\circ$  pitch up, the commander pushed the sidestick forward to  $5.6^\circ$ . By 50 feet radio altitude, the aircraft had covered an estimated distance of approximately 2,500 m since the start of the takeoff roll.

The FDR shows a rotation speed of 116 kt which, for this aircraft configuration, meant that insufficient lift was available to allow the aircraft to lift off and accounted for the sluggish aircraft rotation recognised by the commander. As the main landing gear left the runway, the aircraft was accelerating through 138 kt towards the correct  $V_R$  of 140 kt and the selection of TOGA thrust increased that acceleration.

A tailstrike was avoided in this event as aircraft pitch attitude reached a maximum of  $9.5^\circ$  whilst the main landing gear shock absorbers were compressed;  $11.5^\circ$  of pitch would have been required for the tail to contact the runway.
