BAe 146-300, G-OINV

AAIB Bulletin No: 7/2004	Ref: EW/C2003/03/04	Category: 1.1
INCIDENT		
Aircraft Type and Registration:	BAe 146-300, G-OINV	
No & Type of Engines:	4 Lycoming ALF 502R-3A turbofan engines	
Year of Manufacture:	1990	
Date & Time (UTC):	2 March 2003 at 1055 hrs	
Location:	In the cruise, near Carlisle, Cumbria	
Type of Flight:	Public Transport	
Persons on Board:	Crew - 5	Passengers - 95
Injuries:	Crew - None	Passengers - None
Nature of Damage:	Fuselage insulation entwined in aileron control run	
Commander's Licence:	Airline Transport Pilot's Licence	
Commander's Age:	34 years	
Commander's Flying Experience:	4,700 hours (of which 3,200 were on type)	
	Last 90 days - 160 hours	
	Last 28 days - 25 hours	
Information Source:	Aircraft Accident Report Form submitted by the pilot and other enquiries made by the AAIB

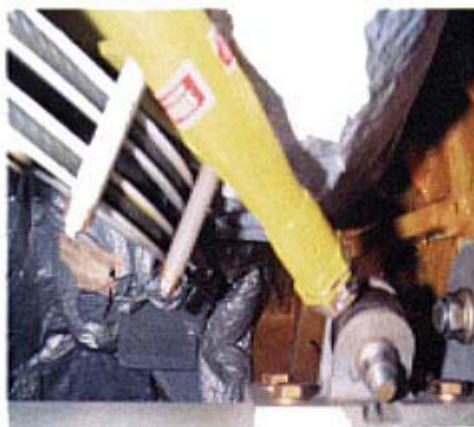
Figure 3 - Photograph showing dislodged insulation bag interfering with aileron cable

Examination of the aircraft at the operator's maintenance facility showed that a section of insulation on the rear wing spar at Frame 29 on both the left and right sides had become entwined with the aileron cables where they passed through pressure bungs (see Figure 3).

G-OINV - Photographs showing (above) dislodged insulation bag interfering with aileron cable and (below) with bag removed, the pressure bungs (note retaining button)

The insulation bags had become dislodged from their retaining buttons but it appeared that the particular zone had not been disturbed during recent maintenance, how long this condition had existed was not known. Other aircraft in the operator's fleet were inspected and loose bags were found, however none were actually touching the cables.

The manufacturer has stated that they intend to revise the Maintenance Manual for the aircraft to include more comprehensive inspection and securing information for insulation in this area.
