No: 5/90

Ref: EW/C1151

Piper PA25-150 Pawnee, G-ATFR

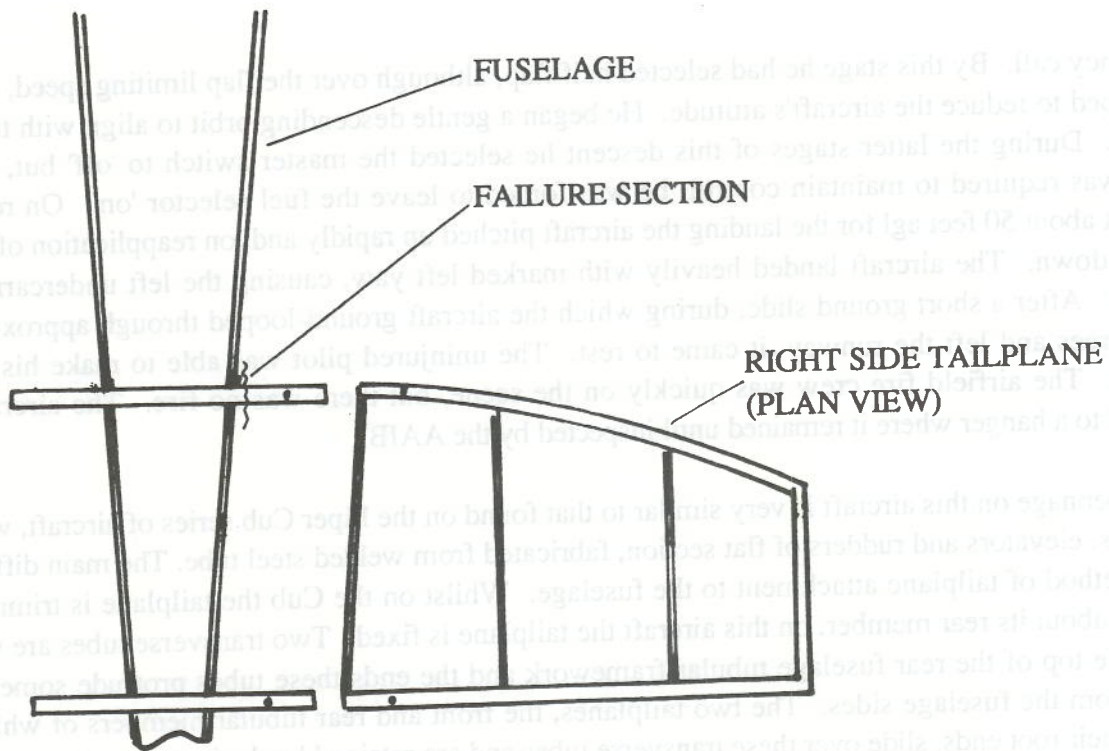
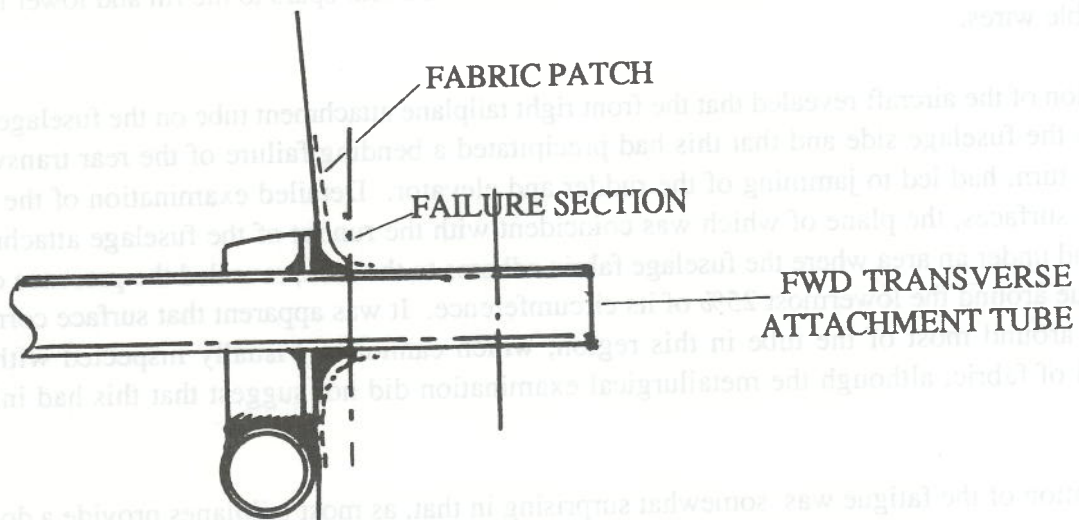
Inspection of the aircraft revealed that the front right tailplane attachment tube on the fuselage had failed close to the fuselage side and that this had precipitated a bending failure of the rear transverse tube. This, in turn, had led to jamming of the rudder and elevator. Detailed examination of the front tube fracture surfaces, the plane of which was coincident with the runout of the fuselage attachment weld fillet, and under an area where the fuselage fabric adheres to the tube, revealed the presence of a region of fatigue around the lowermost 25% of its circumference. It was apparent that surface corrosion was present around most of the tube in this region, which cannot be visually inspected without some removal of fabric, although the metallurgical examination did not suggest that this had initiated the fatigue.

The location of the fatigue was somewhat surprising in that, as most tailplanes provide a download in stable flight, the region of this tube which would be anticipated to experience tensile loading would be at the top, and this would be where any fatigue problem might be expected to occur. However, the tailplane had rotated upwards rather than downwards in the slipstream following the failure. For fatigue to occur, a cyclic loading mechanism must be present with, at least, part of the cycle resulting in sufficiently high tension stresses in the subject area. The empennage on Piper Cubs and Pawnees can be seen to vibrate, both on the ground and in flight, in resonance with engine/propeller induced vibration. However, no previous failures of this type have been recorded by the manufacturer or by the CAA's accident/incident data base.

One factor which may have been of significance was the method used by the operators to expedite the descent following release of a glider. After release, high drag was induced by pulling back on the stick in a spiral descent until the stall buffet was reached, and this was maintained until the aircraft entered the circuit to land. The effects of such buffet-induced loads on the tail area is not known but it is considered likely that increased levels of oscillatory stress may be induced by such additional vibration.

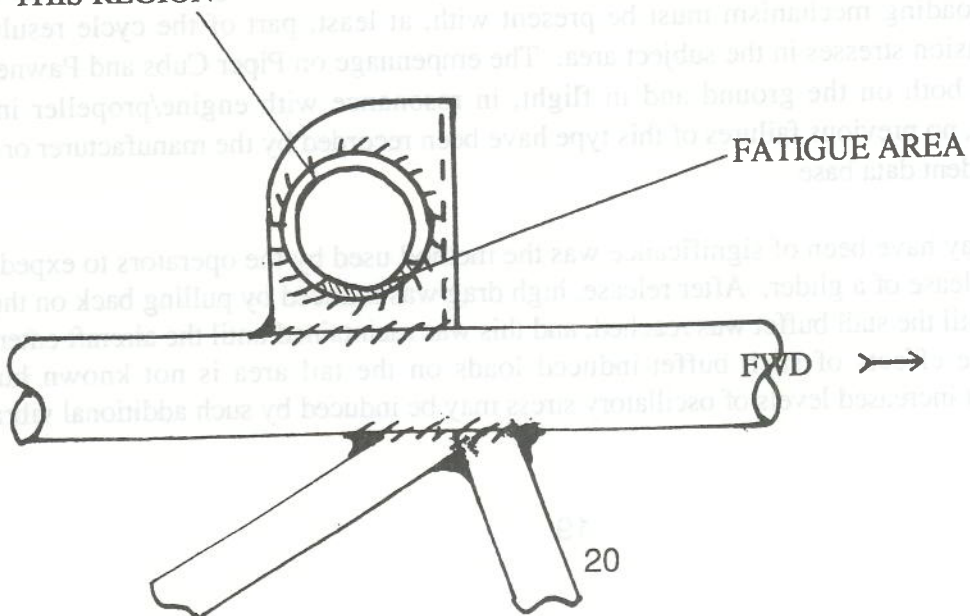
OVERLOAD FAILURE AROUND THIS REGION
