## ACCIDENT

| <b>Aircraft Type and Registration:</b> | Europa, G-BWIJ | |

## Synopsis

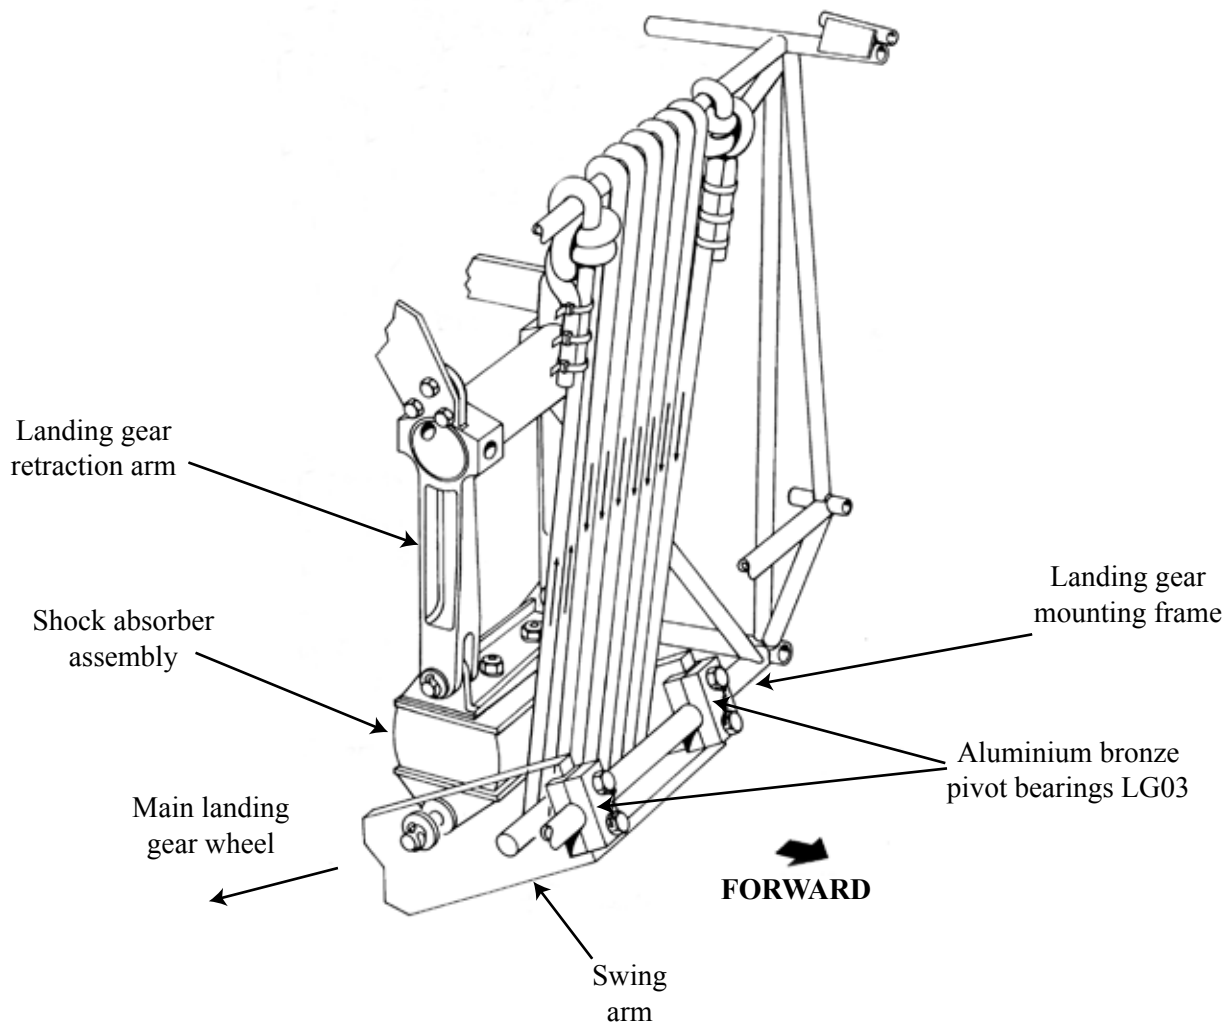
**Figure 1**

The pilot, who was also a PFA Inspector, carried out a detailed examination of the landing gear system and found that the aluminium bronze pivot bearings, part number LG03 (Figure 1), that allow the main landing gear swinging arm to rotate around the landing gear mounting frame, had seized onto the steel shaft of

Main landing gear pivot

the mounting frame. There was very good evidence of aluminium bronze pick-up on the steel shaft of the mounting frame and there was also evidence of corrosion on the steel shaft.

The aircraft was complete towards the end of 2006 following a build lasting several years. Following the third test flight it was found that the engine coolant was well above the normal operating temperature. The aircraft was dismantled and transported uncovered by road, on an open trailer, to a facility where larger capacity radiators were fitted. During the road journey a very heavy rain storm was encountered. The aircraft was then stored for approximately two months in an unheated covered facility whilst awaiting the fitting of the larger radiators. It is possible that this could have contributed to the corrosion in the landing gear system.
