ACCIDENT

Aircraft Type and Registration:	Fournier RF4D, G-AVKD	
No & Type of Engines:	1 Volkswagen Rectimo 4AR-1200 piston engine	
Year of Manufacture:	1967	
Date & Time (UTC):	31 January 2006 at 1500 hrs	
Location:	Lasham Airfield, Hampshire	
Type of Flight:	Private	
Persons on Board:	Crew - 1	Passengers - None
Injuries:	Crew - None	Passengers - N/A
Nature of Damage:	Propeller broken, engine tested for shock load	
Commander's Licence:	Private Pilot's Licence	
Commander's Age:	55 years	
Commander's Flying Experience:	429 hours (of which 155 were on type) Last 90 days - 11 hours Last 28 days - 4 hours	
Information Source:	Aircraft Accident Report Form submitted by the pilot and additional enquiries by the AAIB

Synopsis

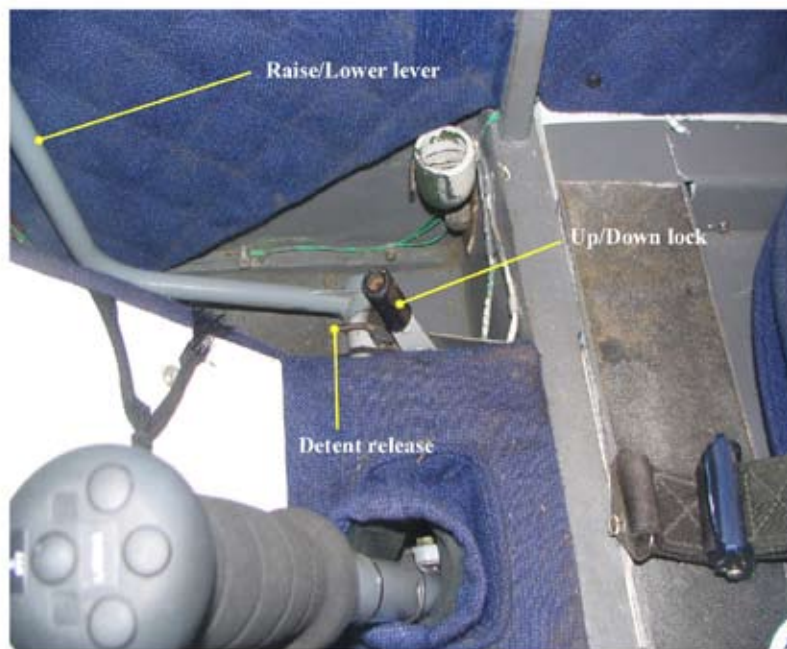
Figure 1

The Fournier RF-4 uses a manually-retractable single mainwheel with fixed outriggers and a tailwheel. The wheel is raised and lowered by a lever on the right side of the cockpit (see Figure 1): the lever is vertical when the gear is fully down and the pilot moves it aft and down to retract the wheel. In either the UP or DOWN position a locking lever on the right side of the centre console is engaged to lock the wheel in that position.

flown with the gear locked down and, when it came to extend it before landing, he simply operated the Raise/Lower lever to reverse its previous position, even though this retracted the gear. He pointed out that the positions were not labelled, but doubts whether this would have prevented the error.

Landing gear controls, G-AVKD
