INCIDENT

Aircraft Type and Registration: Cessna F150H, G-AWPI

Date & Time (UTC): 28 April 1994 at 1332 hrs

Location: Near Humberside International Airport

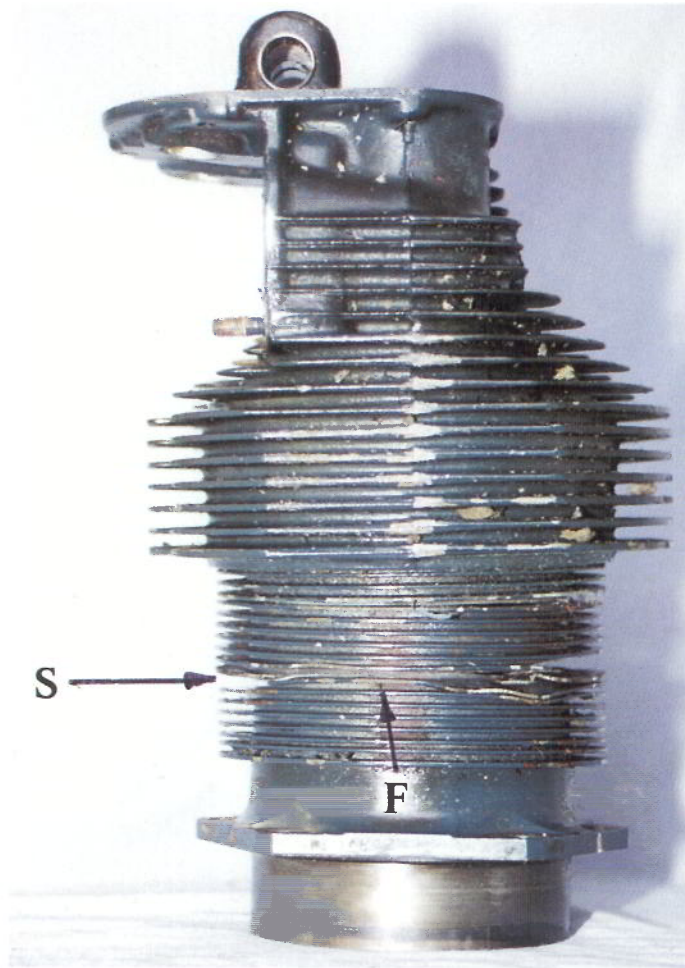
Figure 1

An initial examination of the engine revealed that the No 4 cylinder had failed. The upper half of this cylinder had separated and its piston had vacated the stub barrel, precipitating further damage to the cylinder, piston, associated rings and connecting rod.

General view of No 4 cylinder. Separation occurred across diameter at arrow S, fatigue initiation region centered at arrow F

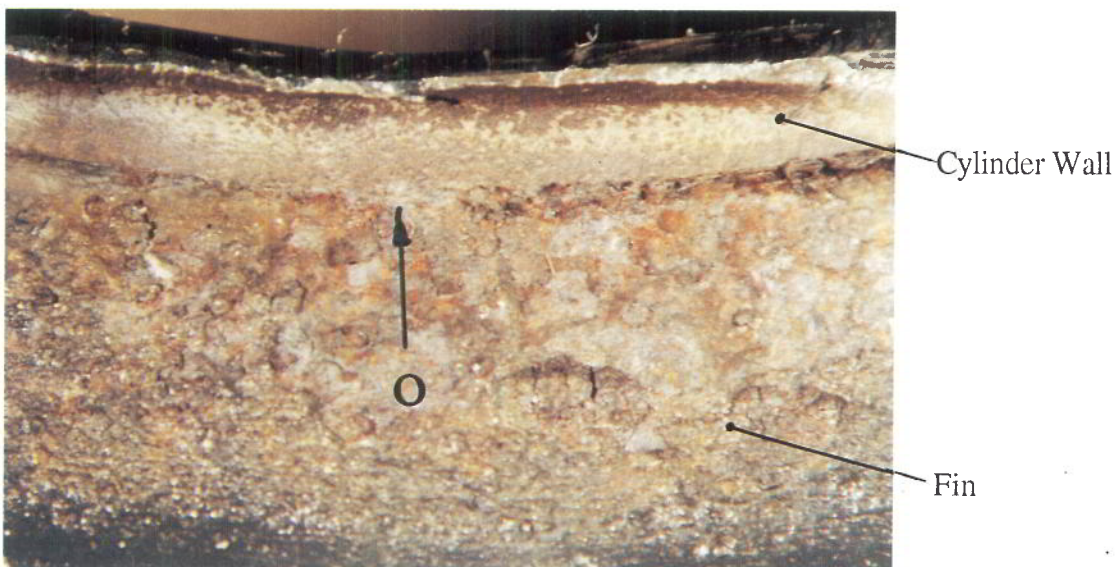
Figure 2

The two sections of the cylinder were subjected to a detailed metallurgical examination by the AAIB. Initial examination revealed that it had failed across the mid point of the lower parallel finned section of the cylinder and that the fracture surfaces had been mechanically damaged after separation. Despite this damage it was clear that separation had occurred by a low stress high cycle fatigue mechanism, initiation being in the region shown in 'Figure 1'. Detailed examination of the initiation region, 'Figure 2', showed that separation had started in the outer surface of the cylinder wall, between two of the integral cooling fins, and that the adjacent fins had been extensively damaged by pre-existing corrosion.

Close up of fatigue initiation region, centered on O showing corrosive attack at base of fin

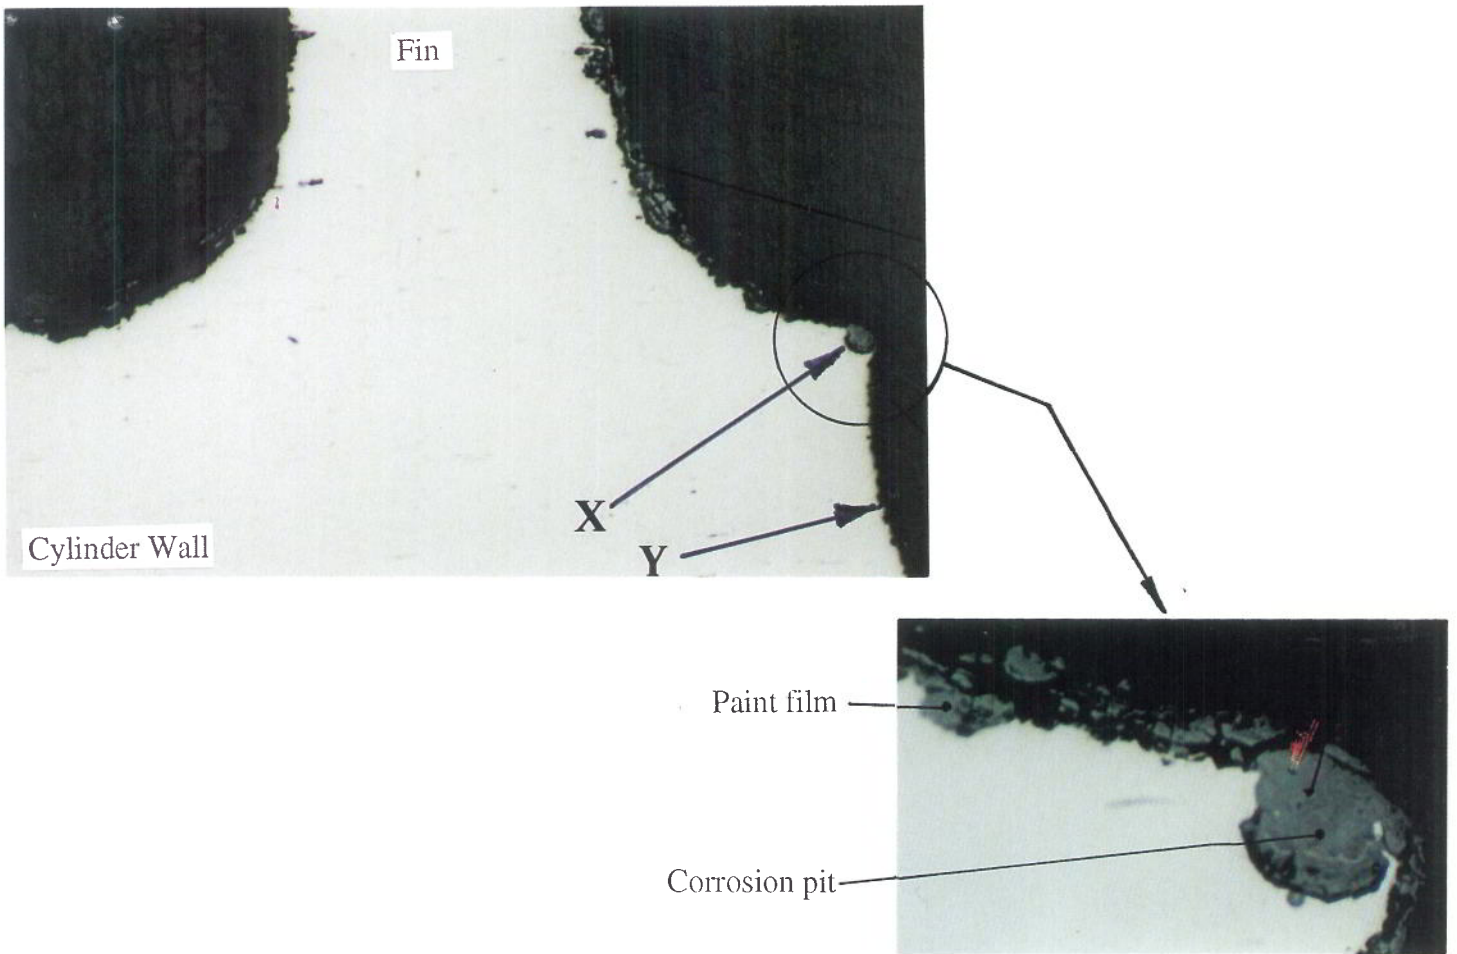
Figure 3

A micro cross-section prepared of the fatigue initiation region, 'Figure 3', confirmed the above corrosion but also that some was present on the fracture surface itself. Measurement of the fin thickness indicated that the cylinder wall thickness in this area had decreased by at least 17% due to corrosive attack. Paint was present over the external corrosion, within a corrosion pit in the fracture initiation region and on the initial part of the fracture surface, thus indicating that the initial part of the crack was present when the cylinder was last painted. The general characteristic of the paint finish on this cylinder did not suggest that it had been 'touched up' by local application of paint but rather that the complete unit had been painted at some time.

Edge containing fatigue initiations arrowed X, fatigue separation arrowed Y

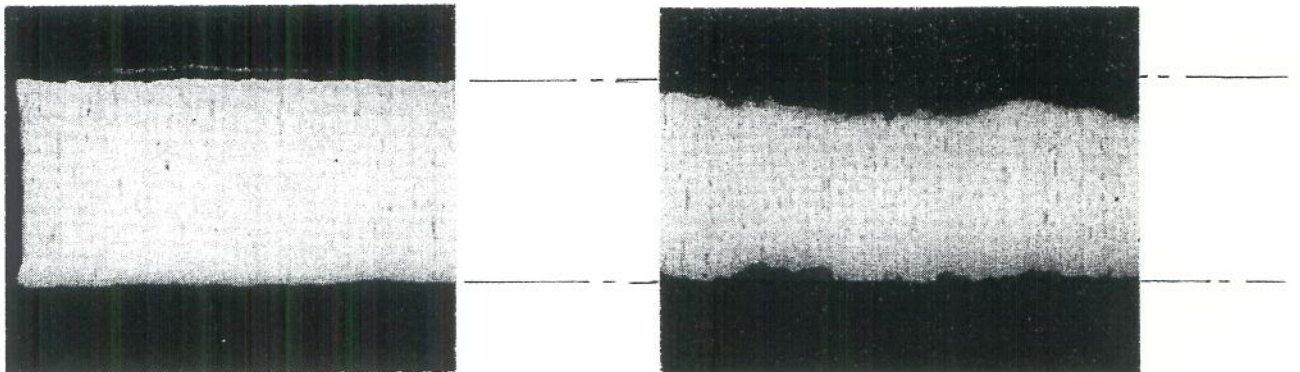
Figure 4

Typical outer and inner sections of corroded, paint covered, cooling fin
