SERIOUS INCIDENT

Aircraft Type and Registration: Airbus A330-343, G-VKSS

Location: On departure from Orlando International Airport, USA

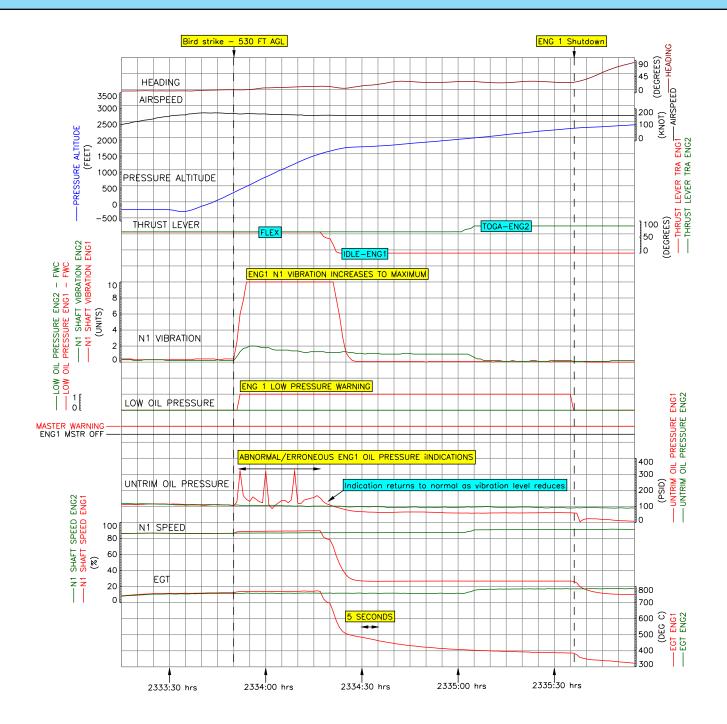
Figure 2

The aircraft took off from Orlando International Airport Runway 35L at 2333 hrs (1833 hrs local). The takeoff roll was uneventful, but at a height of approximately 530 ft during the climb out, there was a loud bang, which was almost immediately followed by the activation of the master warning and ENG 1 FAIL and ENG 1 LO PR captions being displayed on the ECAM. The left engine N₁ shaft vibration increased

from 0.4 to 10 units⁵, which is the maximum range of the parameter, EGT increased by 10° C to 771° C and all three engine shaft speeds, N_{1} , N_{2} and N_{3} , increased slightly and a series of rapid and erroneous fluctuations in the left engine untrim oil pressure were also recorded. The right engine N_{1} shaft vibration also increased from 0.2 to 1.8 units at this time.

Almost immediately, the commander (PNF) confirmed the ECAM indications and the left engine thrust lever was retarded to the idle position. He declared a "PAN" to ATC which was then upgraded to a "MAYDAY". As the left engine speed reduced, the N₁ shaft vibration level also reduced to 0.1 units and the untrim oil pressure normalised. The PF increased the right engine thrust to the TOGA position, before the shutdown procedure for the left engine was completed. The total time from initial warning to shutdown was 1 minute 46 seconds.

Data recorded between takeoff and engine shutdown
