<b>Aircraft Type and Registration:</b>	Socata TB20 Trinidad, G-HGPI	
<b>No &amp; Type of Engines:</b>	1 Lycoming IO-540-C4D5D piston engine	
<b>Year of Manufacture:</b>	1988	
<b>Date &amp; Time (UTC):</b>	1 December 2004 at 1455 hrs	
<b>Location:</b>	Bournemouth International Airport, Dorset	
<b>Type of Flight:</b>	Private	
<b>Persons on Board:</b>	Crew - 1	Passengers - 1
<b>Injuries:</b>	Crew - None	Passengers - None
<b>Nature of Damage:</b>	Damage to aircraft underside, right wing and stabilator	
<b>Commander's Licence:</b>	National Private Pilot's Licence	
<b>Commander's Age:</b>	77 years	
<b>Commander's Flying Experience:</b>	925 hours (of which 770 were on type) Last 90 days - 8 hours Last 28 days - 3 hours	
<b>Information Source:</b>	Aircraft Accident Report Form submitted by the pilot and further enquiries by the AAIB

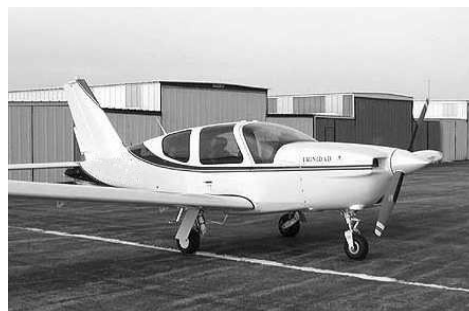
to the control tower he performed a low fly-by. During the fly-by the tower controller reported that the main landing gear appeared to be extended. The pilot carried out a normal circuit to the right to land on Runway 08. Upon touchdown the right main gear leg collapsed and the right wing tip struck the runway. The aircraft came to rest on the runway and the occupants vacated the aircraft unassisted. The airfield's fire and emergency services arrived on the scene soon afterwards but there was no fire.

An examination of the landing gear system was carried out by a maintenance organisation. The aircraft was raised on jacks and it was discovered that the left and right main gear hinged struts were stiff in operation. The nuts on the hinged struts were loosened and then gear retraction and extension tests were carried out. Even with the loosened hinges the electro-hydraulic generator appeared to be 'weak' and only barely able to extend and retract the gear. The electro-hydraulic generator was stripped and inspected but no obvious fault was found that would have reduced its effectiveness. The generator was cleaned and fitted with new O-ring seals prior to re-assembly. The left and right main gear hinged struts were removed, treated for corrosion, lubricated and then re-fitted. Following this work the gear retracted and extended satisfactorily. The emergency gear extension system was also tested and operated satisfactorily.

The maintenance engineer who examined the aircraft believed that the stiffness in the hinged struts was the primary reason why the landing gear did not lock down. Once the hinges were lubricated and the corrosion treated, the landing gear could be extended and retracted normally. According to maintenance records the hinges had been lubricated during the 50 hour check less than three months before the accident, but the aircraft was parked outside during this period so rain and lack of frequent use could have contributed to a deterioration of the state of the hinges.
