ACCIDENT

Aircraft Type and Registration:	Rans S6-ES Coyote II, G-CCNB	
No & Type of Engines:	1 Rotax 582-48 piston engine	
Year of Manufacture:	2004	
Date & Time (UTC):	28 March 2005 at 1530 hrs	
Location:	Weston Park near Shifnal, Shropshire	
Type of Flight:	Private	
Persons on Board:	Crew - 1	Passengers - 1
Injuries:	Crew - 1 (Minor)	Passengers - 1 (Minor)
	Public - 1 (Serious)	
Nature of Damage:	Substantial aircraft damage plus minor damage to two vehicles	
Commander's Licence:	Private Pilot's Licence	
Commander's Age:	44 years	
Commander's Flying Experience:	109 hours (of which 9 were on type) Last 90 days - 3 hours Last 28 days - 2 hours	
Information Source:	AAIB Field Investigation

Synopsis

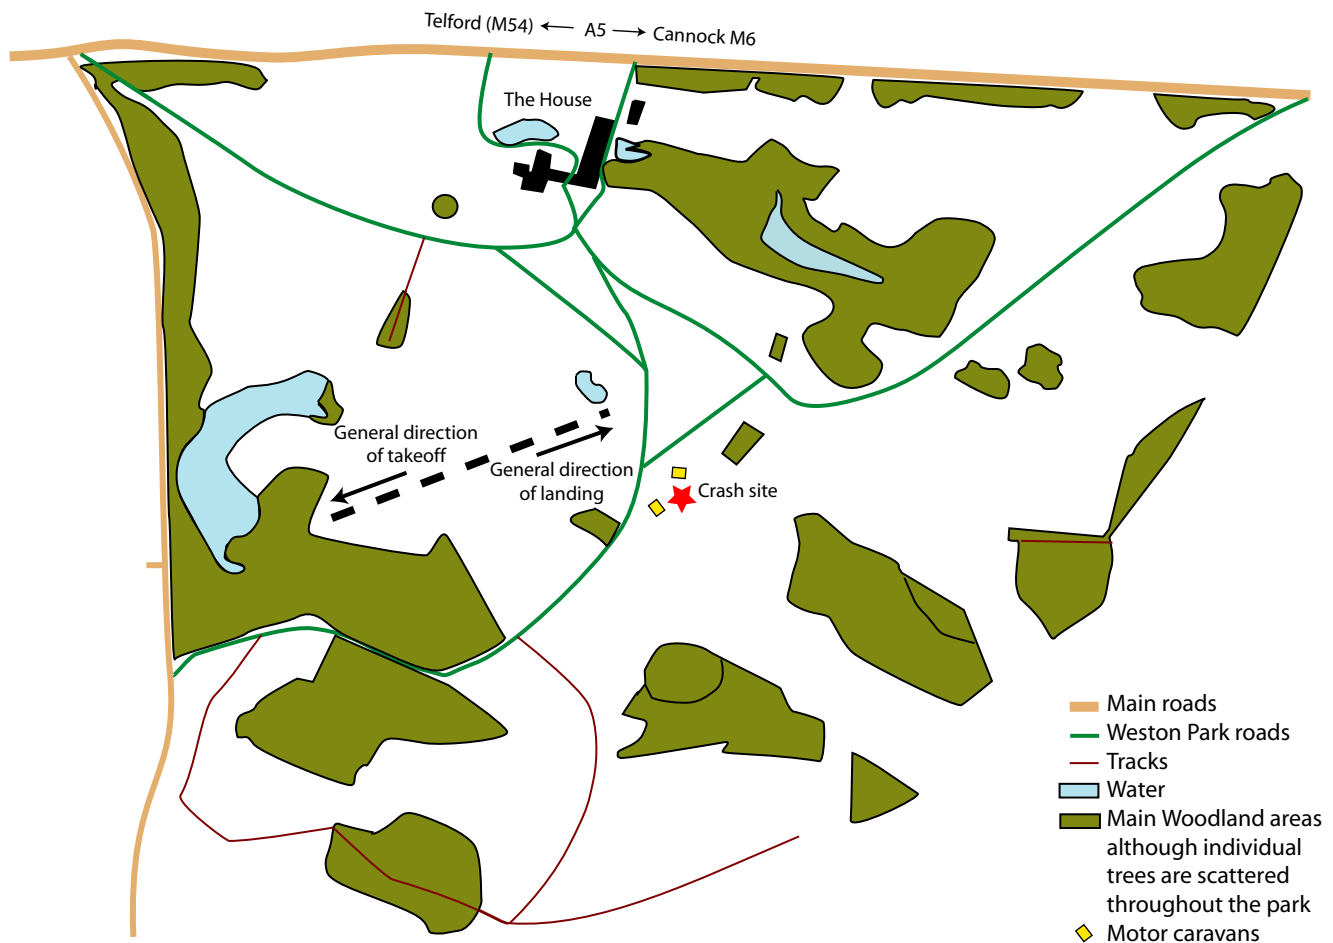
Figure 1
Weston Park

A 'Festival of Transport', attended by several thousand people, was taking place in the grounds of Weston Park, a country house. The Festival activity included Microlight flying and static displays of aircraft. A landing area, some 680 m by 100 m was in use (see Figure 1).

The landing area was a reasonably smooth grass area clear of trees and other obstructions, within the parkland of the Estate. The area had been used for occasional flying operations for many years. The landing area had a significant slope, with the south-western end some 39 ft lower than the north-eastern end. This slope dictated that landings were commonly conducted in a north-easterly direction, and takeoffs were in a reciprocal direction.

The significant slope of the landing area caused the visual horizon to appear above the local horizontal when viewed from the south-western end of the area. This aspect would, for a period, present a false or illusory horizon to a pilot going around from low height in the north-easterly direction because the visible horizon would be above the true horizon. Mature tall trees just beyond the end of the landing area, some 177 ft higher than the lower end of the landing area, could add to the illusion.
