No: 10/90

Ref: EW/G90/04/10

Stolp Starduster Too SA300, G-BOBT

Date and Time (UTC): 16 April 1990 at 0920 hrs

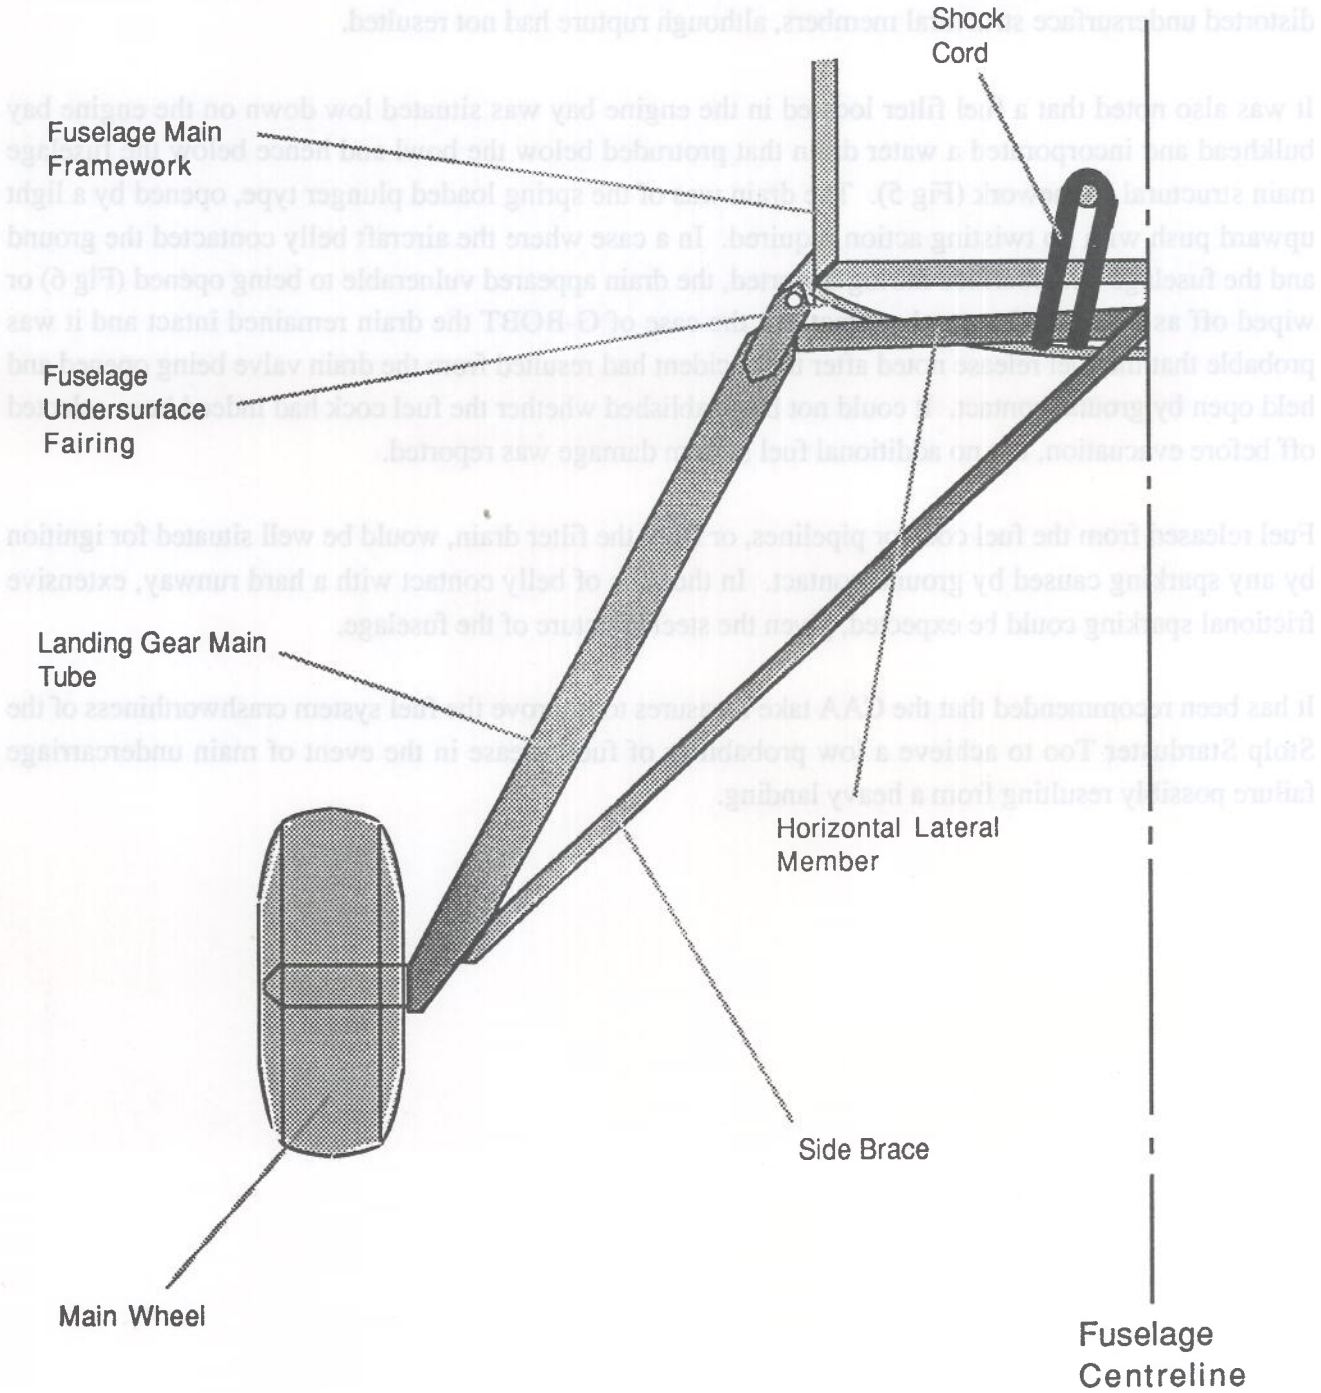
Inspection of the aircraft by a maintenance organisation appointed to repair it revealed that for both main landing gears a fracture had occurred at the welds joining the horizontal lateral tube to the main tube. The horizontal lateral tube had also separated from the side brace. In addition, each of the horizontal lateral tubes had buckled upwards near its inboard end. Close examination revealed that, in the case of both landing gear assemblies, there was little penetration of the weld material into the failed welded joint and that the welds tended to form an external load path bridging the gap (Fig 2). The failure was generally in the weld material itself. However, in spite of the lack of penetration, an inspection by the Materials Department of Royal Aerospace Establishment, Farnborough, revealed no evidence of fatigue. It was to be expected that had fatigue damage occurred, it would have been evident. It was concluded that the failures were probably caused by overload, consistent with excessive vertical velocity on touchdown. Whether the damage had occurred on the accident flight or in the course of a previous landing could not be established. No evidence was found of previous similar failures on this type of aircraft.

Failed Weld

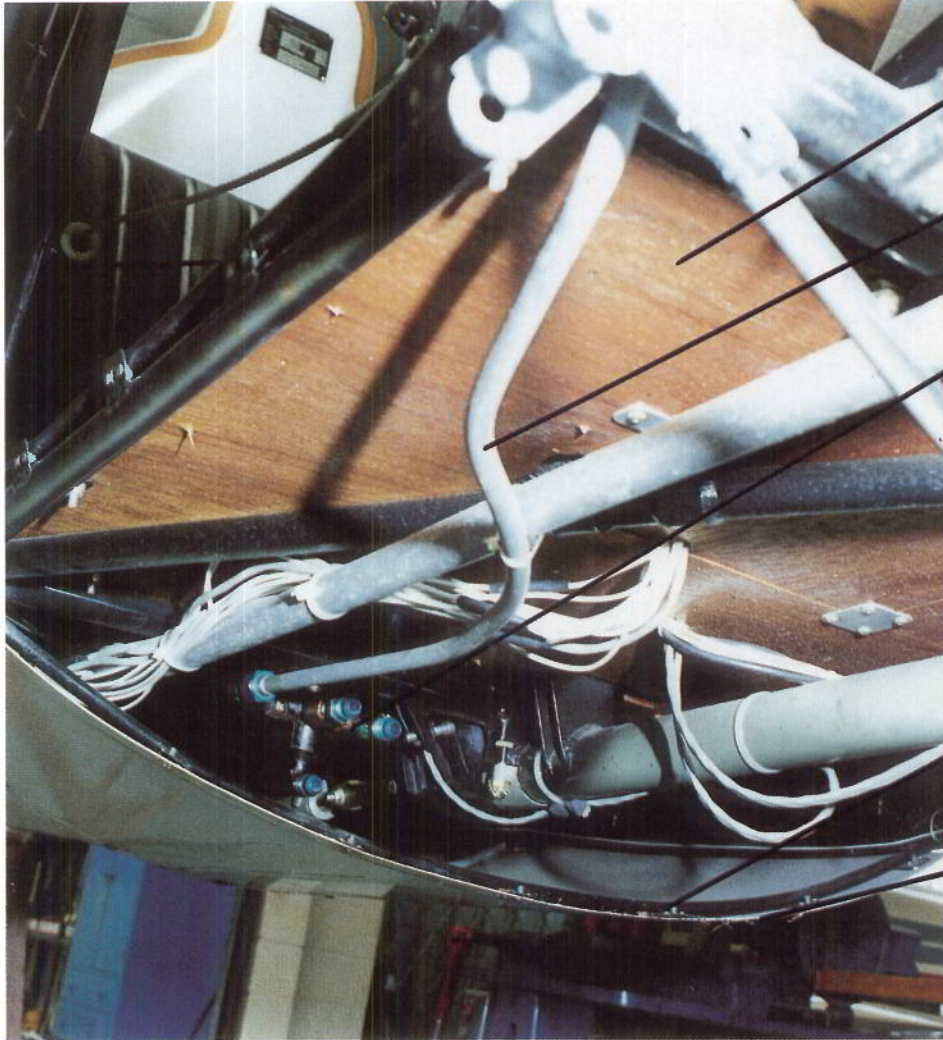
FIG 3

Examination of the aircraft, in a partially repaired condition, also revealed that parts of the fuel system were particularly vulnerable in a situation where main landing gear legs failed. Fuel was contained in tanks in the upper wing and in a triangular section fuel tank located in the forward part of the fuselage, immediately behind the engine bulkhead. Tank selections were made by a fuel cock situated low down in the rear cockpit in the shallow interspace between the bottom of the main structural framework and the undersurface formers (Fig 3). Four rigid aluminium pipelines connecting the tanks and the engine to the fuel cock also ran in the undersurface interspace, generally over a distance of around 3-4 feet and around 2-3 inches above the undersurface fairing. Thus both the fuel cock and the pipelines, immediately below the cockpits, appeared vulnerable to damage in a case where the aircraft belly contacted the ground. Three of these pipelines cannot be shut-off by operation of the fuel cock. In this

It has been recommended that the CAA take measures to improve the fuel system crashworthiness of the Stolp Starduster Too to achieve a low probability of fuel release in the event of main undercarriage failure possibly resulting from a heavy landing.

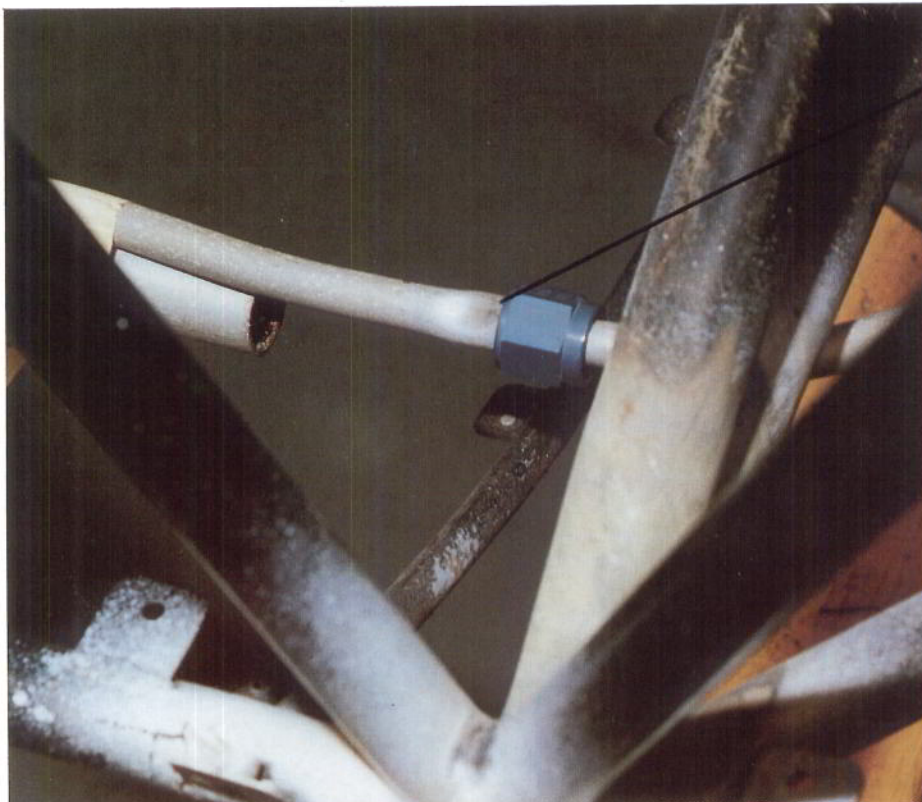
FIG 4

accident, at least one pipeline had sustained significant distortion (Fig 4), as a result of contact with distorted undersurface structural members, although rupture had not resulted.

Damaged Pipeline

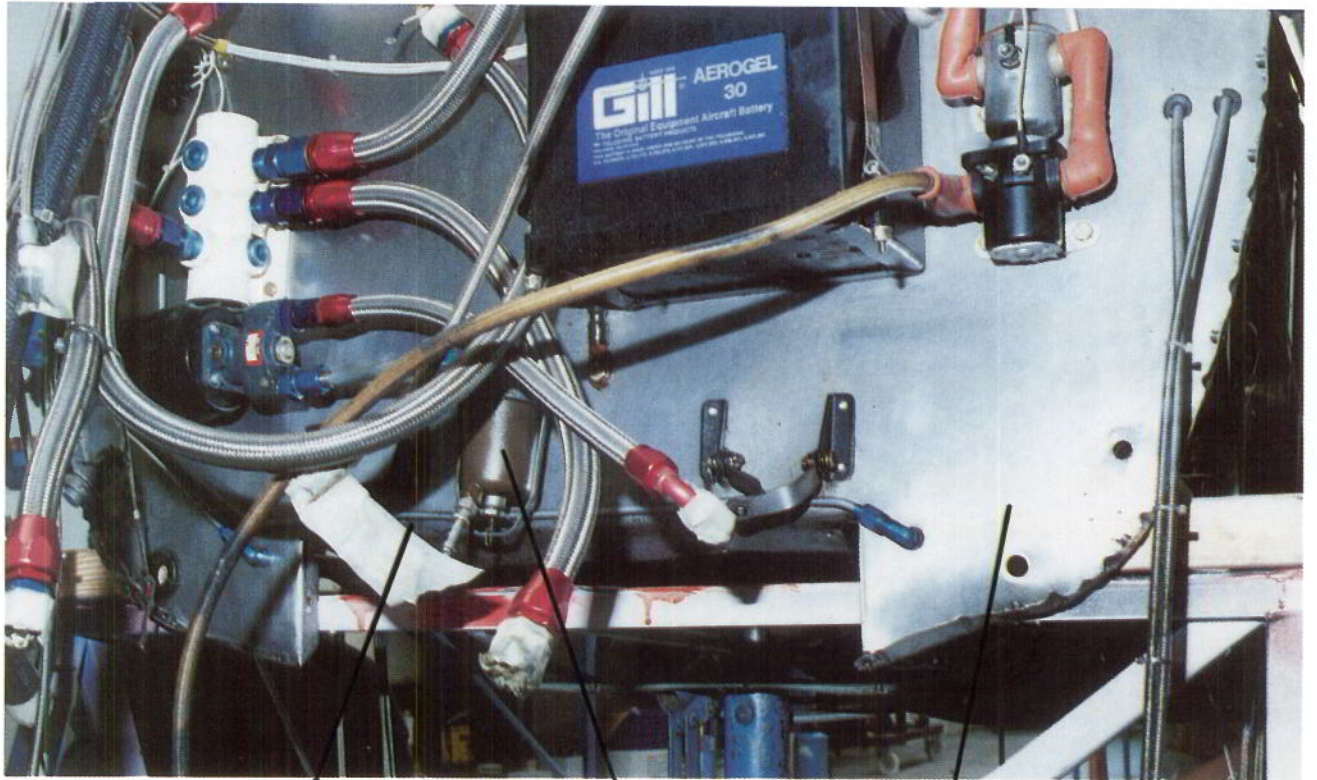
FIG 5

It was also noted that a fuel filter located in the engine bay was situated low down on the engine bay bulkhead and incorporated a water drain that protruded below the bowl and hence below the fuselage main structural framework (Fig 5). The drain was of the spring loaded plunger type, opened by a light upward push with no twisting action required. In a case where the aircraft belly contacted the ground and the fuselage undersurface fairing distorted, the drain appeared vulnerable to being opened (Fig 6) or wiped off as a result of ground contact. In the case of G-BOBT the drain remained intact and it was probable that the fuel release noted after the accident had resulted from the drain valve being opened and held open by ground contact. It could not be established whether the fuel cock had indeed been selected off before evacuation, but no additional fuel system damage was reported.

Fuel released from the fuel cock or pipelines, or from the filter drain, would be well situated for ignition by any sparking caused by ground contact. In the case of belly contact with a hard runway, extensive frictional sparking could be expected, given the steel structure of the fuselage.
