| <b>Aircraft Type and Registration:</b> | Yak-50, G-OJDR | |
| <b>Date &amp; Time (UTC):</b> | 30 October 2004 at 1438 hrs | |
| <b>Location:</b> | Wellesbourne Mountford Airfield, Warwickshire | |

## Synopsis

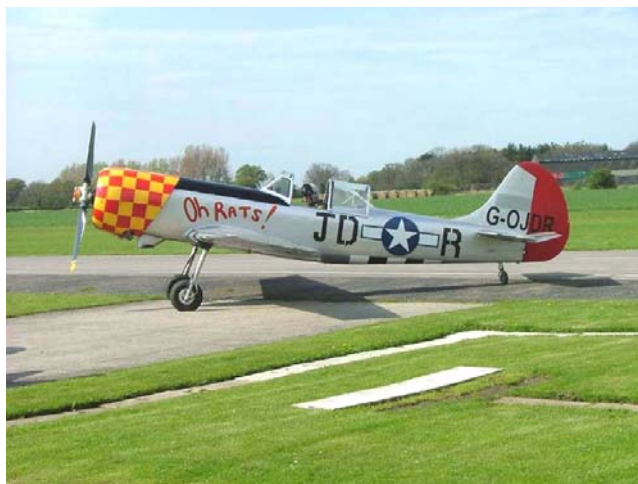
| <b>Nature of Damage:</b> | Damage to aircraft underside and propeller, oil cooler torn off and engine shockloaded | |

**Figure 1** Accident aircraft

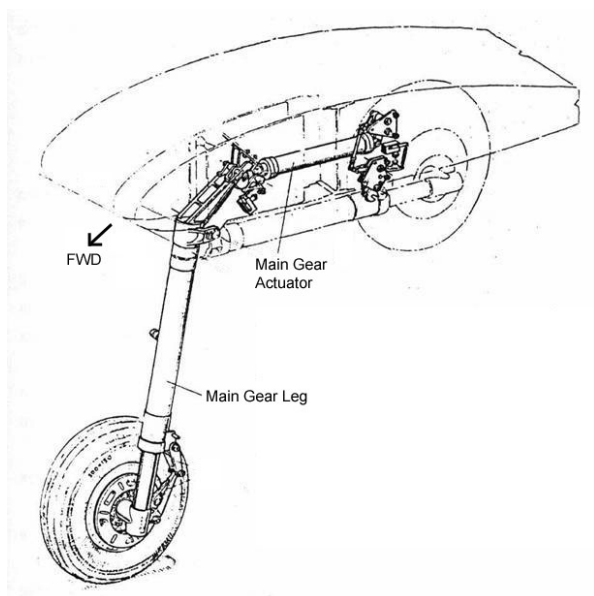
The aircraft has retractable main landing gear and a non-retractable tailwheel. The main landing gear legs are unconventional in that they retract aft into the wing rather than sideways. Half of each wheel retracts into the wing leaving the other half and the landing gear leg exposed to the airstream (see Figure 2). The design makes wheels-up landings (on hard surface runways) practicable while minimising damage to the aircraft's underside. The left and right main gear actuators are pneumatically powered. When the gear is selected DOWN pneumatic pressure causes each actuator arm to pull on the top of the respective main gear leg, rotating the leg forwards into the air stream. The leg needs to rotate approximately 10 degrees forward of the vertical before it will lock down. Two spring loaded hooks on the main gear leg engage a fixed stop within the wing as the leg is forced forwards against it until the hooks lock the gear in place. The hooks also press against a microswitch which triggers the 'green' down and locked light in the cockpit. If not properly rigged it is possible for the 'green' down and locked light to illuminate before the gear has fully locked into position.

It appeared to the pilot that one of the main gear legs was locking down each time he attempted to extend the gear, and yet both main gear legs collapsed on landing. It is probable that neither main gear leg was locked down prior to the landing. The design of the down lock microswitch and locking mechanism makes it possible to obtain a 'green' down and locked indication when the downlock hook is not fully engaged.

**Figure 2** Yak-50 main landing gear

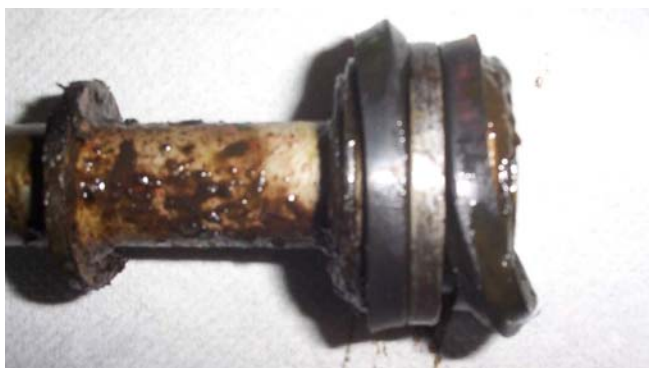
The two O-ring seals on the piston of the right main landing gear actuator are shown in Figure 3. The seal on the left (used for extension) had a rolled lip and the seal on the right (used for retraction) had a side that was severely rolled. The condition of both seals would have resulted in air leakage during both retraction and extension.

Both main gear actuators had been installed on 13 January 2004 following an overhaul which involved replacing the seals. According to the maintenance organisation the grooves in the actuator piston make it easy to install the seals correctly. However, it is possible that inadequate or improper lubrication could have contributed to the rolled state of the seal.

Both main gears collapsed on landing because they were not locked down. The gear did not lock down because there was insufficient pneumatic pressure to extend fully the main gear actuators in flight. The loss of pneumatic pressure was attributed to a leak in the right main gear actuator which was caused by a rolled O-ring seal on the actuator piston.

**Figure 3** Rolled O-ring seals found on right main gear actuator piston
