ACCIDENT

Aircraft Type and Registration:	Jabiru UL-430, G-BYIM	
No & Type of Engines:	1 Jabiru 2200A piston engine	
Year of Manufacture:	1999 (Serial no: PFA 274A-13397)	
Date & Time (UTC):	12 August 2012 at 1915 hrs	
Location:	Ince Airfield, Liverpool	
Type of Flight:	Private	
Persons on Board:	Crew - 1	Passengers - None
Injuries:	Crew - None	Passengers - N/A
Nature of Damage:	Collapsed main undercarriage ¹ and nose leg, damaged propeller and right wing	
Commander's Licence:	National Private Pilot's Licence	
Commander's Age:	49 years	
Commander's Flying Experience:	377 hours (of which 300 were on type) Last 90 days - 26 hours Last 28 days - 8 hours	
Information Source:	Aircraft Accident Report Form submitted by the pilot and AAIB enquiries

Synopsis

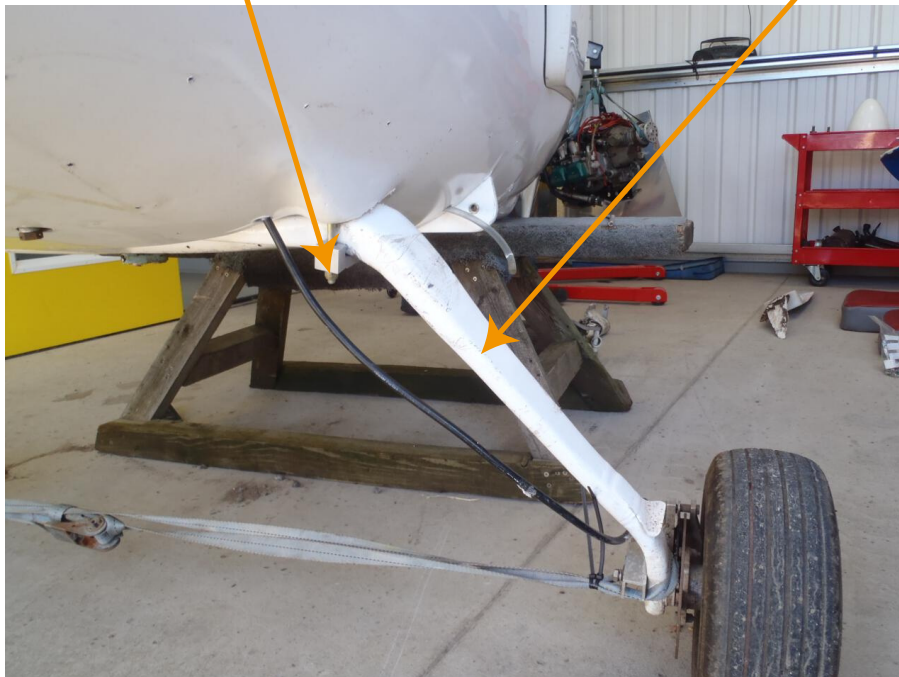
Figure 1

which is bolted to the engine bulkhead. The main undercarriage consists of separate left and right cantilever spring legs, each of which is secured by one inboard and two outboard 5/16" (AN5) attachment bolts (Figure 1).

The right cantilever spring leg collapsed as a result of the nut having come off the forward outboard attachment bolt. The rear attachment bolt, which had bent during the accident sequence, was still intact with its nut in place. The inside of the attachment clamp was highly polished, which the UK Jabiru agent advised was unusual. The six undercarriage attachment bolts were all 5/16" bolts.

Outboard attachment bolts
passing through the attachment bracket

Cantilever
spring leg

Undercarriage attachment

The polished surface on the attachment bracket indicated that there had been some relative movement between the spring leg and the bracket. This could be a result of the nut on the attachment bolt becoming loose, or as a consequence of the nut bottoming out such that the clamping force between the spring leg and bracket was insufficient. All of these issues had previously been identified by the LAA who had brought it to the

- Introduce a mandatory life of 500 hours for the undercarriage attachment bolts fitted to all models of Jabiru aircraft.
- Ensure that any 5/16" (AN5) bolts still fitted to the undercarriage on Jabiru aircraft are replaced with 3/8" (AN6) bolts.

- Remind owners and inspectors of the need to check regularly the torque of the undercarriage attachment bolts.
- Remind owners and inspectors of the need to reweigh aircraft after they have been painted.
