**ACCIDENT**

<b>Aircraft Type and Registration:</b>	Scheibe SF25B motorglider, G-BLZA	
<b>No &amp; Type of Engines:</b>	1 Sauer 1800 ESI piston engine	
<b>Year of Manufacture:</b>	1970	
<b>Date &amp; Time (UTC):</b>	4 March 2006 at 1000 hrs	
<b>Location:</b>	2.5 miles WNW of RAF Halton, Buckinghamshire	
<b>Type of Flight:</b>	Private	
<b>Persons on Board:</b>	Crew - 1	Passengers - None
<b>Injuries:</b>	Crew - None	Passengers - N/A
<b>Nature of Damage:</b>	Loss of propeller	
<b>Commander's Licence:</b>	Private Pilot's Licence	
<b>Commander's Age:</b>	70 years	
<b>Commander's Flying Experience:</b>	1,927 hours (of which 219 were on type) Last 90 days - 6 hours Last 28 days - 4 hours	
<b>Information Source:</b>	Aircraft Accident Report Form submitted by the pilot and examination of propeller and engine by the AAIB

**Synopsis**

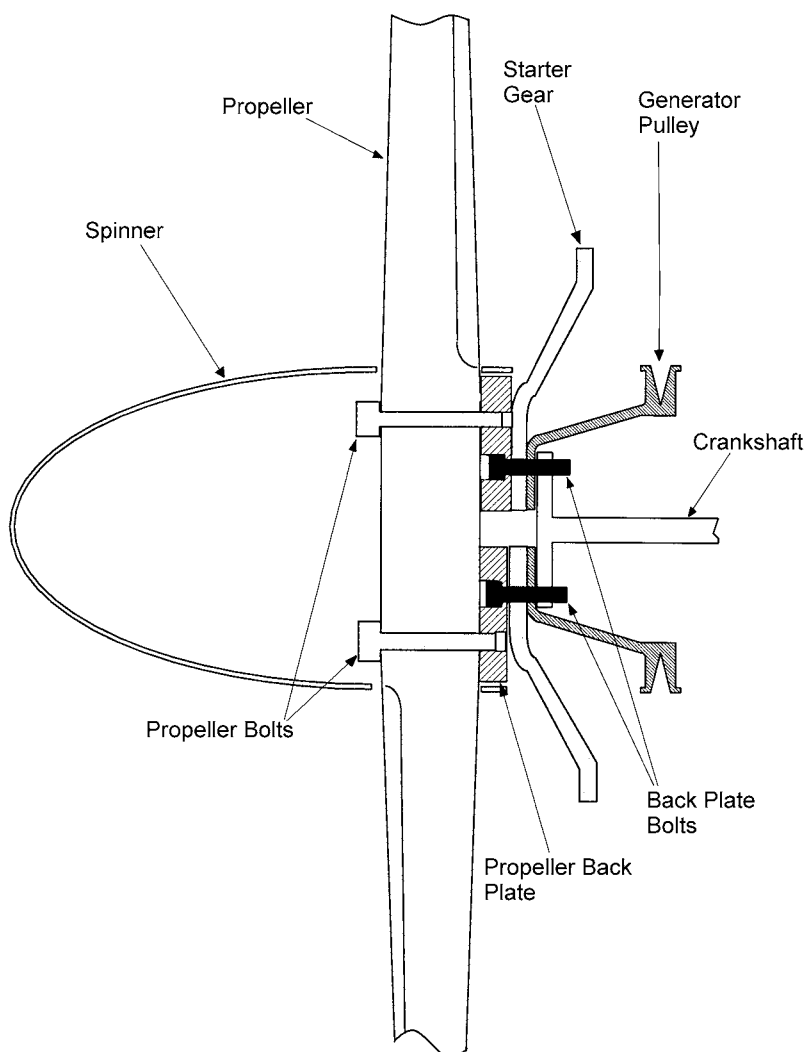
**Figure 1**

Diagram of 'Mt' propeller attachment to Sauer 1800 ESI engine, G-BLZA

This event was the first propeller loss for this engine type. Initial inspection revealed that the bolts holding the back-plate, starter ring gear and generator pulley to the crankshaft had failed. The propeller, together with spinner and back-plate, was located several days after the event and these, and the remains of the bolts held in the crankshaft, were examined in detail. The propeller was found to be securely attached to the back-plate, with all bolts correctly torque tightened and wirelocked; the remains of the bolts which held the back-plate to the crankshaft were also found wirelocked.

All six of the failed bolts were 8 mm in diameter, with the corresponding holes in the back-plate being 8.1 mm in diameter. Four of the bolt heads were marked 's 8.8' and were unthreaded along the first 1.8 mm of the shank. The remaining two were marked 'e D 8.8' and were unthreaded for the first 6.5 mm of the shank. Two adjacent bolts marked 's 8.8', had failed approximately 5 mm along the shank from the head, with the remaining four failing at approximately 17 mm. The fracture surfaces of each bolt showed clear signs of high cycle fatigue across approximately 95% of their surface areas.

The remains of the bolt shanks retained by the crankshaft flange were also examined and found to be between 17 mm and 18.5 mm long. Four of the shanks had failed in fatigue, and matched the four longer bolt heads from the propeller; measurement gave a complete bolt length of approximately 36 mm. The remaining two shanks showed signs of overload failures, which did not match the failure surface of the two shorter bolt heads. Further measurements indicated that approximately 13 mm was missing from each bolt shank. Given that these two bolts had initially failed by fatigue closer to the bolt head than the remaining four bolts, the portion of their shanks retained by the crankshaft would have projected approximately 13 mm further forward than the other four shanks. Distortion of two bolt holes on the starter ring gear indicated that after separation of the propeller, the ring gear had been held in place for a short while by these two longer shanks, until the rotational forces on the gear caused overload failures. The bores of the bolt holes in the back-plate, used to secure the plate to the crankshaft, showed evidence of damage caused by bolt threads.

crankshaft. It was also apparent that the drive to the propeller was being transmitted across the threaded portion of the bolts where their cross sectional area is at its minimum. The damage also indicated that the torque loading of the bolts was insufficient to prevent movement of the back-plate. This may have been the result of either insufficient installation torque or a 'backing off' of the bolts in operation, possibly due to the differential contraction of the back plate, starter gear and generator pulley in the low temperatures experienced on the previous days flight, or both. The possibility of minor torque fluctuations, as a result of operating with spark plugs of the incorrect reach, may also have been a contributory factor to the failure of the bolts.

- Replacement of the current bolts with items that are unthreaded for the first 10 mm, thus preventing contact between the back-plate hole bores and the bolt threads
- Changing the specification of the bolts from 'M 8.8' to 'M 10.9'; this gives a 25% increase in their minimum tensile strength to 150,000 psi
- Increasing the installation torque of the back-plate bolts to 25 Nm
