## ACCIDENT

<b>Aircraft Type and Registration:</b>	Zenair CH 250, G-BIRZ	
<b>No &amp; type of Engines:</b>	1 Lycoming O-290-G conversion piston engine	
<b>Year of Manufacture:</b>	1982	
<b>Date &amp; Time (UTC):</b>	9 September 2006 at 1340 hrs	
<b>Location:</b>	Glenforsa Airstrip, Isle of Mull, Argyll and Bute, Scotland	
<b>Type of Flight:</b>	Private	
<b>Persons on Board:</b>	Crew - 1	Passengers - 1
<b>Injuries:</b>	Crew - None	Passengers - None
<b>Nature of Damage:</b>	Severe damage to airframe, engine propeller, port wing and landing gear	
<b>Commander's Licence:</b>	National Private Pilot's Licence	
<b>Commander's Age:</b>	74 years	
<b>Commander's Flying Experience:</b>	810 hours (of which 169 were on type) Last 90 days - 7 hours Last 28 days - 4 hours	
<b>Information Source:</b>	Aircraft Accident Report Form submitted by the pilot and further enquiries by the AAIB

## Synopsis

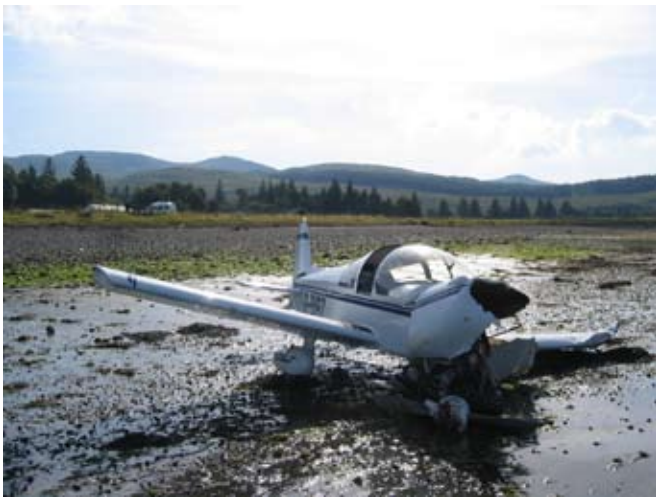
**Figure 1**

G-BIRZ on the beach

In addition to damage attributed to the aircraft striking the fence and crashing onto the foreshore, there was severe damage to the left wing tip.

The damage to the aircraft was beyond economic repair.
