ACCIDENT

Aircraft Type and Registration:	Shorts SC.7 Skyvan, G-BEOL	
No & Type of Engines:	2 Honeywell TPE331-2-201A turboprop engines	
Year of Manufacture:	1977	
Date & Time (UTC):	27 July 2008 at 1555 hrs	
Location:	Runway 21, Oxford Airport, Kidlington	
Type of Flight:	Private	
Persons on Board:	Crew - 1	Passengers - None
Injuries:	Crew - None	Passengers - N/A
Nature of Damage:	Right main landing gear collapsed. Damage to right wing strut, lower fuselage and nosewheel strut attachment structure	
Commander's Licence:	Commercial Pilot's Licence	
Commander's Age:	44 years	
Commander's Flying Experience:	3,384 hours (of which 2,239 were on type) Last 90 days - 137 hours Last 28 days - 53 hours	
Information Source:	Aircraft Accident Report Form submitted by the pilot

Synopsis

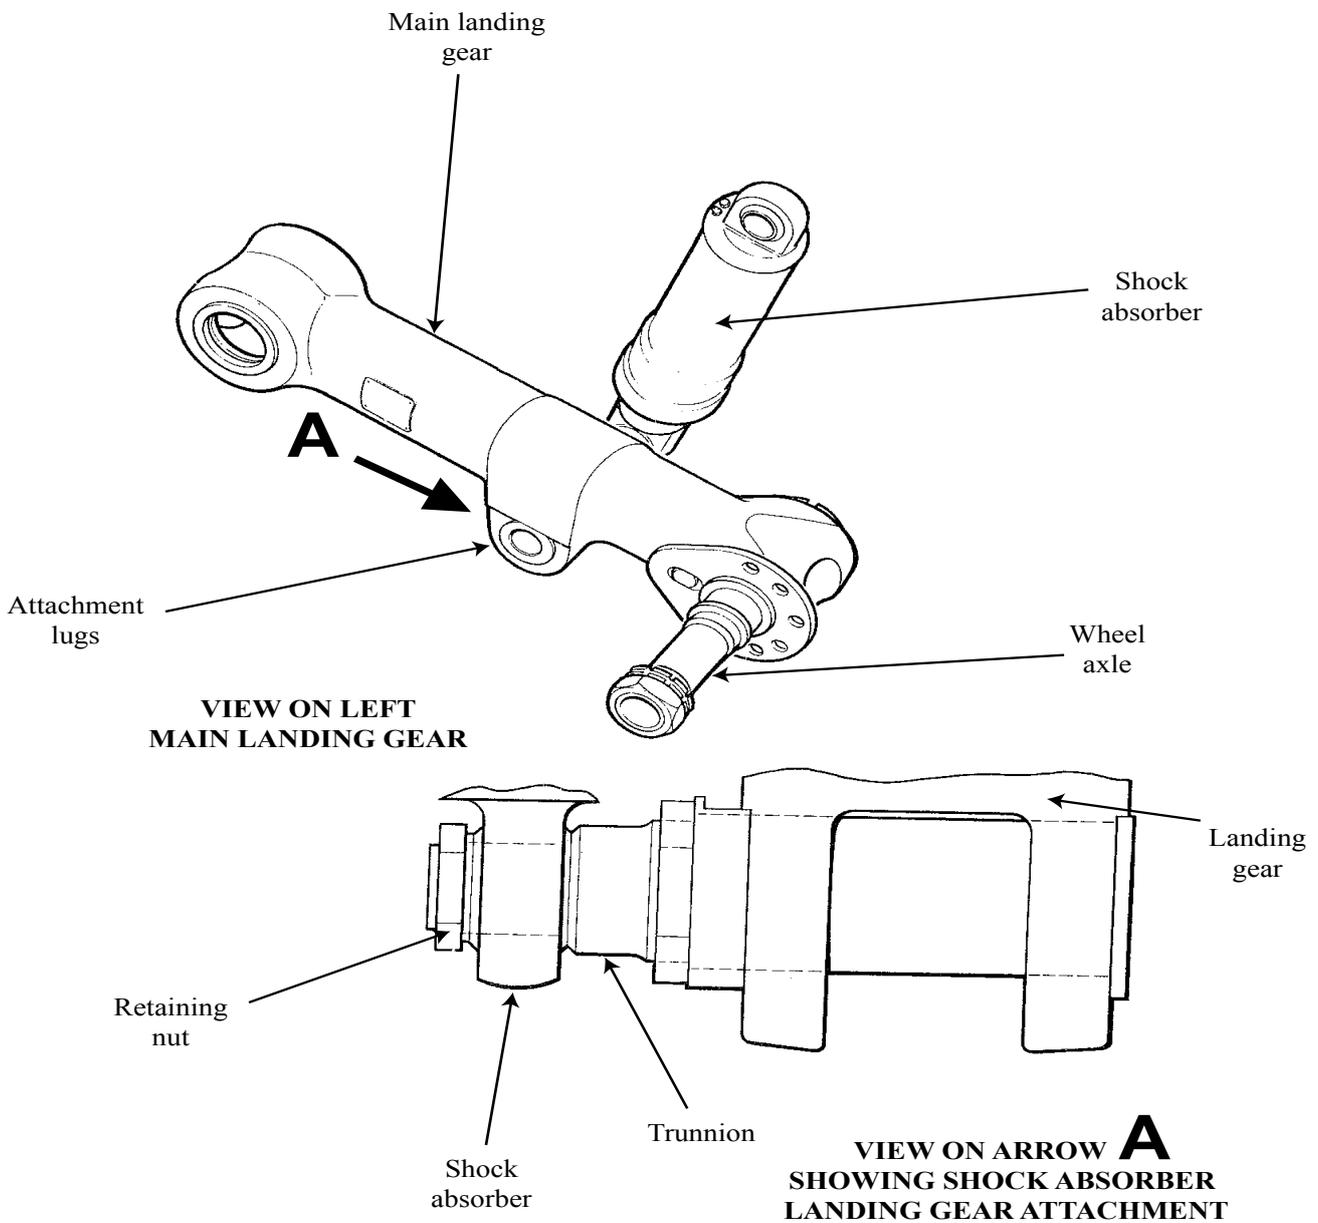
Figure 1
Landing gear shock absorber attachment

Examination of the right landing gear showed that the shock absorber had become disconnected from the lower trunnion on the landing gear and that the retaining nut was missing.

Examination of the screw threads at the end of the trunnion on which the retaining nut (Figure 1) is fitted showed no evidence of deformation or stripping. There was a large area of impact damage on one side of the threaded part of the trunnion, consistent with what would have occurred during the final landing, but the threads on the undamaged side were in very good condition. There was no locking wire present. The retaining nut was found at the initial impact

point, by the right landing gear, on the grass runway. Examination showed no deformation, damage or stripping of the screw threads and there was no locking wire present. The holes in the retaining nut, through which the locking wire should have passed, were clogged with hardened grease and general debris associated with landing gear areas, and this appeared to have accumulated over a long period of time.

The aircraft's logbooks and worksheets were examined in detail and the last recorded time that the main landing gear shock absorbers were recorded as being disturbed was in March 2000, when Dowty Rotol Mandatory Service Bulletin 32-14M was carried out. This Service Bulletin required the removal of the main landing gear shock absorbers to check for cracking of the lower shock absorber attachment trunnion. The aircraft had flown 2,414 hours over 4,985 flights since the Service Bulletin had been carried out. It appears likely that the recorded maintenance work, or subsequent undocumented maintenance work, did not include completion of the wirelocking task.

The manufacturer's Aircraft Maintenance Manual and the shock absorber's Overhaul Manual require that, following fitting of the lower shock absorber, the retaining nut should be torqued and wirelocked.
