ACCIDENT

Aircraft Type and Registration:	Beech 76 Duchess, G-TWNN	
No & Type of Engines:	2 Lycoming O-360-A1G6D piston engines	
Year of Manufacture:	1980	
Date & Time (UTC):	2 April 2009 at 1001 hrs	
Location:	Runway 08, Bournemouth Airport	
Type of Flight:	Training	
Persons on Board:	Crew - 2	Passengers - 1
Injuries:	Crew - None	Passengers - None
Nature of Damage:	Wing tip, flap, flap support, foot step	
Commander's Licence:	Commercial Pilot's Licence	
Commander's Age:	34 years	
Commander's Flying Experience:	2,654 hours (of which 1,035 were on type) Last 90 days - 68 hours Last 28 days - 42 hours	
Information Source:	Aircraft Accident Report Form submitted by the pilot

Synopsis

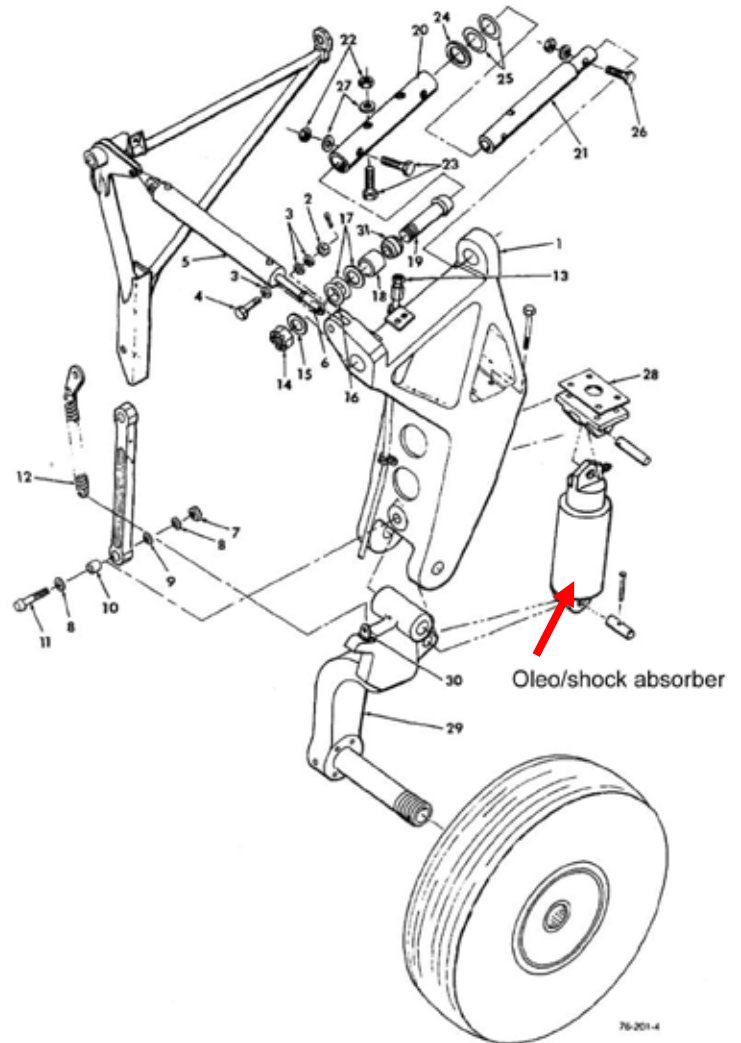
The landing gear on this type of aircraft is operated by a hydraulic system powered by an electric motor. Figure 1 is an illustration of the trailing link main landing gear where vertical movement of the wheel is controlled by an oleo strut/shock absorber. Disassembly of this strut revealed internal corrosion that had inhibited movement of its internal piston. This had had the effect of preventing the strut from fully extending, such that following the previous takeoff, it was probably no more than around three quarters of its maximum length. This in turn would have caused the wheel to trail aft of its normal weight-off-wheels position and it was found that, in this position, the wheel fouled the edge of the wheel-well. Although this had not prevented gear retraction, it had ‘hung up’ during the subsequent attempts at gear extension.

Beech Duchess main landing gear

The oleo is maintained ‘on condition’, meaning it is not subjected to periodic internal inspections. Following this event, the maintenance organisation commented that they were unaware of any previous occurrences of this type of problem. The company has subsequently instigated a maintenance action at the 150 hour inspection, whereby the range of travel of the oleo struts is checked whilst the aircraft is jacked up.
