Aircraft type and registration: Rockwell Commander, G-BIUO and a Cirrus (Competition No 610) (a light single engined fixed wing aircraft and a sailplane)

Date and time (GMT): 12 May 1984 at 1435 hrs

Location: Longdon, Nr Tewkesbury, Gloucestershire

ACCIDENT BETWEEN ROCKWELL COMMANDER 112A, REGISTRATION G-BIUO AND
SCHEMPP-HIRTH CIRRUS GLIDER, BGA No 2138 ON MAY 12 1984.

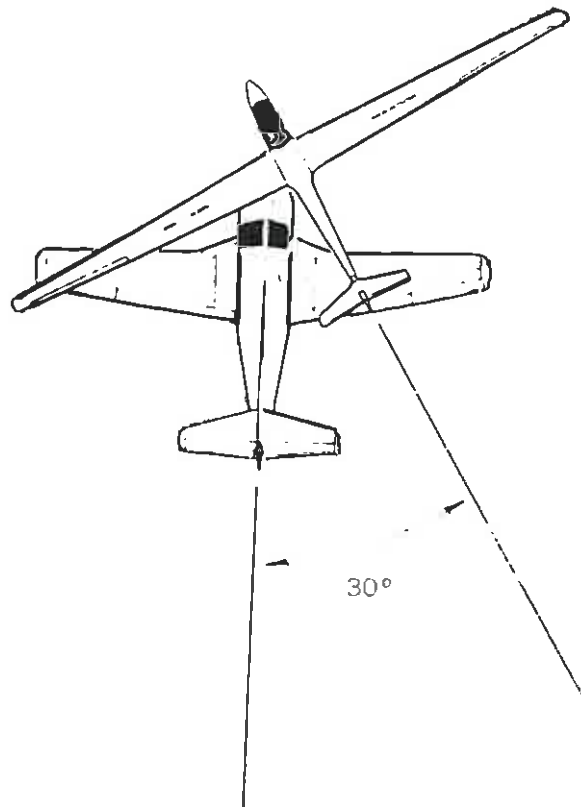
Subsequent examination of the wreckage showed that, as the Rockwell was flying straight and level, the Cirrus had descended on top of it from the right-hand side. Propeller cuts in the wing and fuselage of the Cirrus indicated that the two aircraft had converged at an angle of 29° with the Rockwell overtaking the Cirrus with a relative velocity of 65 kts.

PLAN VIEW OF THE AIRCRAFT AT THE COLLISION POINT

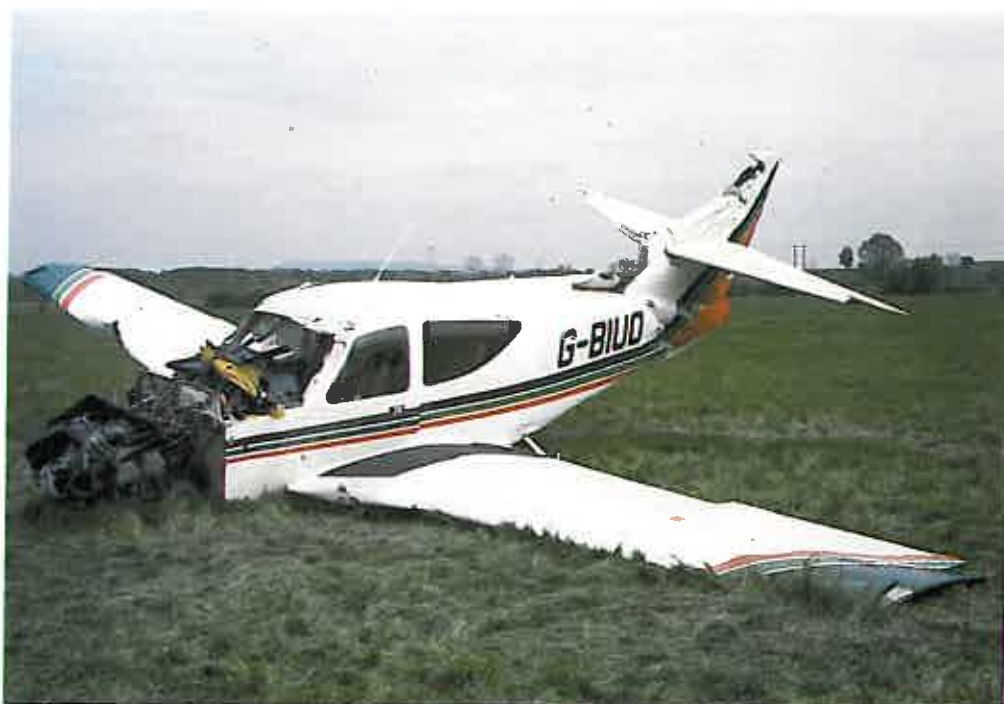
The two aircraft were seen to collide at 1435 hrs, following which the port wing of the glider detached and the remainder of it spiralled earthwards, breaking up and ejecting the pilot. The Rockwell lost the complete propeller assembly and the upper engine cowling in the impact. The windscreen was crushed inwards and the tail empennage, as well as being distorted, suffered fractures of the supporting spar attachments to the fuselage. The rear fuselage also received a compression distortion on the left side.

Despite the severity of the damage to the aircraft, the pilot of the Rockwell managed to regain control of it and execute a safe landing in a meadow. The aircraft undershot the intended shutdown point and consequently passed through a barbed wire and post fence, sustaining further, but comparatively minor damage. When the aircraft came to rest the engine was still running. The pilot closed the mixture control, switched off the magnetos and master switch, and left the aircraft via the passenger door on the right hand side. There was no fire, despite a considerable quantity of fuel spilling from the ruptured right hand tank.

THE ROCKWELL, FOLLOWING THE FORCED LANDING
