**AAIB Bulletin No: 11/95**      **Ref: EW/G95/09/03**      **Category: 1.2**

**Aircraft Type and Registration:** Beagle B206 Series I Bassett, G-BSET  
**No & Type of Engines:** 2 Rolls-Royce Continental GIO-470-A piston engines  
**Year of Manufacture:** 1965  
**Date & Time (UTC):** 2 September 1995 at 1620 hrs  
**Location:** Shoreham Airport, West Sussex  
**Type of Flight:** Private  
**Persons on Board:** Crew - 1      Passengers - None  
**Injuries:** Crew - None      Passengers - N/A  
**Nature of Damage:** Damage to right engine, propeller and wing  
**Commander's Licence:** Private Pilot's Licence with IMC and Night Ratings  
**Commander's Age:** 48 years  
**Commander's Flying Experience:** 2,937 hours (of which 88 were on type)  
Last 90 days - 12 hours  
Last 28 days - 4 hours  
**Information Source:** Aircraft Accident Report Form submitted by the pilot and telephone enquiries by the AAIB

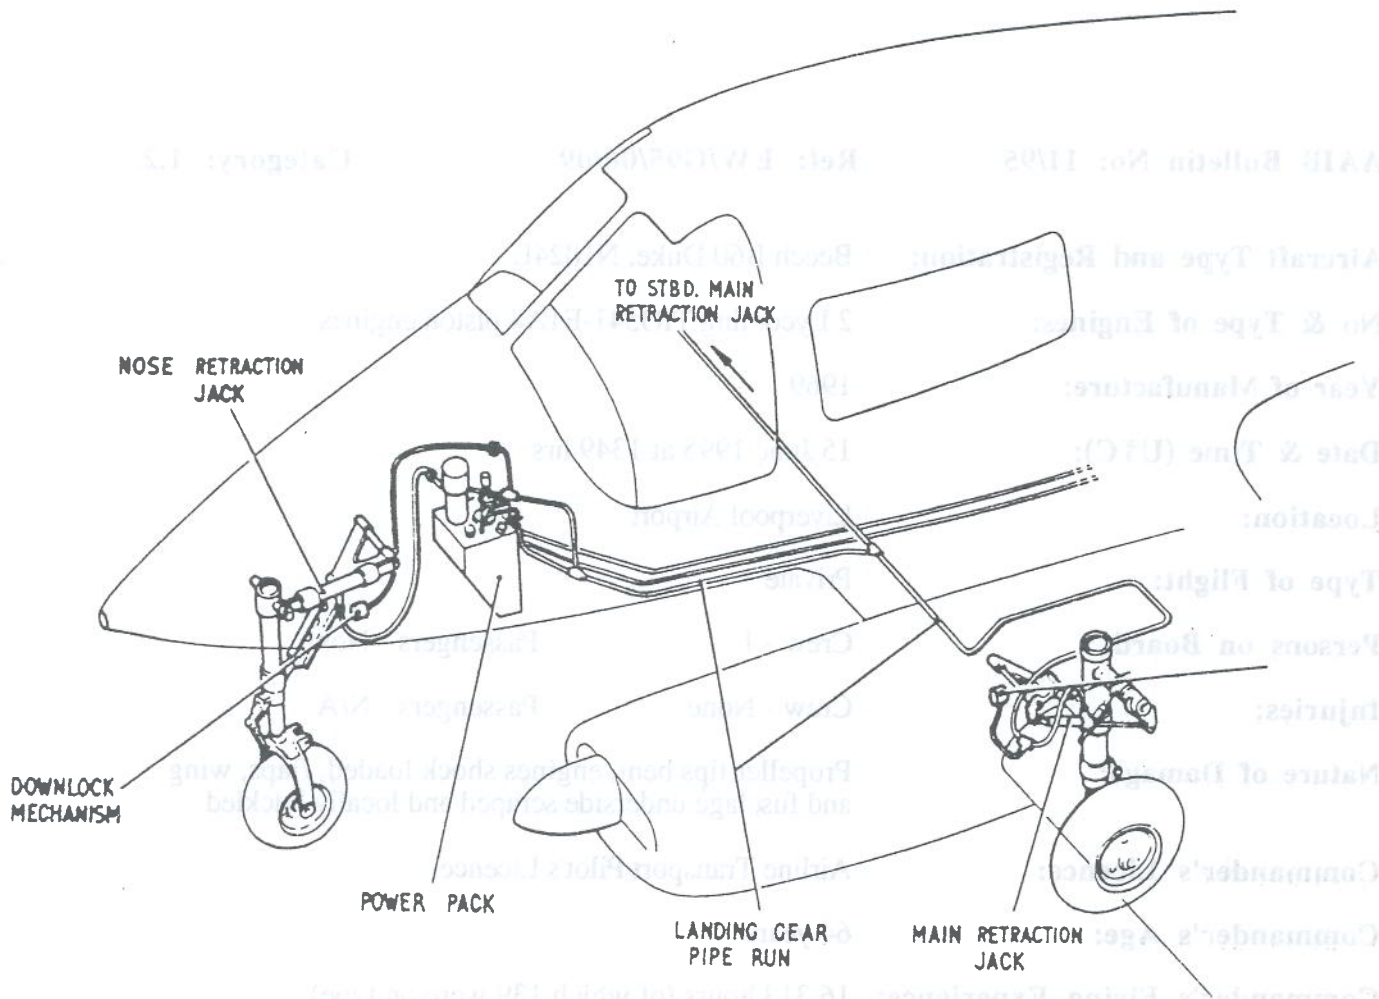
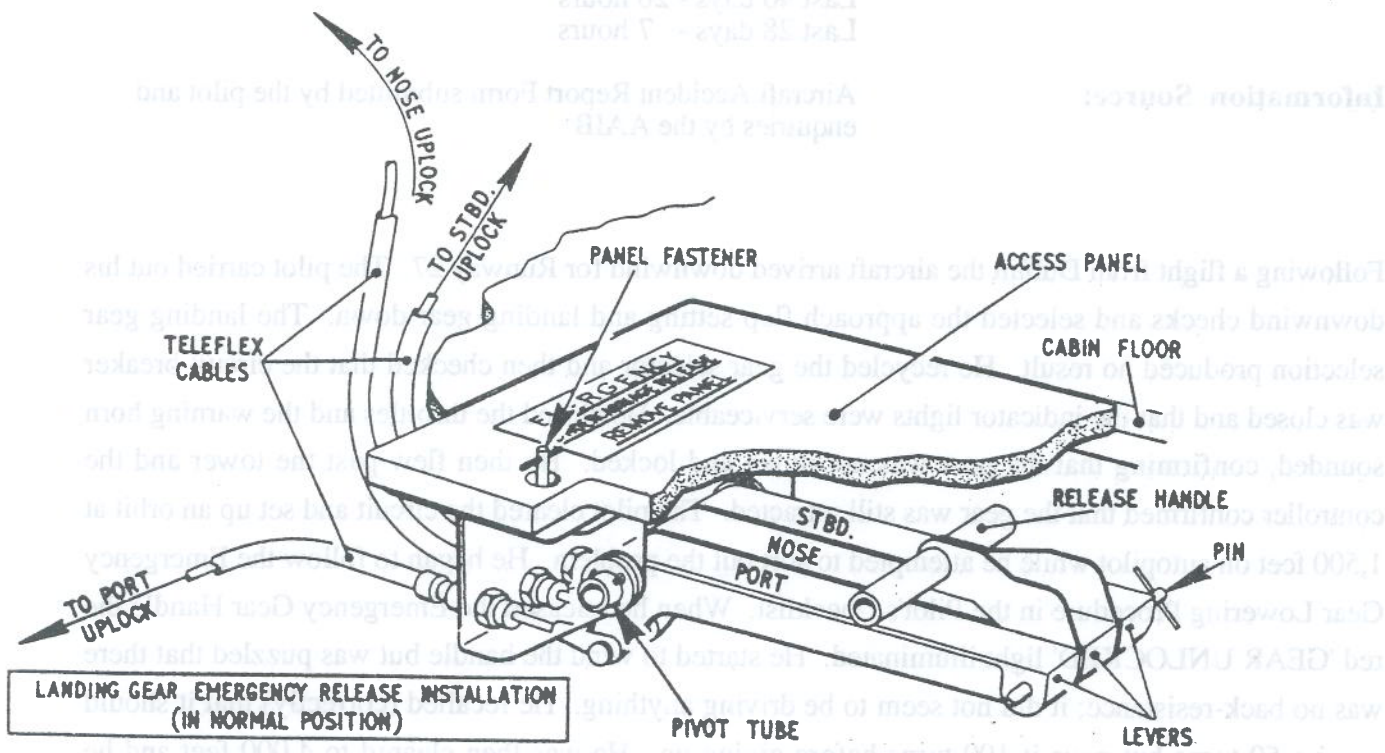
Fig.1 Landing gear and emergency release

power the retraction jacks. When fully retracted, the uplocks are engaged and the gear is fully enclosed by doors mechanically linked to the landing gear units. When DOWN is selected, the uplocks are electrically released and the landing gear extends into its down position under the combined forces of gravity and a spring-box. Hydraulic fluid is expelled and returned to the reservoir in the power pack. Should any, or all, of the gear uplocks fail to release electrically, then mechanical actuation may be accomplished by single, or combined, operation of a triple lever set into the cockpit floor (see Figure 1) which connects to each uplock, via teleflex cables.

Examination of the aircraft after the accident revealed that the right main landing gear leg was fully retracted. After recovery, with the aircraft on jacks, the pilot reported that the emergency uplock release was operated following which the right gear leg extended normally and locked into the down position. The pilot considered that in concentrating on the landing, he had failed to operate fully the uplock release for the right main gear and had probably perceived 'three green lights' when in fact only two lights had been illuminated.
