**Aircraft type and registration:** Gemini Flash G-MNEJ (Microlight aircraft)

**Date and time (GMT):** 22 October 1985 at about 1305 hrs

**Location:** Middleton Sand, near Morecambe, Lancashire

**Information Source:** AIB Field Investigation.

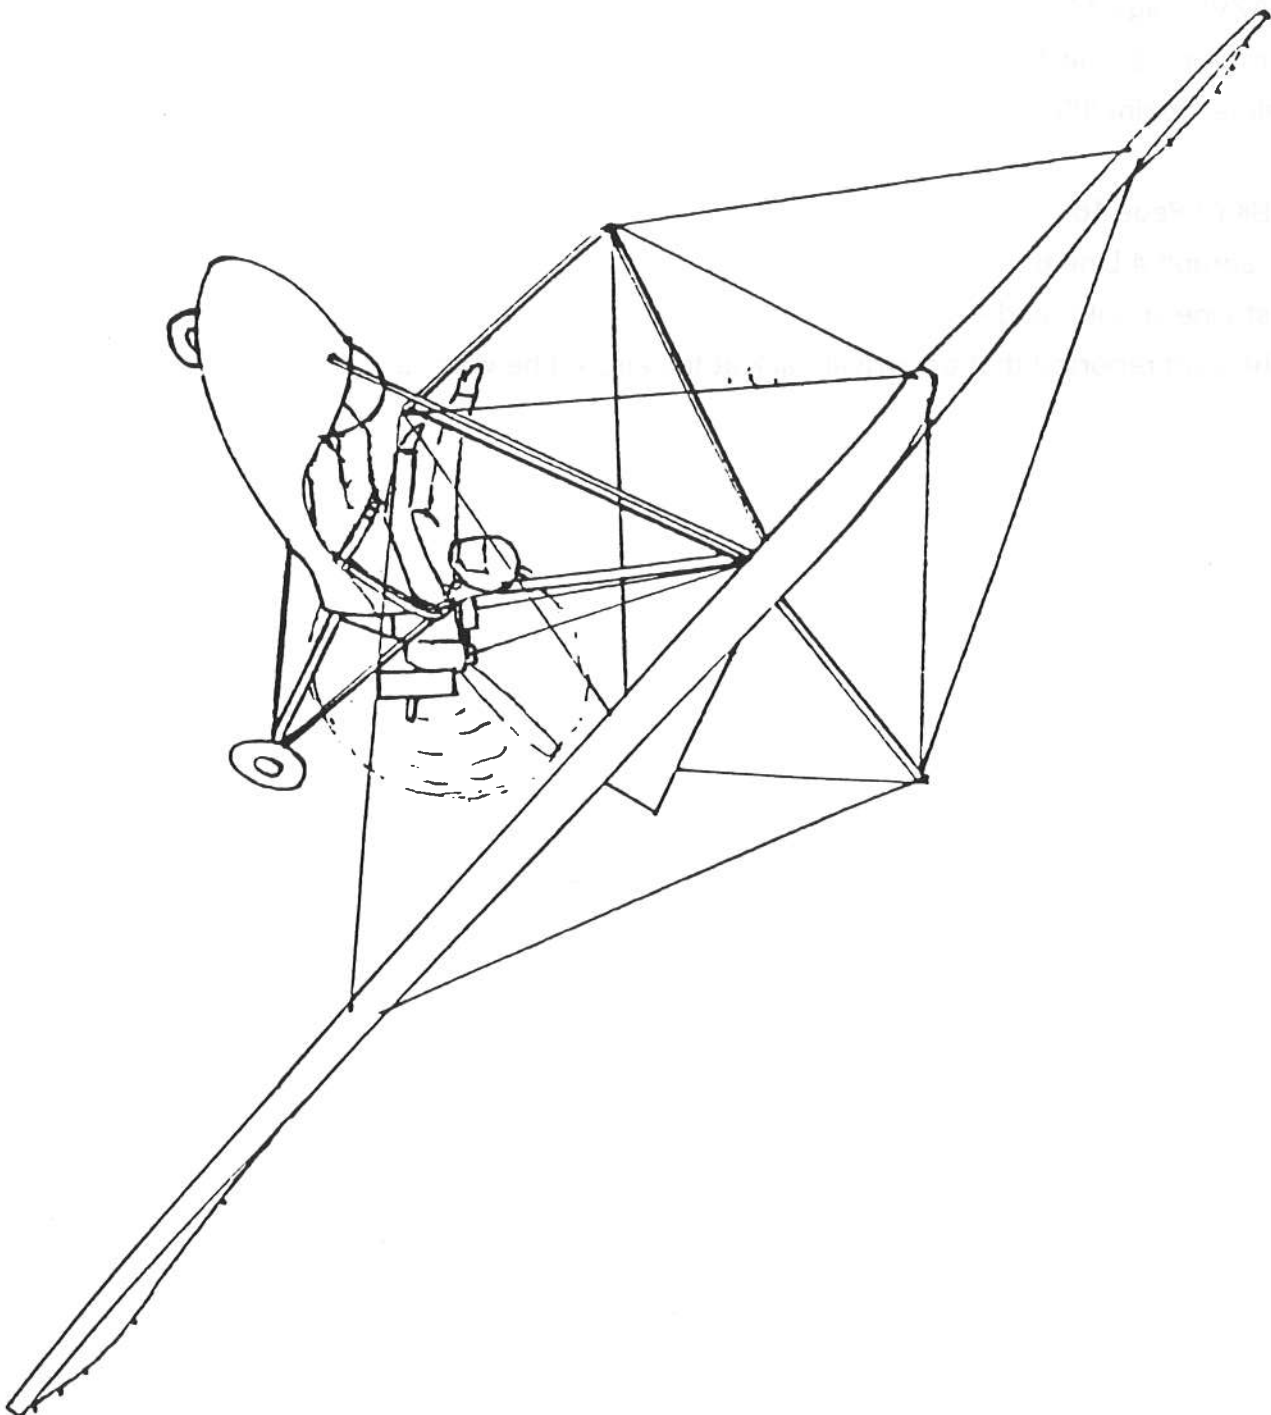
The wing from the accident aircraft was mounted on another identical trike and it was found that, with the control bar moved fully forward and to the right (wing pitched up and rolled to the left), the inboard of the two bolts in the control bar end fitting approached the front strut at the position of the impact marks and failure. Other damage was found which confirmed that the wing and trike had been in the relative positions described above, and illustrated in the sketch.

All the evidence was consistent with a sequence of damage and failure following an initial failure of the front strut, the failure being the result of impact by the left hand end of the control bar and continuing violent movement of the wing and trike relative to one another in the directions indicated.

In sum, therefore, the mechanical evidence is most consistent with a failure sequence starting with an asymmetric aerodynamic load on the wing which caused it to tilt violently left and to pitch up relative to the trike. When the control bar hit the front strut high loads would have been generated in accelerating the mass of the trike and pilot. The failure of the front strut, due to such an impact, was the beginning of the break-up sequence. The front strut is a primary structural member and the mast was not designed to sustain the high bending loads to which it was exposed when the front strut failed.
