ACCIDENT

Aircraft Type and Registration:	Piper PA-32RT-300 Cherokee Lance II, G-RHHT	
No & Type of Engines:	1 Lycoming IO-540-K1G5D piston engine	
Year of Manufacture:	1978	
Date & Time (UTC):	3 June 2011 at 1243 hrs	
Location:	Wycombe Air Park, Buckinghamshire	
Type of Flight:	Private	
Persons on Board:	Crew - 1	Passengers - 4
Injuries:	Crew - 1 (Minor)	Passengers - 4 (Minor)
Nature of Damage:	Left wing severed, right wing attachment, stabilator and propeller damaged	
Commander's Licence:	Private Pilot's Licence	
Commander's Age:	32 years	
Commander's Flying Experience:	195 hours (of which 57 were on type) Last 90 days - 14 hours Last 28 days - 14 hours	
Information Source:	AAIB Field Investigation

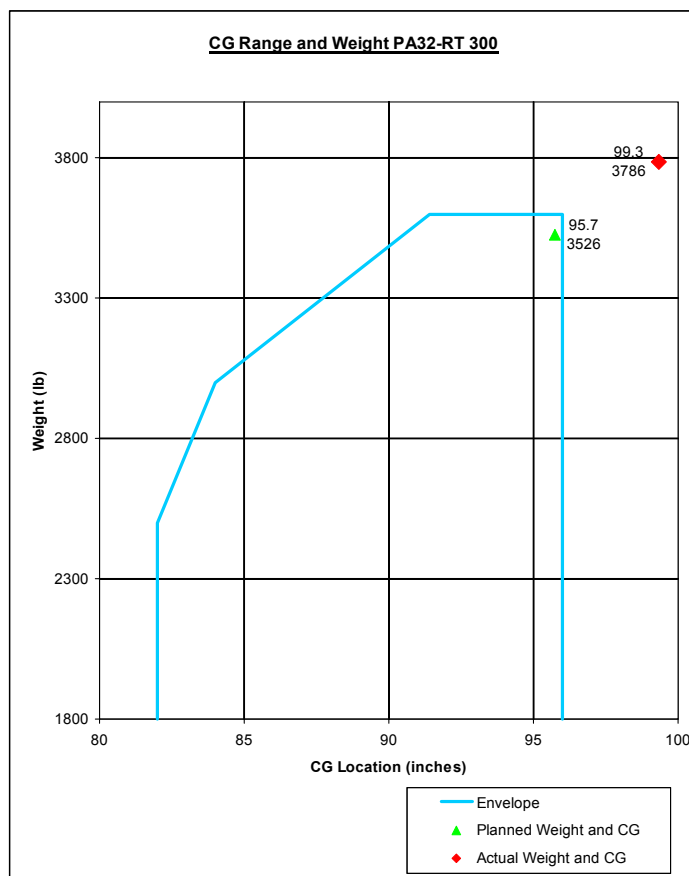
Figure 1,
Flight Envelope

The pilot stated that he did not have access to the actual passenger and baggage weights and therefore assumed values for his weight and balance calculation. He calculated a takeoff weight of 3,526 lb and a CG of 95.75 inches behind the datum. Analysis of aircraft weight and balance using the actual weights for the occupants and their baggage produced a takeoff weight of 3,786 lb and a CG of 99.34 inches aft of the datum, exceeding the weight limit by 186 lb, and CG aft limit by 3.34 inches. The CG range and weight chart, overlaid with these points, is shown in Figure 1.

The CG of the aircraft on takeoff was 3.4 inches aft of the rear CG limit. This CG position would have had a marked effect on the longitudinal manoeuvre stability of the aircraft, which would have been unusually sensitive and light to control in pitch. These handling qualities could cause the pilot to over-control the aircraft in pitch, leading to over rotation on takeoff.
