INCIDENT

Aircraft Type and Registration:	Airbus A340-311, 4R-ADB	
No & Type of Engines:	4 CFM56-5C2 turbofan engines	
Category:	1.1	
Year of Manufacture:	1994	
Date & Time (UTC):	26 June 2005 at 0913 hrs	
Location:	School Hill Lane, Wargrave, Berkshire	
Type of Flight:	Public Transport (Passenger)	
Persons on Board:	Crew - 14	Passengers - 304
Injuries:	Crew - None	Passengers - None
Nature of Damage:	Damage to right inboard flap, No 3 flap fairing and No 3 engine exhaust nozzle	
Commander's Licence:	Air Transport Pilot's Licence	
Commander's Age:	54 years	
Commander's Flying Experience:	17,000 hours (of which 5,760 were on type) Last 90 days - 223 hours Last 28 days - 48 hours	
Information Source:	AAIB Field Investigation

Synopsis

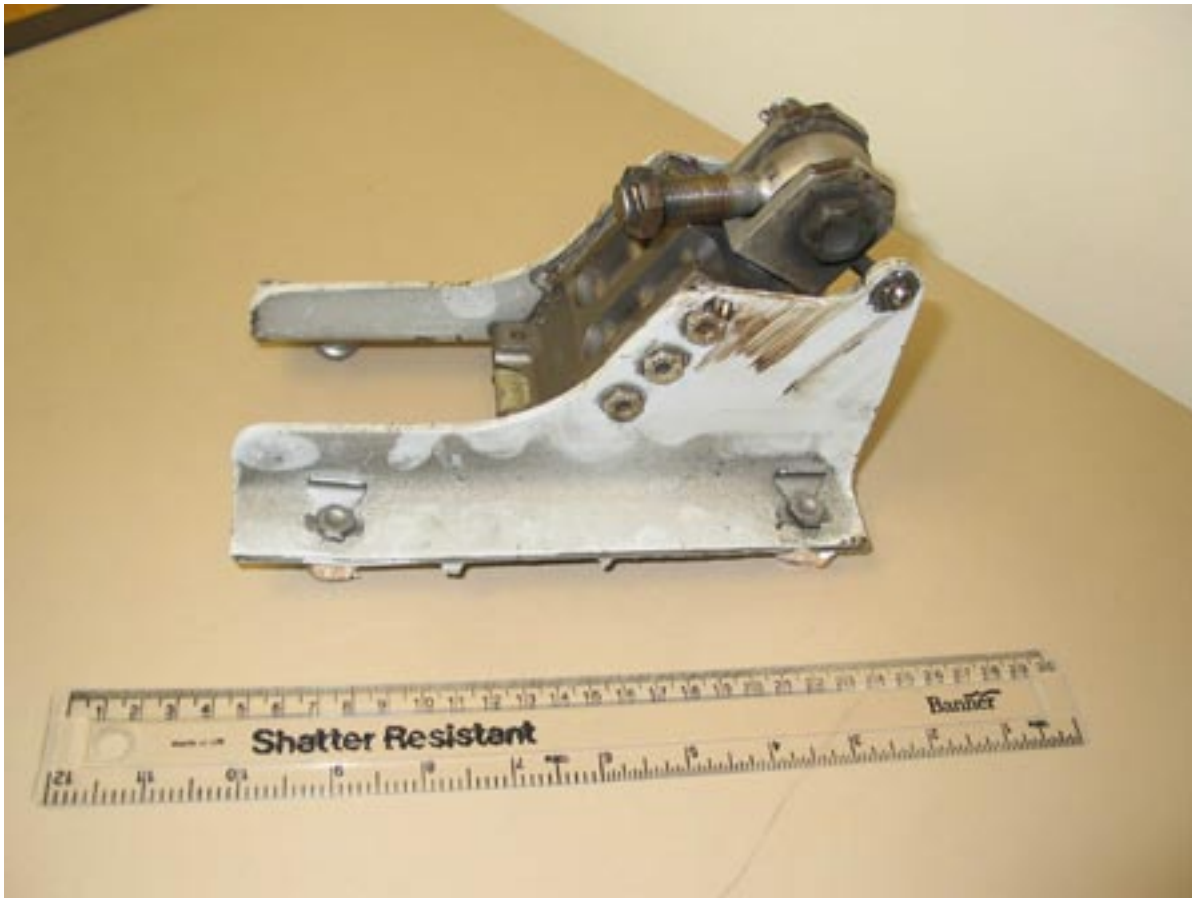
Figure 1

The object, shown in Figure 1, had little distinguishing features except for part numbers on the bolt heads and the threaded eye end; it weighed approximately 1.5 kg. After a lengthy investigative process, it was established that the object had come from an Airbus A330, A340-200 or A340-300, and in fact was a flap fairing lower attachment fitting, see Figure 3.

The No 3 flap track fairing exhibited damage where the inserts that locate the attachment fitting had pulled out of the fairing honeycomb structure. In addition, there was damage to the trailing edge of the inboard flap directly aft of the flap track fairing. Inspection of the fairing attachment fitting revealed that the nut of the lower eye end of the connecting rod was close to the end of the thread. In addition, a bar located behind the connecting rod attachment point was bent downward, consistent with contact with the eye end; this could only have occurred once the eye end had become detached from the connecting rod. The four fasteners which normally secure the attachment fitting to the fairing were still locked in place, but the inserts into which the fasteners locate, which are normally bonded into the honeycomb structure of the fairing, had been pulled out of the fairing together with some honeycomb material, and remained attached to the fitting.

The reason for the detachment of this fitting from the flap fairing was not established. The four attachment bolts had remained with the fitting and did not appear to have come loose, as their locking tabs were intact, and they were still engaged with the inserts. This, together with the fact that the inserts had been pulled from the honeycomb structure, suggested that the fitting had either experienced higher than intended loading or, possibly, had not been manufactured or repaired properly. However, had the fairing been defective since manufacture, then it might be expected that a failure would have occurred earlier in its life. Excessive loading on a serviceable fairing is not likely to be generated by normal 'operational' loads, otherwise detachment of the fitting from any fairing would likely be a fairly common event. Therefore, the possibility remains that excessive loads could have been generated by a combination of in-service loading, defective repair and/or incorrect rigging of the fairing to the flap upon its last fitment.

The departure of the fitting from the aircraft, once free from the fairing, was likely due to the airflow through the fairing having caused the unattached fitting to rotate and eventually unscrew from the lower eye end of the connecting rod. With the fitting now totally detached, it then departed the aircraft rearwards hitting the inboard flap in the process. Had the lower eye end not been able to unscrew, then the fitting would have remained with the aircraft, albeit with some damage being caused to the fairing and flap assembly.

The manufacturer has been made aware of this incident and has already changed the design of the connecting rod such that the lower eye end always remains attached to the connecting rod. A Service Bulletin will be introduced to rework or replace existing connecting rods.

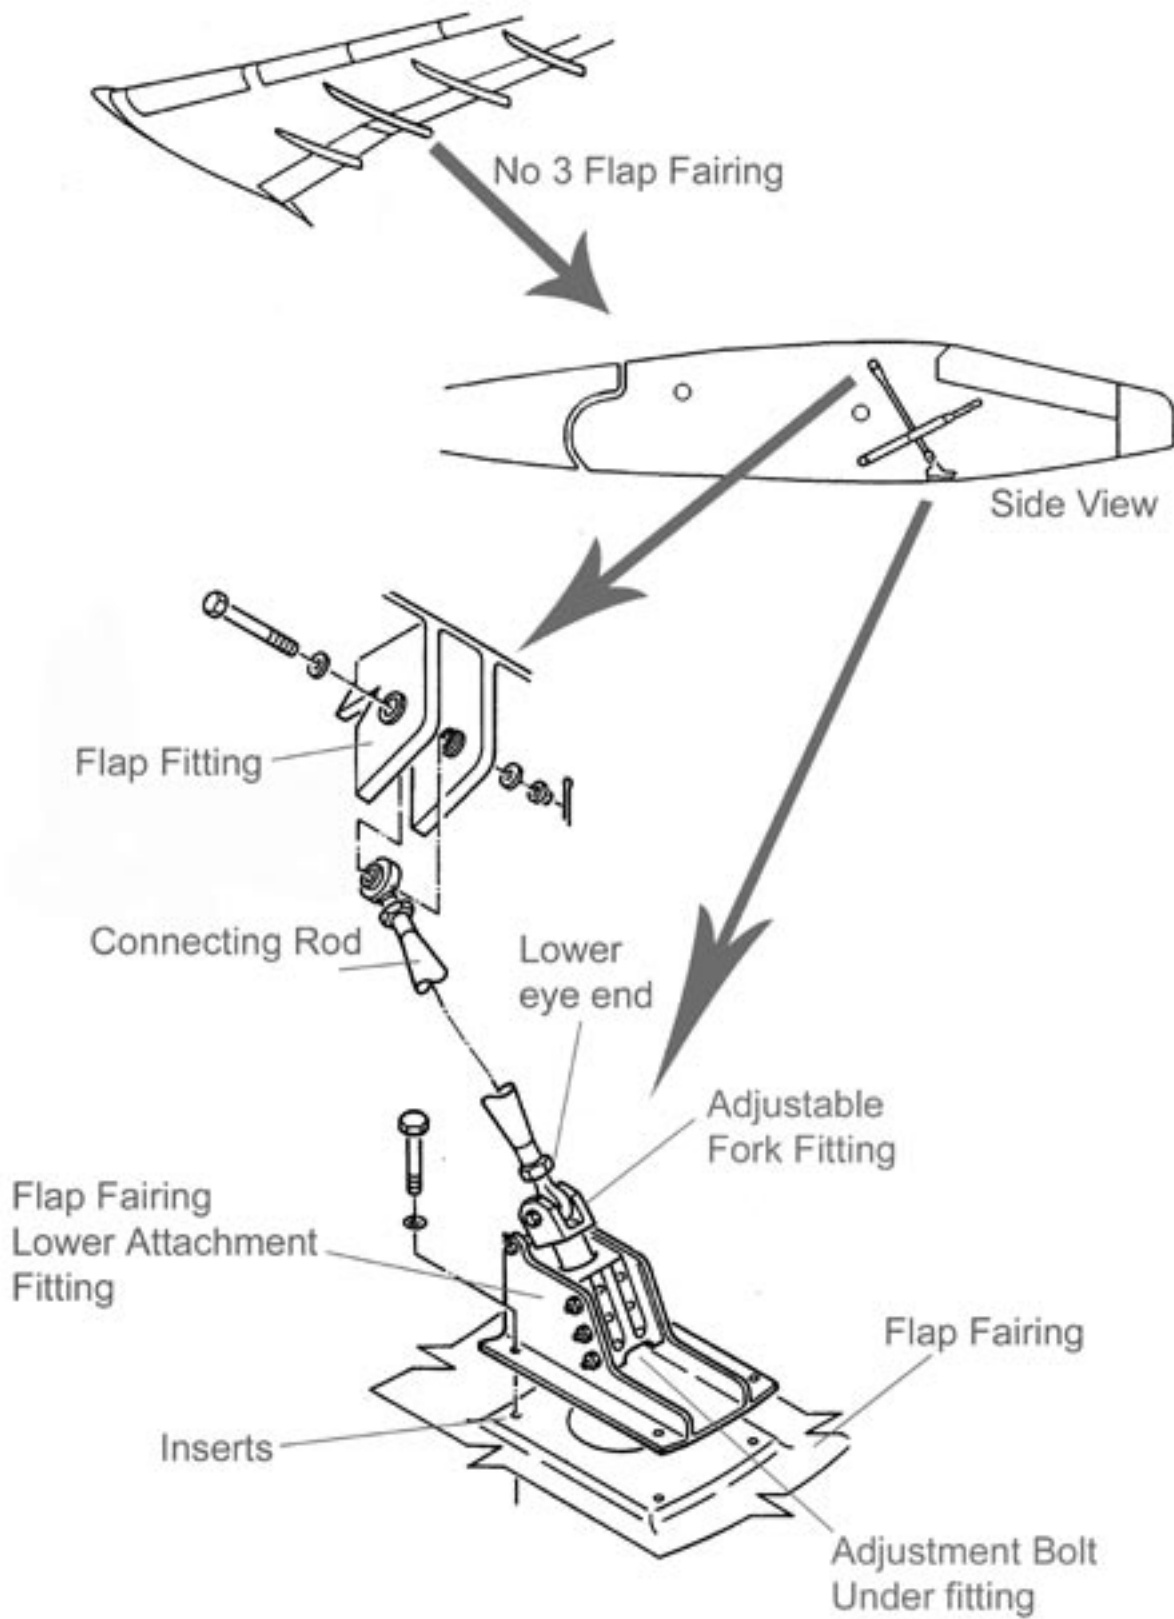
Description of flap system, Figure 3

On each wing of the Airbus A340-300 there are two trailing edge flaps, inboard and outboard. The flaps are mounted on flap carriages which are driven along flap tracks attached to the lower wing surface. To protect the flap tracks and reduce drag, each track is enclosed in a fairing. The rear section of the fairing is pivoted at the flap track and is allowed to move in sympathy with

the flap by the use of a connecting rod attached to the underside of the flap at one end, and to a fork fitting on the flap fairing lower attachment fitting, at the other. As the flap moves aft and downward, the connecting rod transfers this motion to the flap track fairing lower attachment fitting, and pushes the rear section of the fairing downward.

Adjustment of the clearance between the fairing and flap is accomplished at the lower fairing attachment fitting. An access hole on the underside of the fairing gives access to a bolt that, in turn, alters the height of the fork fitting to which the connecting rod is attached. This changes the distance between the flap and the fitting. This means of adjustment is designed to preclude the need to perform any adjustment on either of the eye ends on the connecting rod.
