INCIDENT

Aircraft Type and Registration:	Boeing 757-236, G-LSAA	
No & Type of Engines:	2 Rolls-Royce RB211-535E4-37 turbofan engines	
Year of Manufacture:	1988	
Date & Time (UTC):	2 March 2009 at 1327 hrs	
Location:	FL390, 30 nm north-east of Athens, Greece	
Type of Flight:	Commercial Air Transport (Passenger)	
Persons on Board:	Crew - 9	Passengers - 183
Injuries:	Crew - None	Passengers - 4 (Minor)
Nature of Damage:	None	
Commander's Licence:	Airline Transport Pilot's Licence	
Commander's Age:	63 years	
Commander's Flying Experience:	14,090 hours (of which 9,371 were on type) Last 90 days - 106 hours Last 28 days - 28 hours	
Information Source:	Aircraft Accident Report Form submitted by the commander, and further enquiries by the AAIB

Synopsis

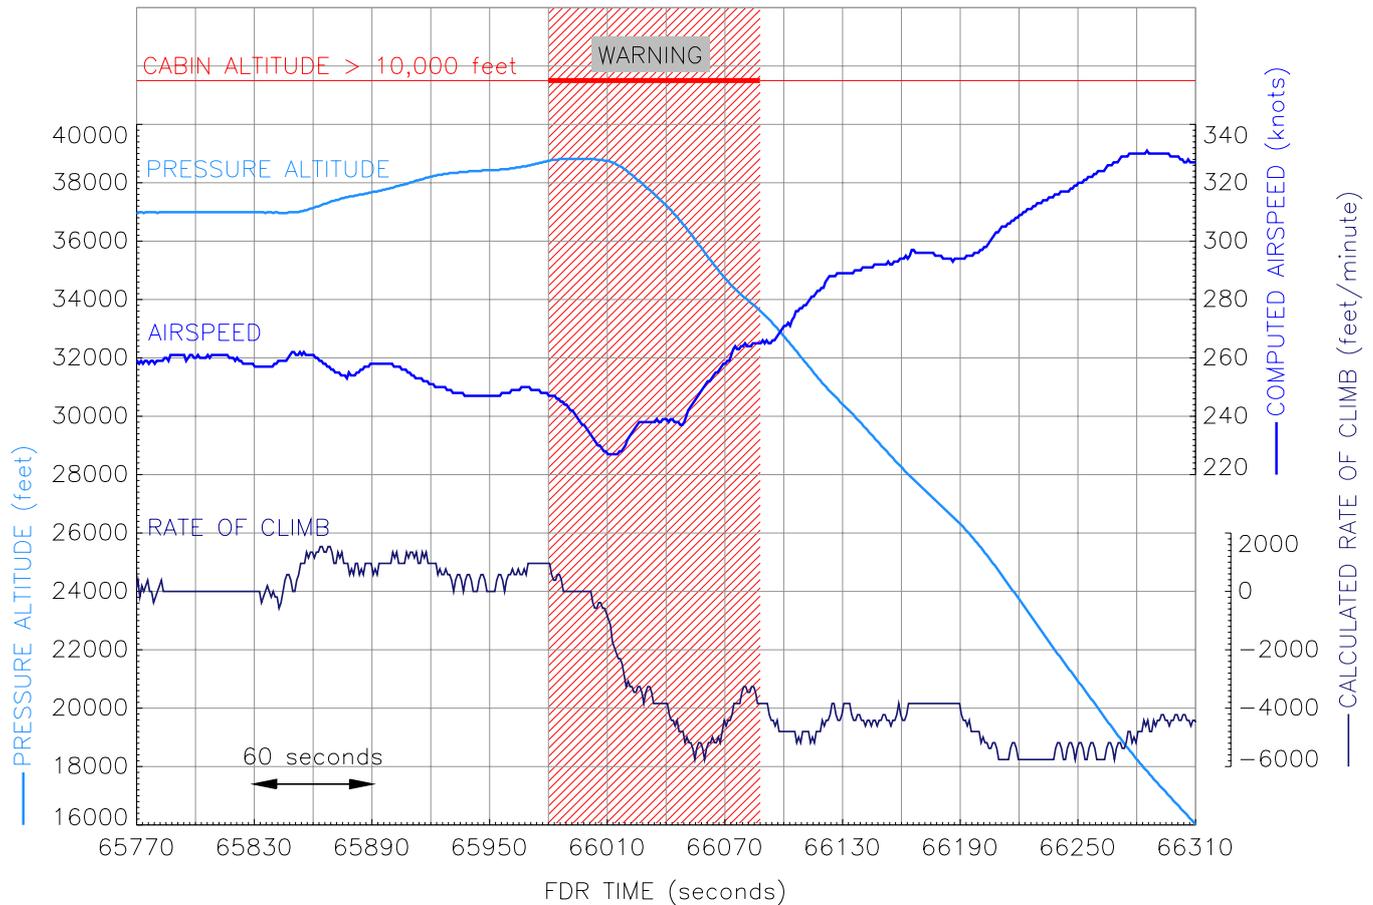
Figure 1

The flight data recorder (FDR) did not record cabin altitude but there was a discrete parameter, recorded once a second, that indicated when the cabin altitude exceeded 10,000 feet. This discrete (*CABIN ALTITUDE > 10,000 feet*) and other salient parameters recorded on the FDR are illustrated in Figure 1. The figure shows that the cabin altitude exceeded 10,000 feet for a period of 108 seconds, starting as the aircraft climbed through 38,700 feet and ending as the aircraft descended through 33,700 feet.

Salient FDR parameters
