**ACCIDENT**

| <b>Aircraft Type and Registration:</b> | Extra EA 230, G-CBUA | |
| <b>Location:</b> | White Waltham Airfield, Berkshire | |

**Synopsis**

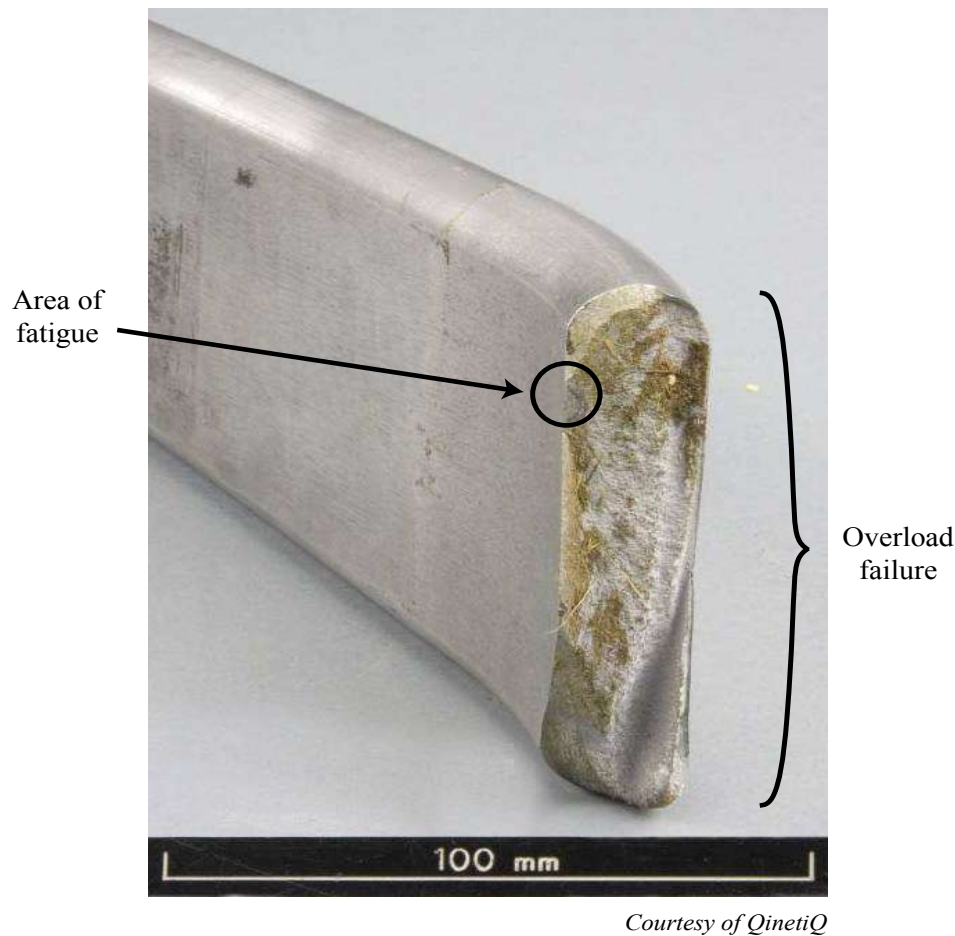
**Figure 1**

Initial examination of the failure surface of the aluminium landing gear indicated an area of fatigue (Figure 1).

Landing gear leg, G-CBUA

In summary, the QinetiQ examination revealed that the landing gear was manufactured from a single length of 2024 aluminium alloy 22.5 mm thick, which was then formed to the desired profile. It was found that the gear had fractured at the bend at the top of the right leg. It was concluded that the failure of the right main landing gear was caused by the growth of a fatigue crack which originated at a small corrosion pit on the inner surface of the bend radius at the top of the leg. There was evidence of a second similar crack

originating from a small corrosion pit on the matching (unbroken) left leg of the landing gear. There was no evidence of protective measures having been taken to prevent corrosion pitting other than surface polishing, which had been carried out only to the lower part of the landing gears. There was no associated mechanical damage that would have influenced the failure.

Examination of the fracture surface in a scanning electron microscope (SEM) revealed coarse growth bands across the crack length and attempts to count them showed there to be between 45 and 50 visible. Contained within the major visible growth bands there appeared to be a number of less distinct bands and

individual fatigue striations. It is possible that each of the major growth bands visible on the fracture surface indicated a landing, whilst the minor bands found within these could be associated with bumps during taxiing over rough ground. Therefore it is possible that the crack may have been progressing for up to 50 landings before final fracture occurred.

The metallurgist further commented that there was no evidence to suggest that the material's mechanical properties contributed to this failure, but that the high copper content of 2024 alloy makes it susceptible to corrosion and the material commonly requires additional protection from environmental degradation. In this case there was no evidence found of an effective protection scheme applied to the undercarriage leg, which would have increased the likelihood of the formation of the corrosion pit which initiated the fatigue cracking. The metallurgist considered that the adoption of additional corrosion protection measures, such as inhibited paint coatings over anodising or conversion treatments on the landing gear, would reduce the occurrence of the fatigue-initiating corrosion pits. There is evidence<sup>1</sup> to suggest that there can be in-service fatigue failures originating from corrosion damage in components under sustained stresses acting in the longitudinal or short-transverse directions relative to the grain structure of the material.

It is recommended that EXTRA GmbH review the continued airworthiness of the main landing gear fitted to the Extra EA 230 aircraft, to ensure adequate protection measures to reduce the occurrence of corrosion pitting.
