**Illustrations of damage to rudder and trim tab**

Fokker F27 vertical tail surfaces

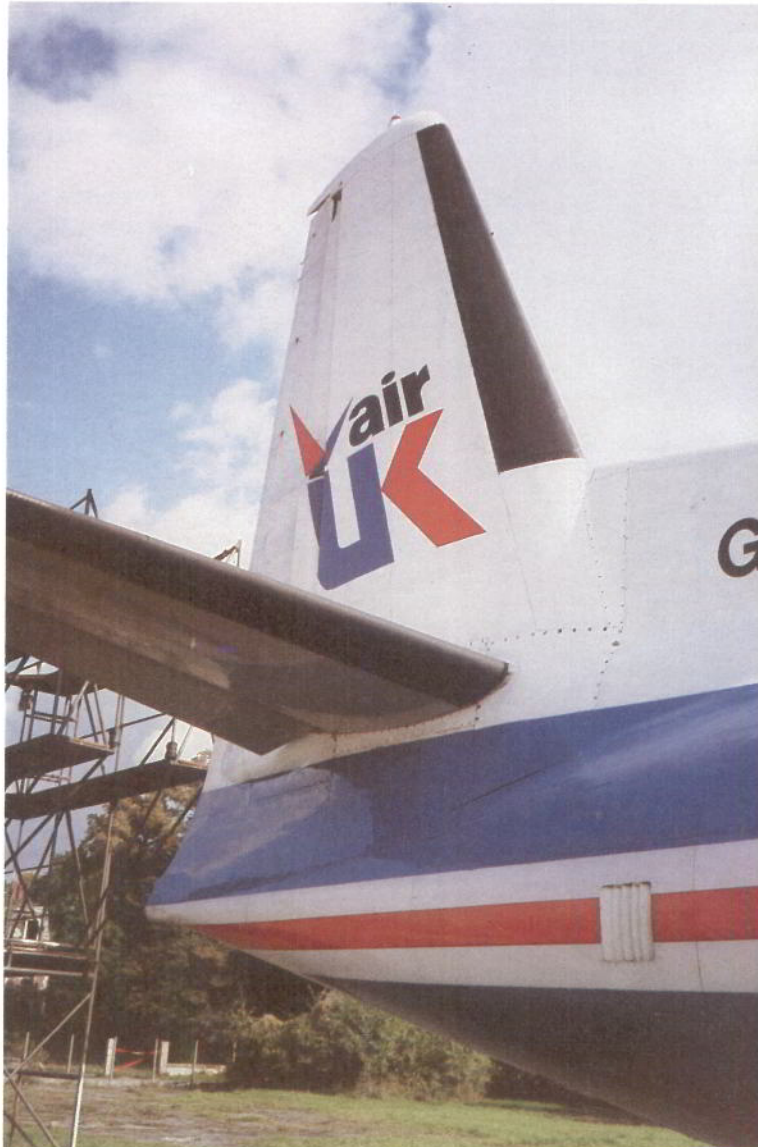
**(i) Overall view of vertical tail surfaces with damaged rudder and trim tab**

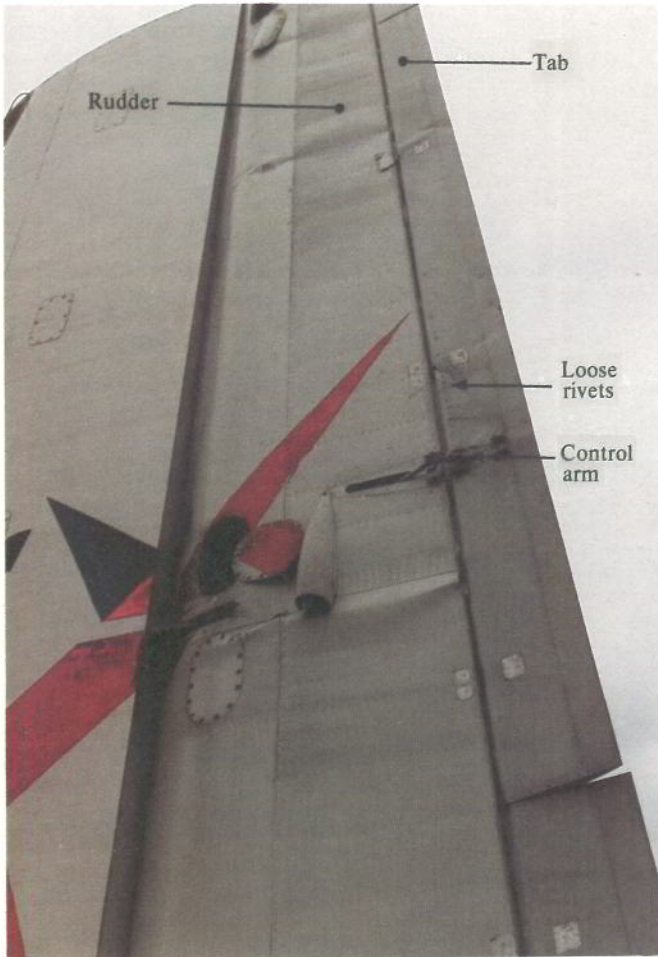
**(ii) Left side of damaged rudder and trim tab showing :-**

- a) Transverse wrinkling of rudder skin, indicating occurrence of reverse lateral bending
- b) Deformation of trim tab, particularly above control arm
- c) Evidence of loose rivets on tab just above control arm shown by dark marking round rivet heads and rearward streaking

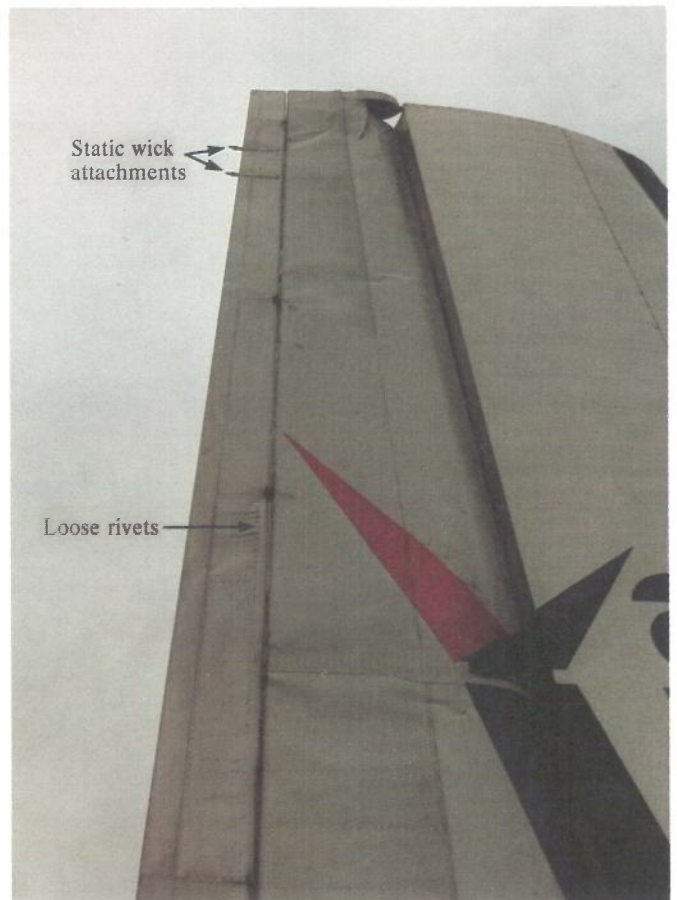
**(iii) Right side of damaged rudder and trim tab**

- a) Broken static wicks indicative of the severity of the flutter
- b) Area of loose rivets below second hinge

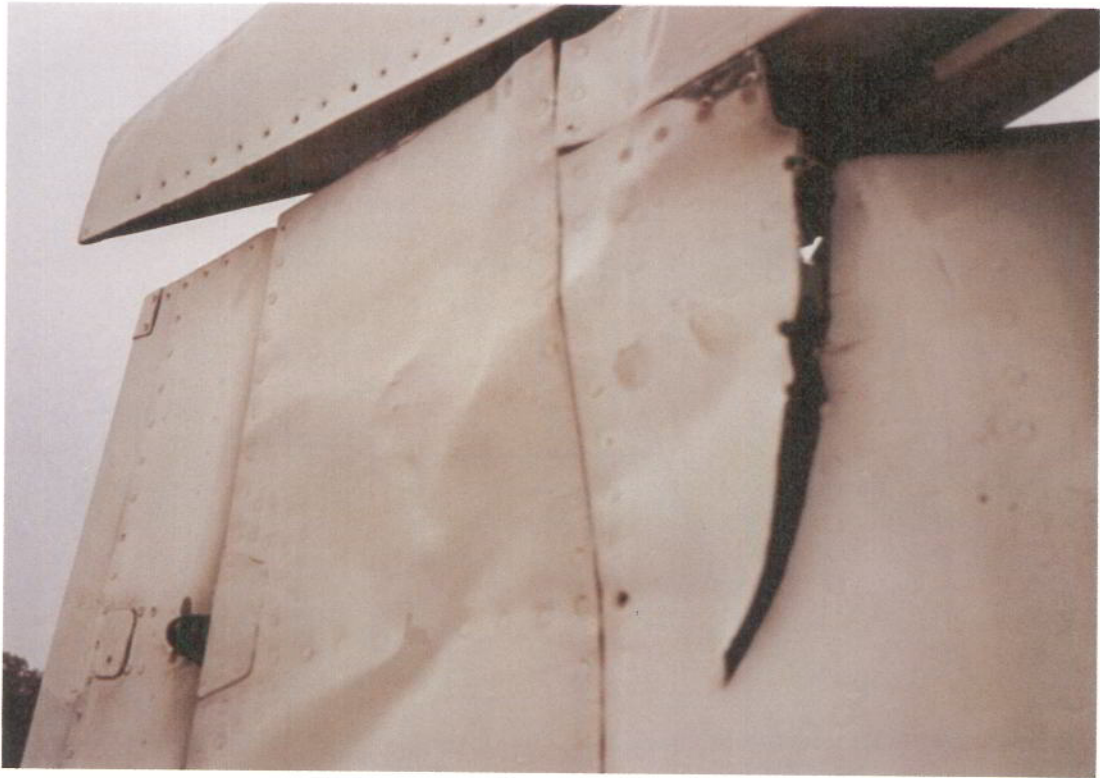
(iv) Damage to rudder structure at top hinge

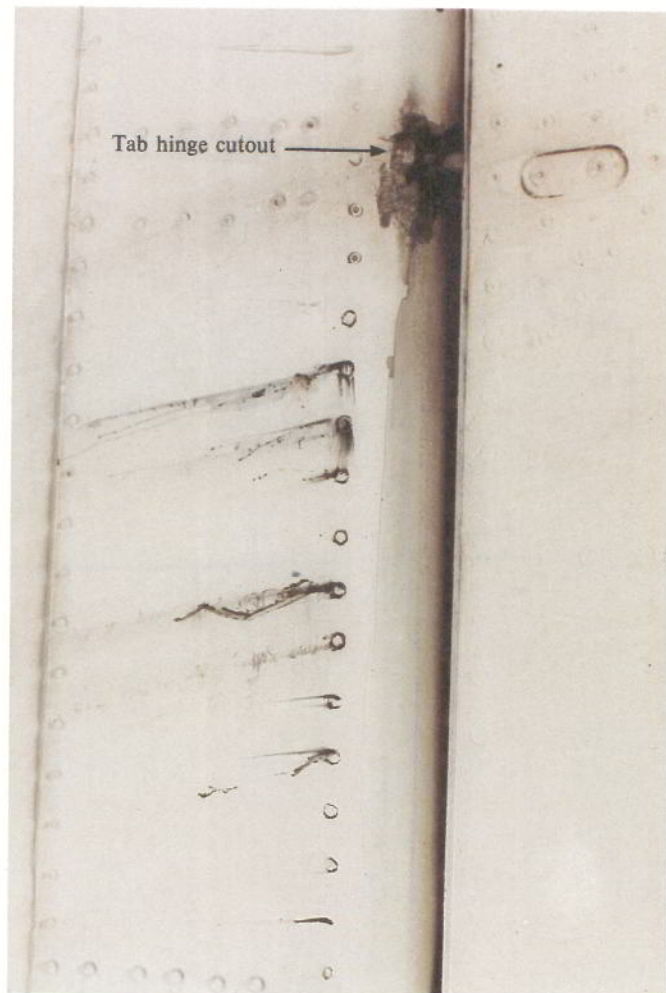
(v) Close view of evidence of rivet looseness

Note cracks in paint finish around rivet heads and characteristic streaking of fretting products away from loosened rivets. Also showing damage at tab hinge cutout due to tab overrotation
