**ACCIDENT**

<b>Aircraft Type and Registration:</b>	Airbus A319-131, G-EUOE
<b>No &amp; Type of Engines:</b>	2 x IAE V2522-A5 turbofan engines
<b>Year of Manufacture:</b>	2001 (Serial No 1574)
<b>Date &amp; Time (UTC):</b>	24 May 2013 at 0716 hrs
<b>Location:</b>	London Heathrow Airport
<b>Type of Flight:</b>	Commercial Air Transport (Passenger)
<b>Persons on Board:</b>	Crew - 5                      Passengers - 75
<b>Injuries:</b>	Crew - None                      Passengers - None
<b>Nature of Damage:</b>	Fire damage to the right engine; mechanical damage to: fuel and hydraulic pipes, slats, flaps, horizontal stabiliser, landing gear and fuselage skin
<b>Commander's Licence:</b>	Airline Transport Pilot's Licence
<b>Commander's Age:</b>	50 years
<b>Commander's Flying Experience</b>	14,337 hours (of which 8,036 were on type)
<b>Information Source:</b>	AAIB Field Investigation

**Synopsis**

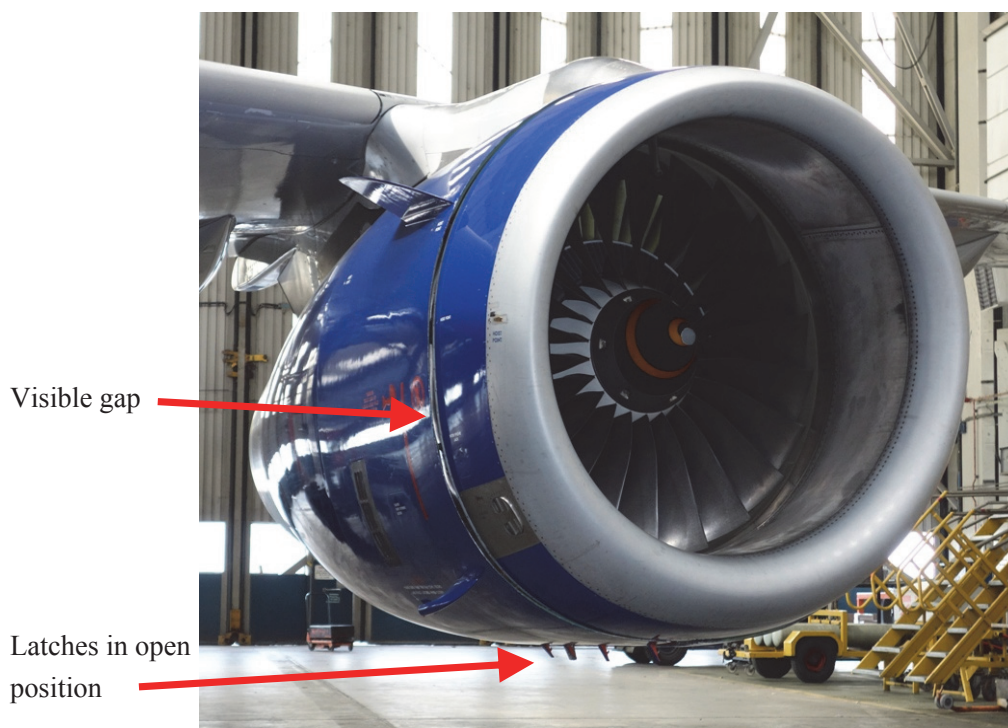
**Figure 1**

cowl doors from closing fully under gravity. In this condition the fan cowl doors stand slightly proud of the nacelle (Figure 1), to provide a visual cue that the doors are not latched.

Following the event photographs of the aircraft, taken prior to pushback, were provided to the AAIB. These photographs show the fan cowl doors unlatched on both engines.

Generic photograph showing fan cowl doors in the unlatched condition

It is recommended that Airbus formally notifies operators of A320-family aircraft of the fan cowl door loss event on A319 G-EUOE on 24 May 2013, and reiterates the importance of verifying that the fan cowl doors are latched prior to flight by visually checking the position of the latches.
