AIB Bulletin

No: 3/85

Aircraft type and registration: Bölkow BO 105D G-AZOM (twin engined light helicopter)

Location: 5½nms due east of Skegness, Lincolnshire

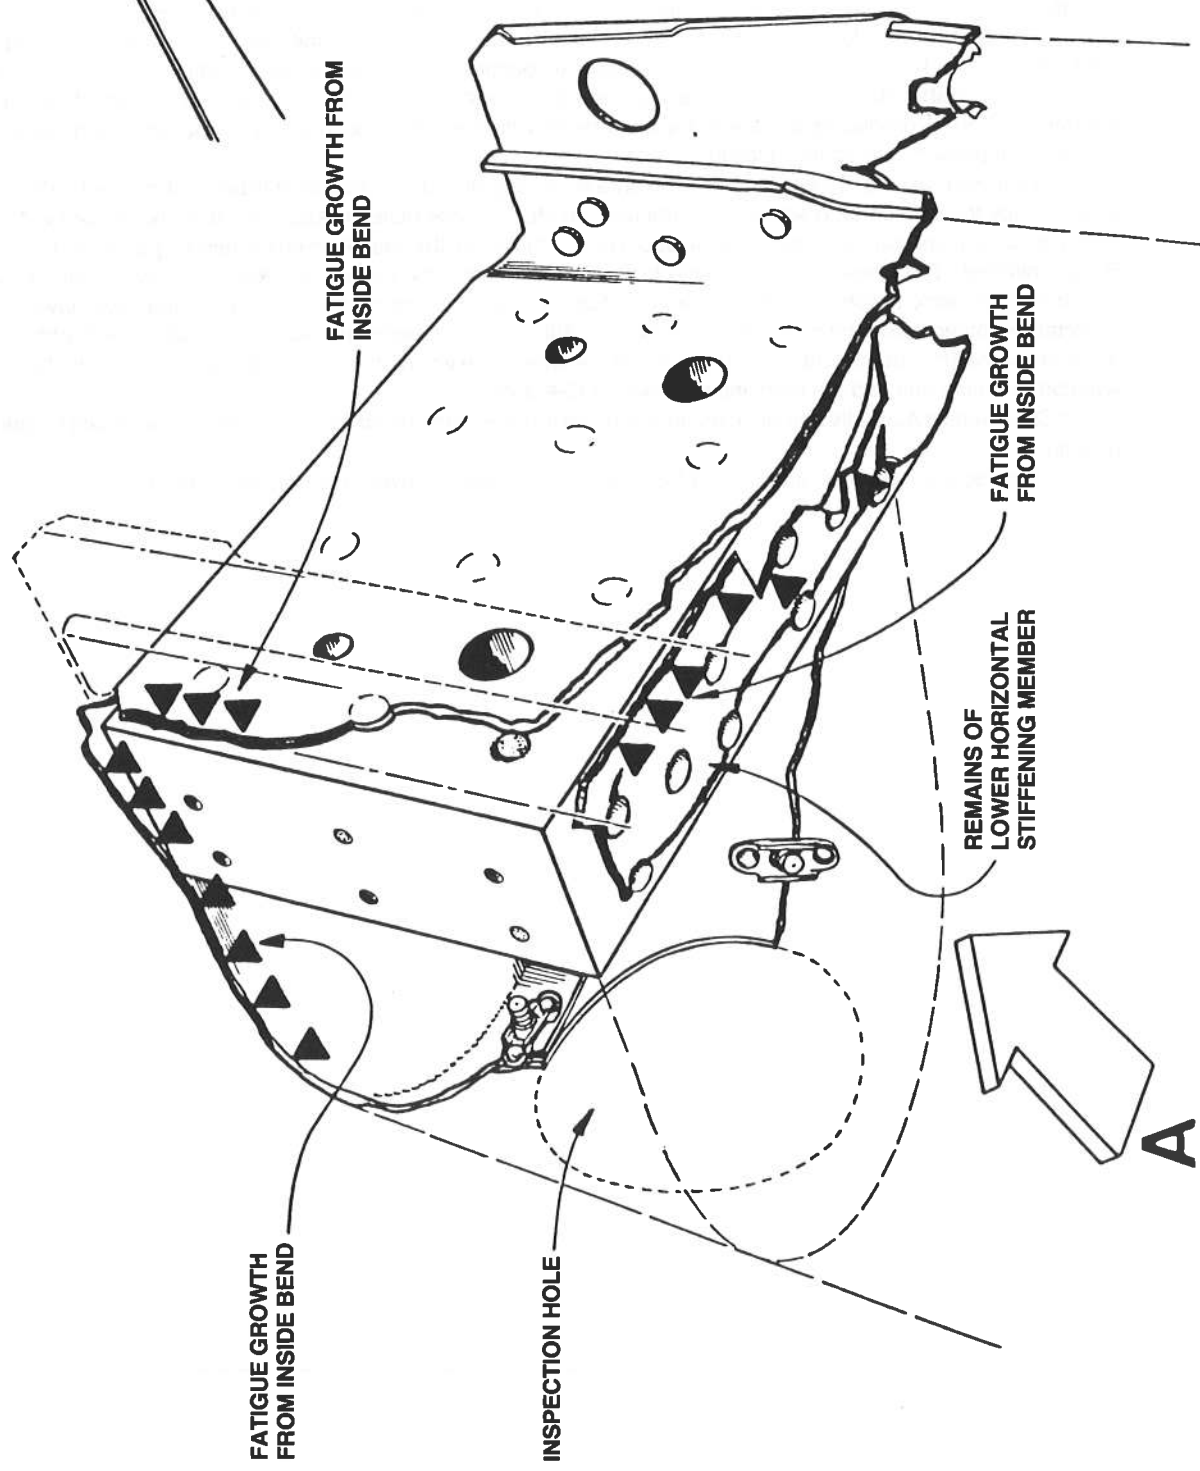
FIG.1

Of particular interest was a failure of the structure close to the top of the vertical fin, resulting in partial separation of the tail rotor gearbox. Although this was clearly not totally a pre-impact failure, examination of the fracture faces revealed the presence of a considerable amount of fatigue. (See Fig.1)

It was considered from the evidence that the unusual indications first experienced by the pilot occurred when the upper coupling failed, and that the orbiting end of the Bendix shaft continued to provide limited drive to the tail rotor gearbox whilst it machined away the failed diaphragm. The fatigue cracking of the tailfin appeared to have been exploited during the impact or salvage operation, so that complete structural failure of the upper tailfin section then occurred.

The extensive cracking of the tailfin was in an area where significant modification has been introduced on BO 105 aircraft since the type entered service. In particular, an MBB service Bulletin, issued in 1976 and revised in 1978, called for local modifications to reinforce the upper part of the tailfin. It is described on the heading sheet as 'Urgently Recommended'. The following wording included in a section within the Bulletin headed "Compliance" states that, "An immediate accomplishment of this Service Bulletin is urgently recommended if discrepancies have been ascertained, otherwise at the next suitable occasion". Although this modification was approved by the Certification Authority of the state of manufacture, it had not, at the time of the accident, been made mandatory by the UK Civil Aviation Authority and had not been incorporated in G-AZOM.

FATIGUE GROWTH FROM INSIDE BEND

REMAINS OF LOWER HORIZONTAL STIFFENING MEMBER

SKETCH OF DAMAGED TAIL ROTOR GEAR BOX MOUNTING STRUCTURE.

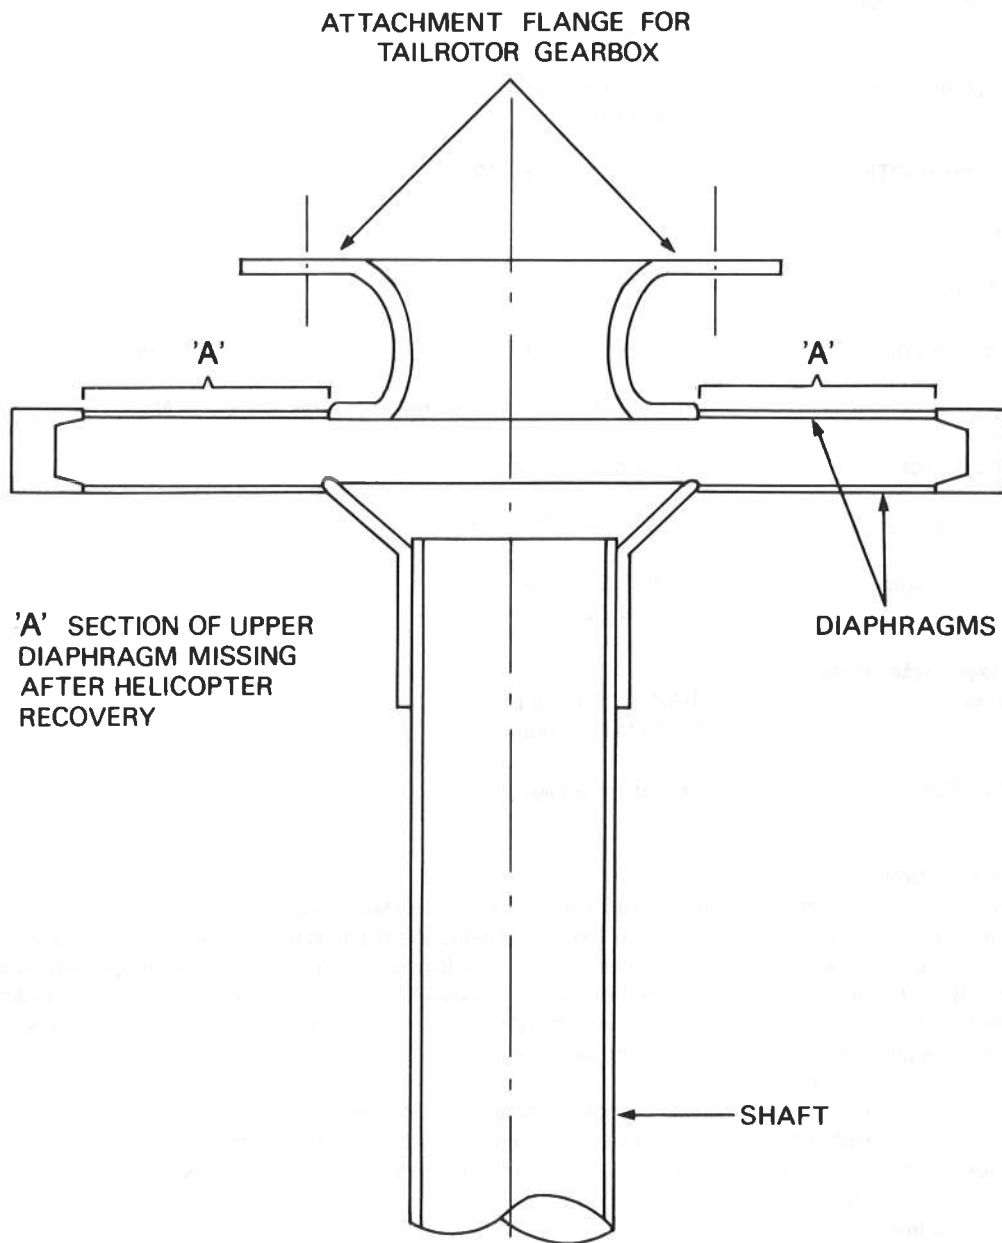
FIG 2: BENDIX COUPLING DESIGN

It was further noted that the upper coupling of the tail rotor drive rear Bendix shaft had failed and considerable relative rotation had taken place between the failed components of the coupling, causing the failed diaphragm to be machined away by the orbiting end of the shaft. Examination of the remainder of the tail rotor drive and control system showed no evidence of any other pre-impact failure.

No direct evidence for the cause of failure of the shaft coupling could be found; the mode of failure of the diaphragm could not be established due to its subsequent destruction by the orbiting end of the shaft. The coupling design, however, permits very limited misalignment between input and output shafts to occur. It seems possible that the extensive fatigue cracking, noted in the tailfin, may have sufficiently reduced its stiffness to cause excessive structural flexing. Hence, loss of alignment between the Bendix shaft axis and the axis of the input shaft to the tail rotor gearbox could result. If such excessive misalignment occurred under high tail rotor loading, the upper coupling of the Bendix shaft would have been forced to operate outside its design limits. It must be assumed that such operation occurred, producing damage to the diaphragm, which was then exploited by normal operation leading to complete diaphragm and coupling failure.
