AAIB Bulletin No: 2/94

Ref: EW/C93/5/3

INCIDENT

Aircraft Type and Registration: Airbus Industrie, A320-211, D-AIPP

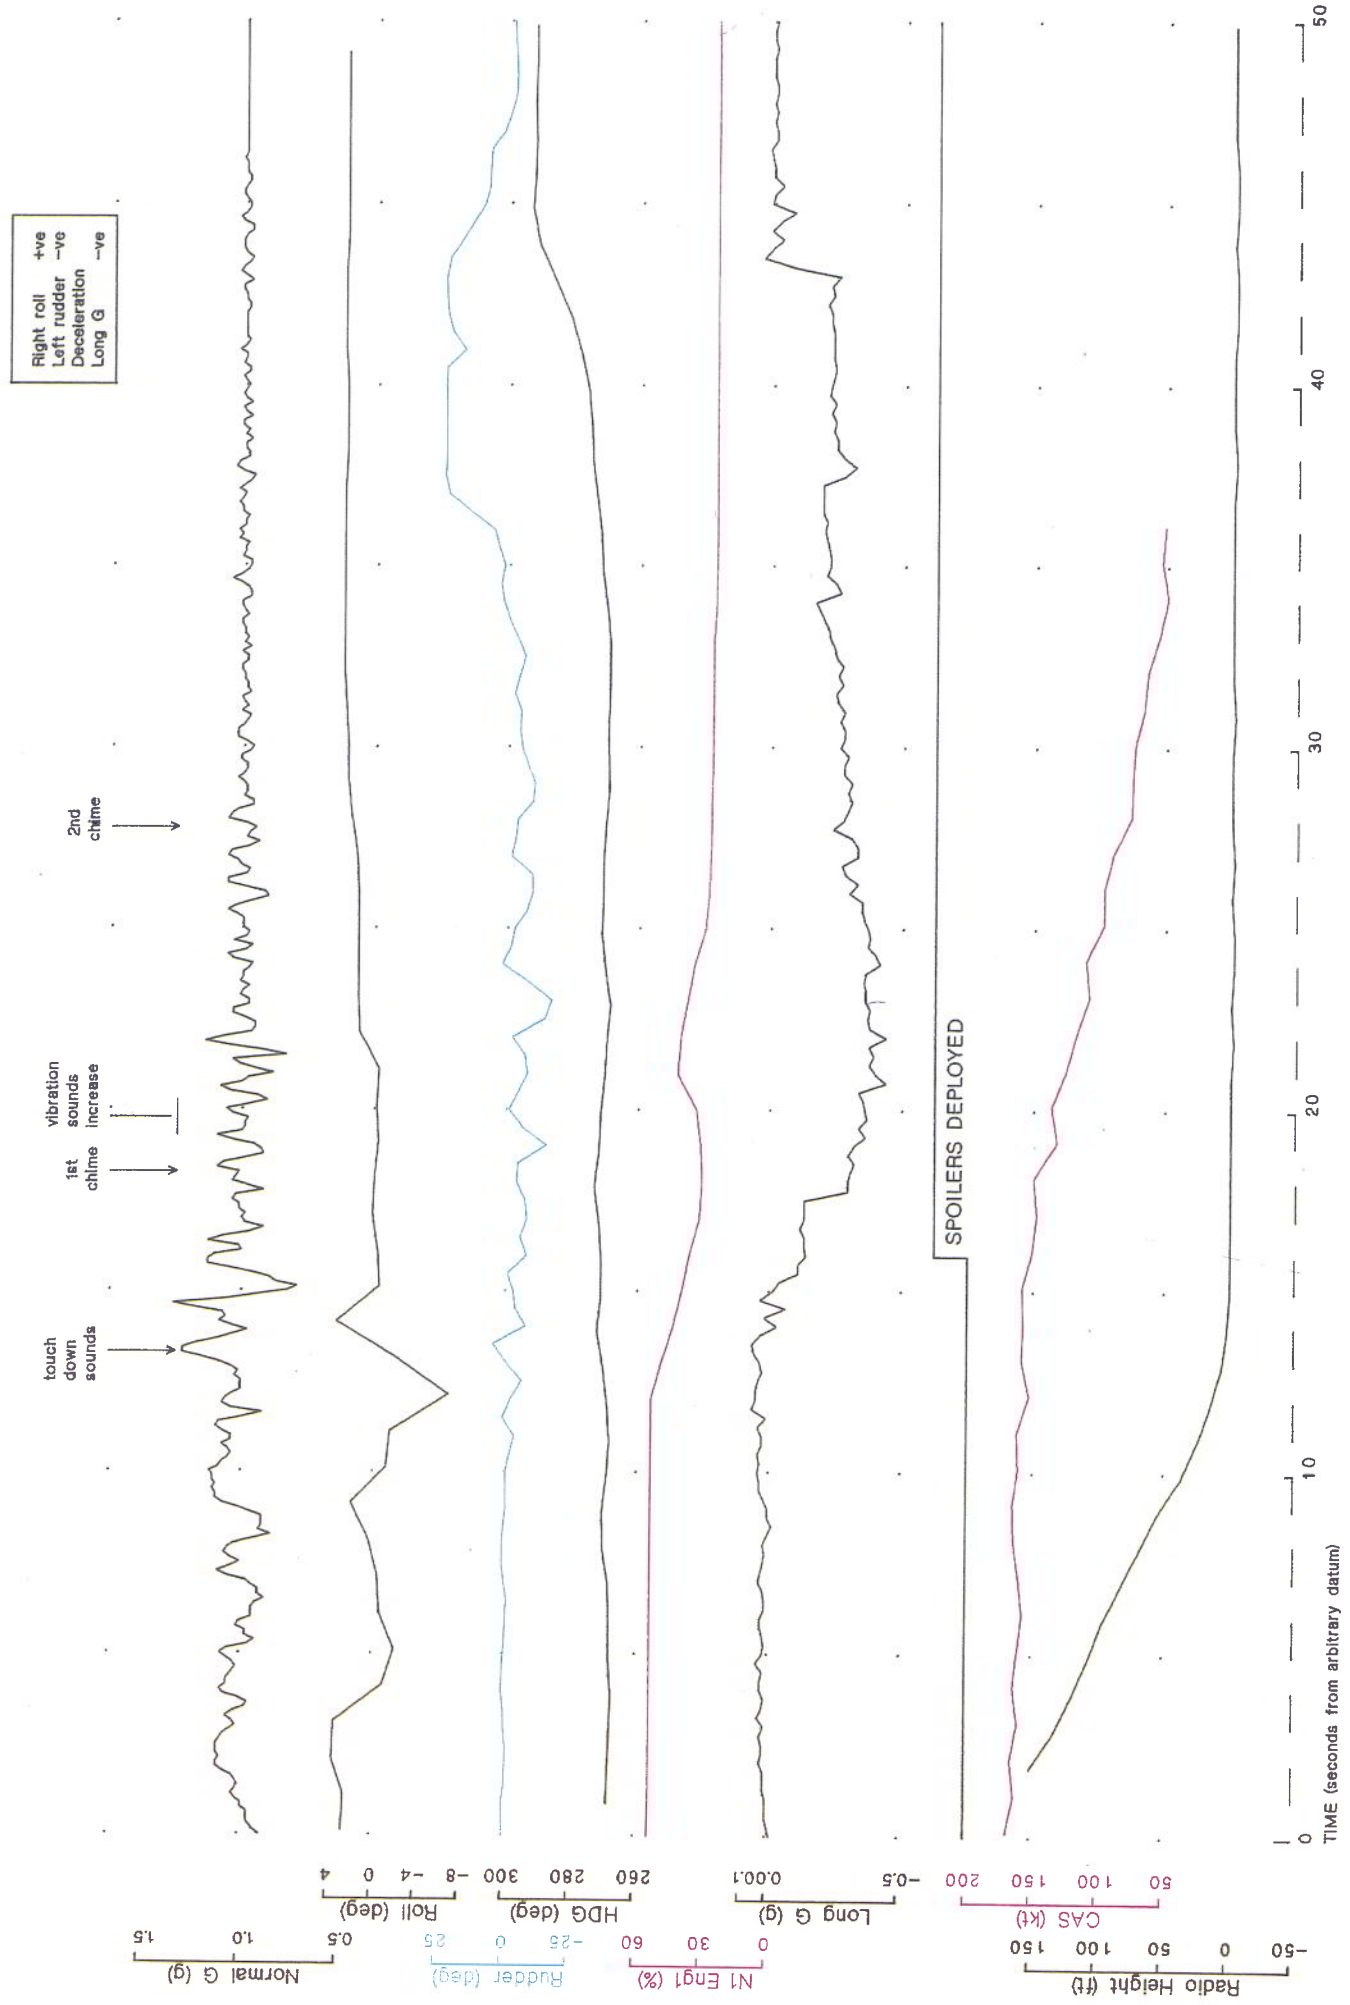
The FDR recorded over two hundred parameters, however, the recorder did not record the positions of the brake pedals and the parking brake or the hydraulic braking pressures. A selection of the relevant parameters that were recorded is shown in Figure 1 from shortly before landing to the end of the landing run.

Following a normal descent the aircraft touched down at a recorded airspeed of 158 kt and a groundspeed of 140 kt at time 13 seconds in Figure 1. The left main landing gear contacted the runway first, then the right gear only and finally all three gears, as indicated by the peak normal 'g' values of 1.30 g, 1.34 g, and 1.17 g respectively. By 16 seconds the spoilers had deployed and the aircraft was decelerating at an average of 0.13 g. This corresponds to aerodynamic braking; LO autobrake produces 0.17g deceleration and MED 0.3g. The deceleration increased to 0.30 g at 17 seconds, peaking to 0.44 g at 20 and 21 seconds, times at which the reverse thrust, indicated by N1 Eng1, was 40% to 42%. During the period 21 to 22 seconds the aircraft attitude changed from wings level to 1.5° right wing down. Towards the end of the landing run, roll had increased to 3° right wing down, and deceleration had decreased to 0.20 g to 0.25 g. The nominal landing heading of 270° was maintained until 31 seconds, after which it increased to a final value of 290°. The rudder, biased to the right during the early stages of the landing roll moved to a maximum of 24° left, as the aircraft turned to the right. The first cockpit chime sounded at a recorded groundspeed of 128 kt (airspeed 150 kt) at 18 seconds, and the second warning chime at 27 seconds when the aircraft had a recorded airspeed of 77 kt.
