AAIB Bulletin No: 10/93

Ref: EW/G93/07/30

Aircraft Type and Registration: Agusta A109, VR-CCK

Location: Westland/London Heliport, Battersea

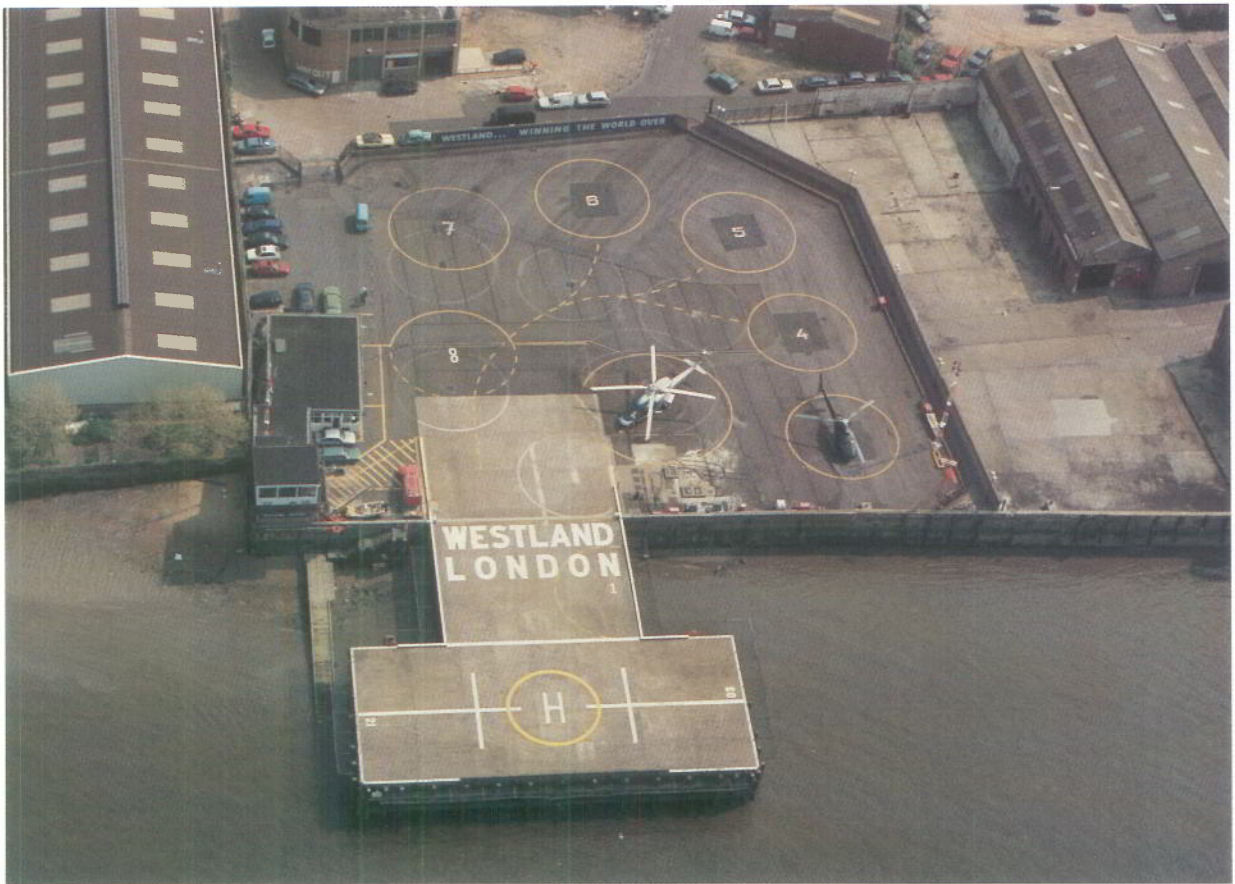
The pilot commented that the positioning of a large helicopter on spot No 2 seriously limited the area available for entry and exit from the rest of the parking area at Battersea. He further believed that, due to the limited space, he must have been marshalled with his main rotor under one of the tail rotor blades of the S76. The tilt angle on the main rotor necessary for ground taxiing caused the collision only when the rear of the rotor disc approached the tail rotor of the S76 and when the pilot and, apparently, both the marshalls considered the obstacle to have been safely passed.

Westland (Battersea) Heliport
 showing a Sikorsky S76 parked on spot No2, and an Aerospatiale Twin Squirrel on spot No3.

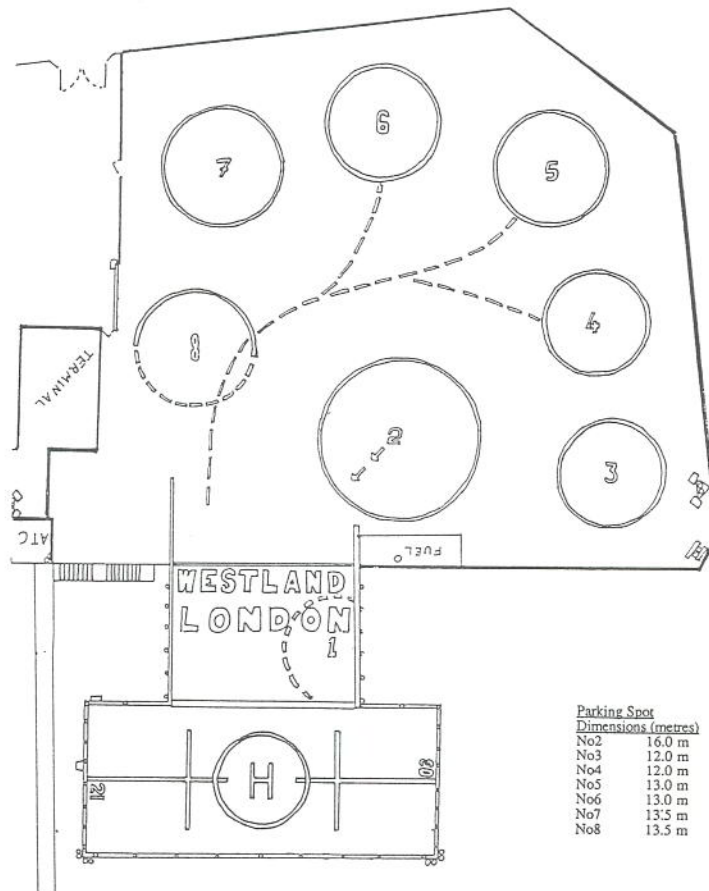
Battersea Heliport ground markings

The helicopter arrived at Westland/London Heliport, disembarked a passenger and carried out a rotors running refuel. It was directed by ATC to park facing north on Spot No 4 (see plan attached). Spot No 3 was already occupied by an Aerospatiale Twin Squirrel and spot No 2 by a Sikorsky S76 (VR BNR). These helicopters were facing north and northeast respectively (see photograph). With the refuelling complete the pilot was given departure and taxi clearance. A northerly wind was blowing at 11 kt.

Two marshalls were on the ramp as the helicopter commenced its ground taxi from spot No 4. One marshaller was positioned between Spots No 2 and 3 and the second marshaller was positioned near to the taxiway centreline between spots Nos 2 and 7. The pilot was to ground taxi by moving forward and turning immediately to the right to pass behind the tail of the S76 helicopter parked on Spot No 2. Before the helicopter taxied the first marshaller saw the pilot shaking his head. This he understood to mean that the pilot thought that there was insufficient room to manoeuvre. The first marshaller

believed that sufficient space existed and signalled to the second marshaller for confirmation. This was confirmed and relayed to the pilot with a 'thumbs up'. Having been given the all clear signal the pilot manoeuvred the helicopter with a tight turn to the right and proceeded to taxi behind spot No 2. The marshalls reported that "at no time did it look as though the main rotor of the A109 would overlap the tail rotor of the parked S76". After the widest part of the A109's rotor disc had cleared the tail rotor of the S76 the second marshaller walked towards the S76 to hold down one of the main rotor blades to prevent it flapping in the down draft. At this point the higher left rear quadrant of the A109's rotor disc hit the tail rotor of the parked S76. The pilot, who had heard a bang and felt a slight lateral vibration, shut down, vacated the helicopter, and inspected the damage.
